AC NO: AC 20-52

MAINTENANCE INSPECTION NOTES FOR
DOUGLAS DC-6/7 SERIES AIRCRAFT

AUGUST 24, 1967

DEPARTMENT OF TRANSPORTATION
Federal Aviation Administration

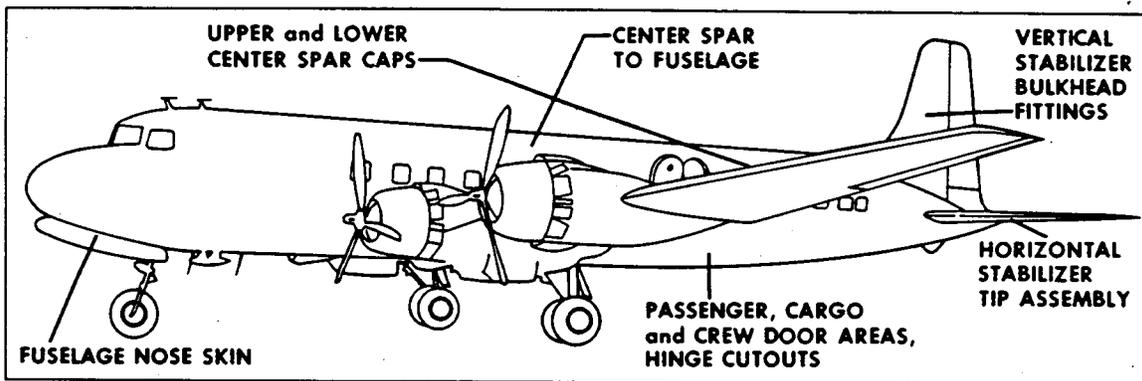
FIGURE 1- AREAS SUBJECT TO FATIGUE CRACKS

- (1) Wing to fuselage attach fittings at center spar.
 - (2) Horizontal stabilizer and tail stub front spar attach fittings.
 - (3) Fuselage nose skin plating.
 - (4) Main crew/cargo entrance door latch plates.
 - (5) Rear fuselage frame and transverse floor beams.
- c. Corrosion Prone Areas. Figure 2 refers to some of the corrosion prone areas in the aircraft. Manufacturer's service bulletins and manuals have been issued to provide detailed repair instructions.

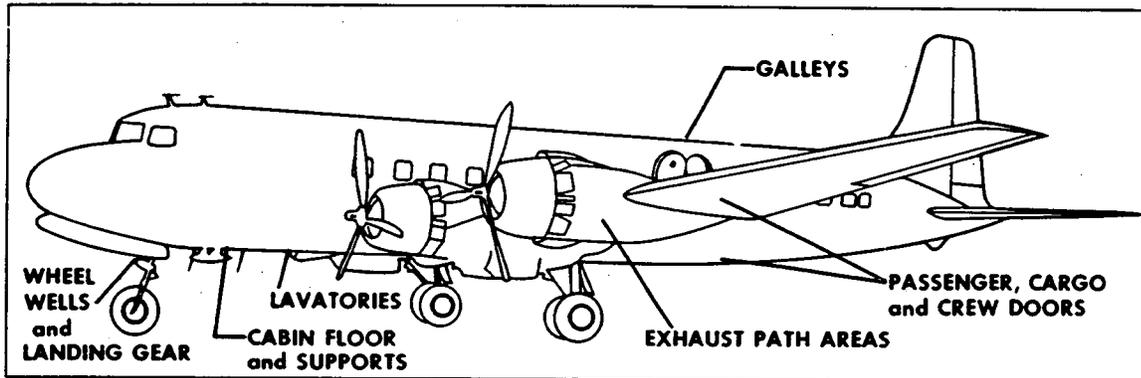
FIGURE 2 - AREAS SUBJECT TO CORROSION DAMAGE

- (1) Exhaust path areas.
- (2) Battery areas and vents.
- (3) Lavatories, galleys, and cabin floors.
- (4) Wheel wells and landing gear.
- (5) Joints between extruded aluminum sections and laminations.
