Report No. FHWA/RD-80/158

# STABILITY OF RELOCATED STREAM CHANNELS

March 1981  
Final Report

1. Report No. FHWA/RD-80/158		2. Government Accession No.		3. Recipient's Catalog No.	
4. Title and Subtitle  Stability of Relocated Stream Channels				5. Report Date March 1981

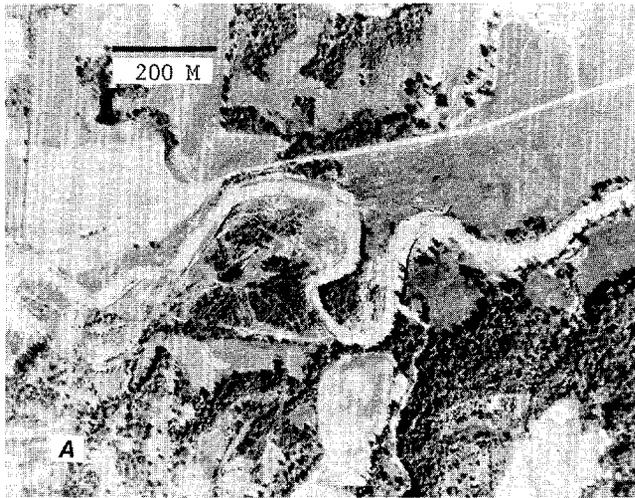
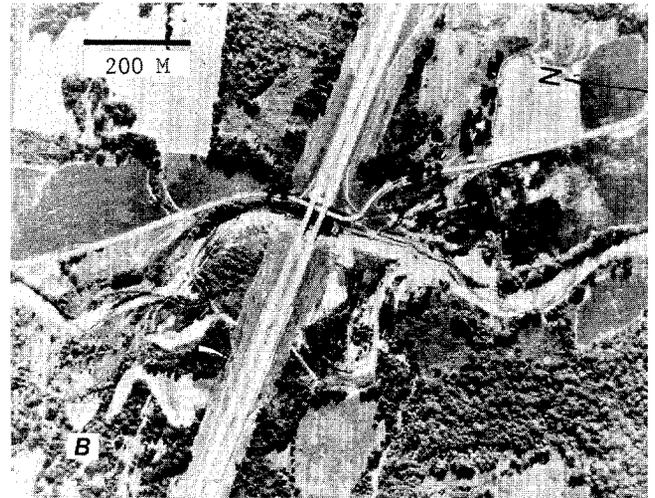
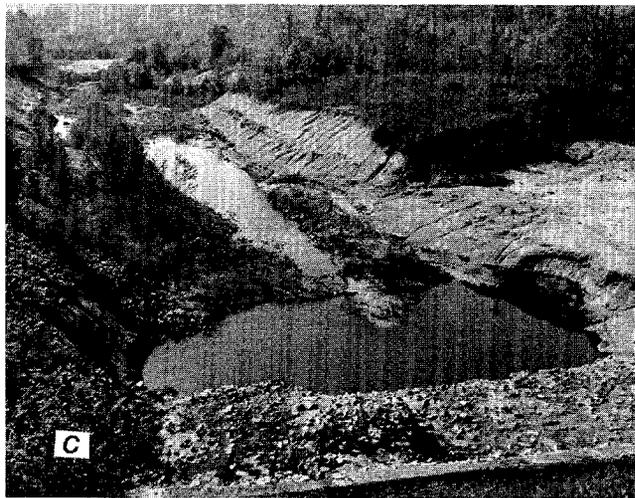
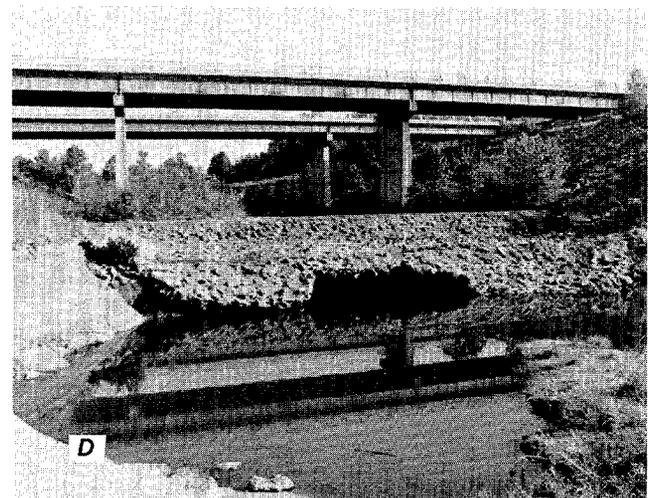
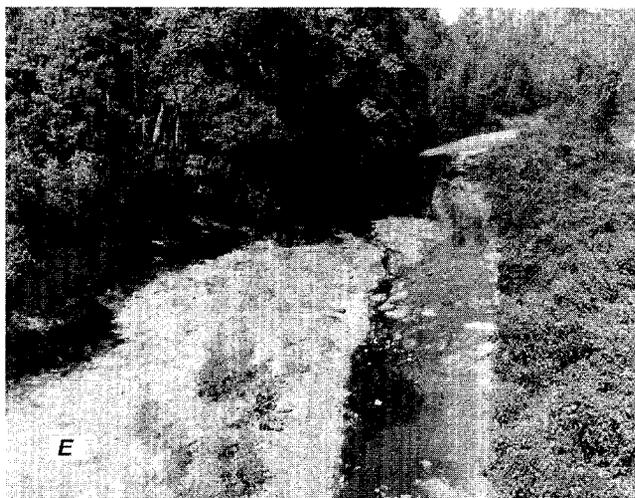
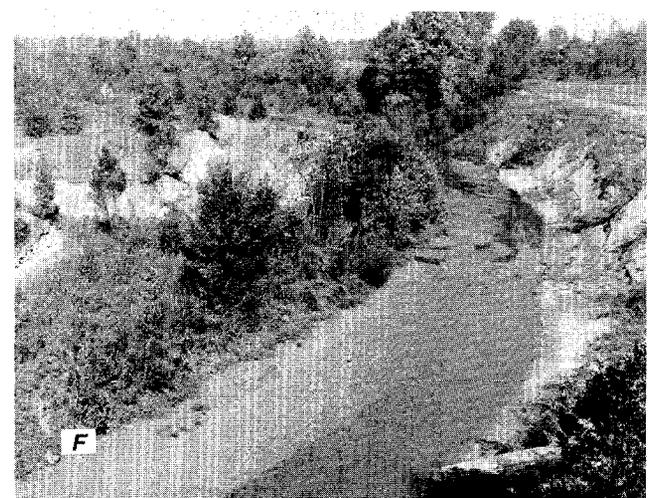
DISCUSSION--Instability, particularly with regard to degradation, of the natural channel was not taken into account in the design of pier foundations, and the check dam was added as a countermeasure. Although the check dam has prevented further degradation, it presents continuing problems of erosion and maintenance. If the bridges were located about 50 m upstream from the existing site, the danger of encroachment of the meander against the highway embankment would be removed and flow alignment at the bridges would be reasonably good without channel alteration. The high streambanks near the bridge could then have been stabilized by grading, placement of flexible revetment, and planting with vegetation.

Figure 41. Crow Creek at site 10. A, Airphoto of site in 1957, prior to relocation. Position of relocated channel shown in dashed lines. (From U.S. Dept. of Agriculture). B, Airphoto in 1968, four years after relocation. (From U.S. Dept. of Agriculture). C, Relocated channel as viewed downstream from bridge, in 1978. Check dam is in foreground. D, Scour at check dam, as photographed in 1978. E, Natural channel 2.7 km downstream from relocation, in 1978. F, Channel as viewed upstream from bridge in 1978.

DISCUSSION--In 1979, the lip of the check dam stood 2.5 m above the surface of the plunge pool at its base. If the check dam fails, degradation will proceed upstream along the tributary, but it will be detained by the resistant cemented gravel in the streambed. The most serious erosion has been induced by overfall at the check dam. Overfall of this magnitude could probably have been prevented by a series of low, flexible check dams of rock riprap, rather than a single check dam.

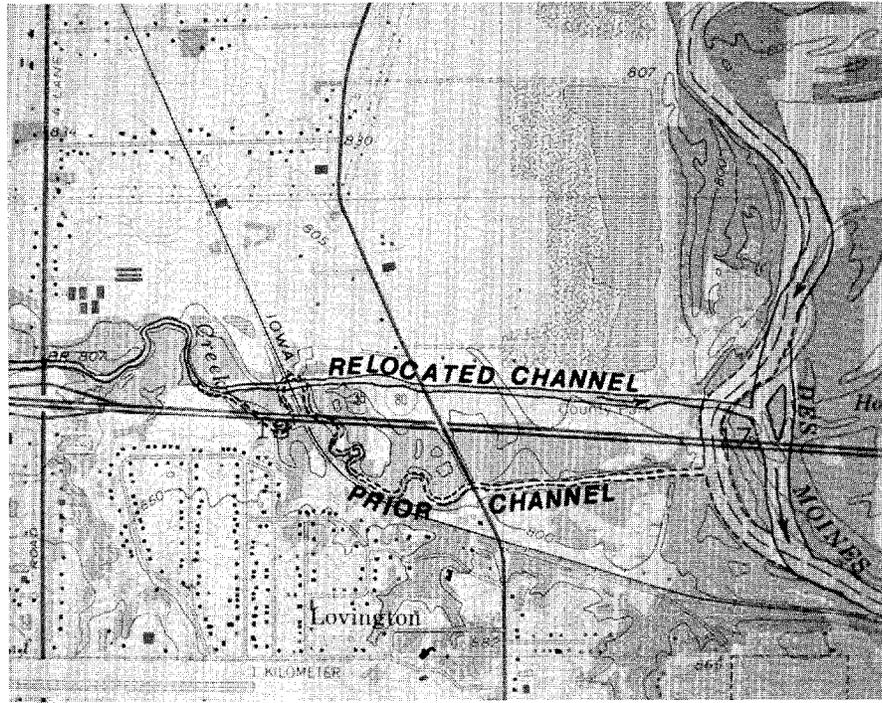
Relocation of the Des Moines River has led to a bank erosion problem near the west bridge abutment because of the growth of an island in the channel. Islands are uncommon in the Des Moines River, and this one is probably due to sediment discharged into the Des Moines from Beaver Creek and derived from eroding banks of relocated Beaver Creek.

Figure 58. Topographic map showing relocation of Beaver Creek and Des Moines River. (From U.S. Geological Survey Des Moines NW 7.5' map)

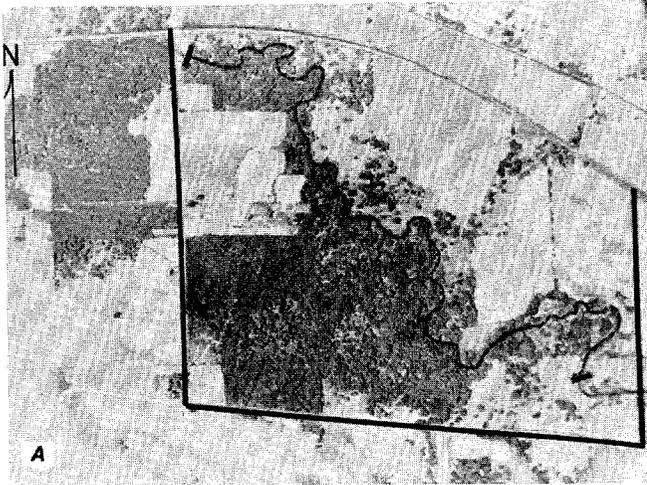
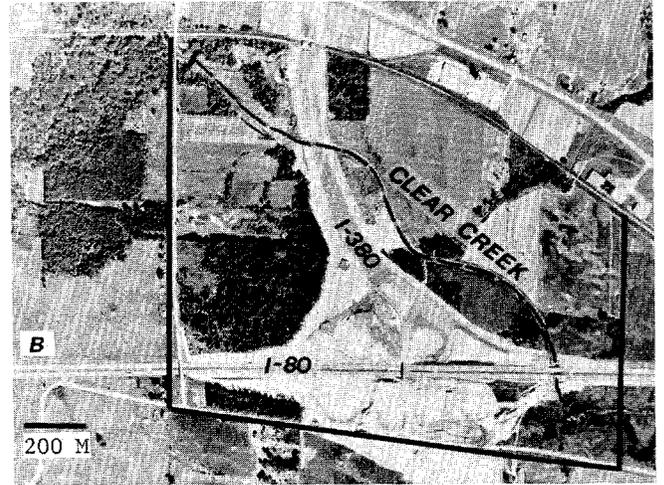
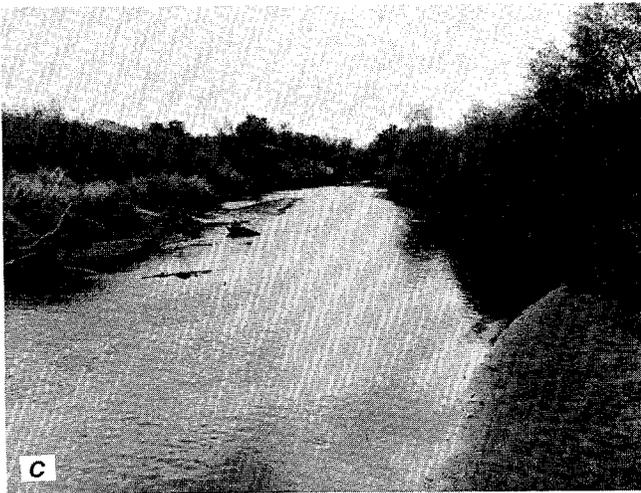
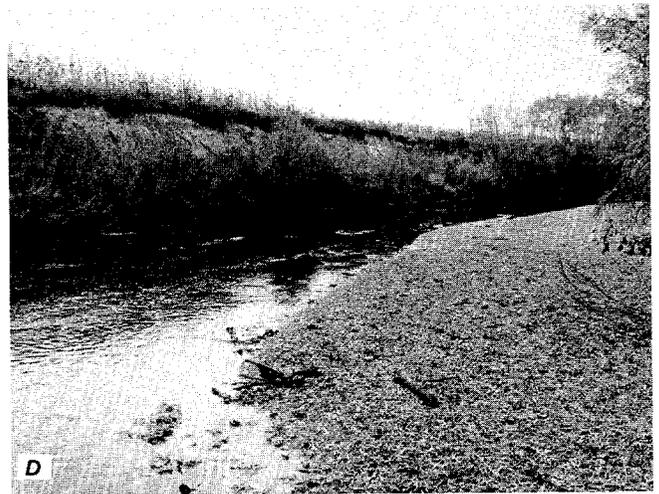
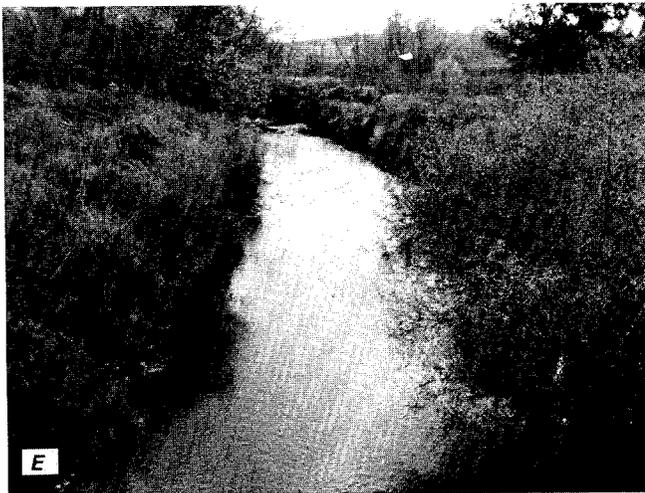
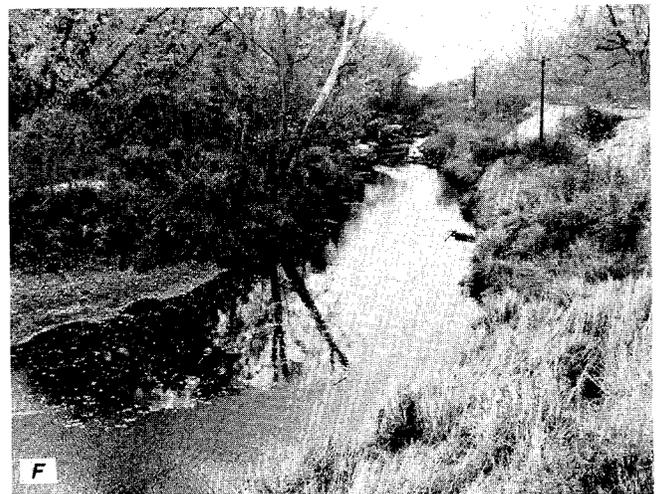
DISCUSSION--Establishment of vegetation along the berm at the toe of the bank is the only apparent factor in the halting of progressive bank erosion. The reason for little or no degradation is not apparent.

Figure 62. Clear Creek at site 21. A, Airphoto of site in 1956. Meandering course of Clear Creek is indicated by dotted line. Distance between vertical lines bounding area is 1,400 m. (From U.S. Dept. of Agriculture). B, Airphoto of Clear Creek site in 1970. Relocated course of creek is indicated by heavy dashed line. (From U.S. Dept. of Agriculture). D, Relocated channel at bend downstream from I-380 crossing, in 1979. D, Relocated channel at bend upstream from I-80 crossing, in 1979. E, Natural channel downstream from I-80 crossing, in 1979. F, Natural channel upstream from relocation, in 1979.

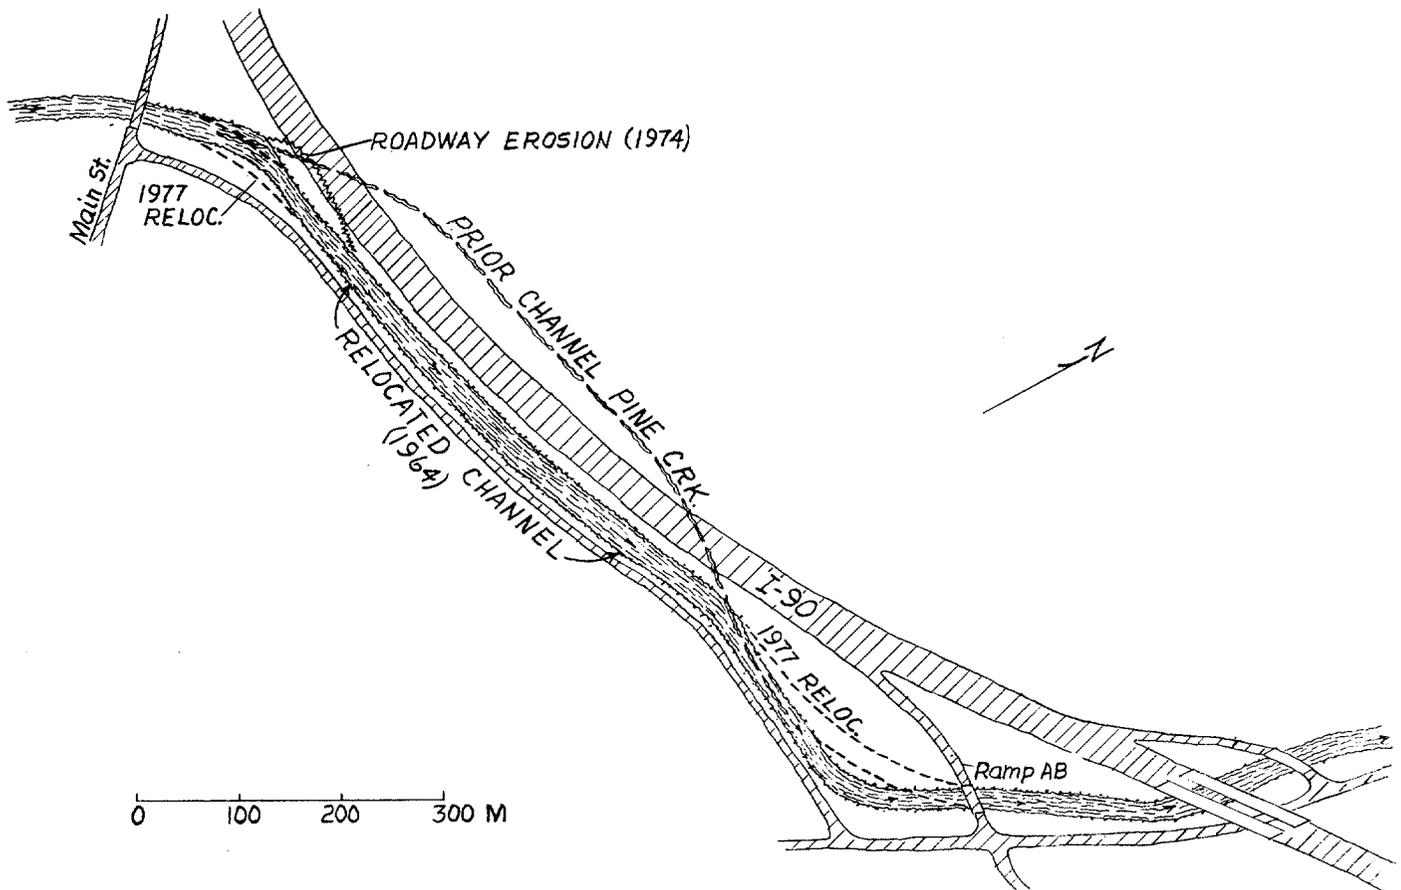
Figure 66. Plan sketch of Pine Creek channel relocation.

In 1977, the relocated channel was modified to prevent a recurrence of flood erosion damage. The radius of the bend at the Main Street bridge was increased from 84 m to 349 m, and the radius of the bend above the Ramp AB bridge was increased from 81 m to 218 m. Riprap on the banks of the modified channel was placed to a depth of 1 m, and the toe of the riprap blanket was extended to 1.5 m below the channel bottom. Riprap on the outside of the curve above the Ramp AB bridge was concrete grouted. There has been little growth of vegetation along the channel since 1977.

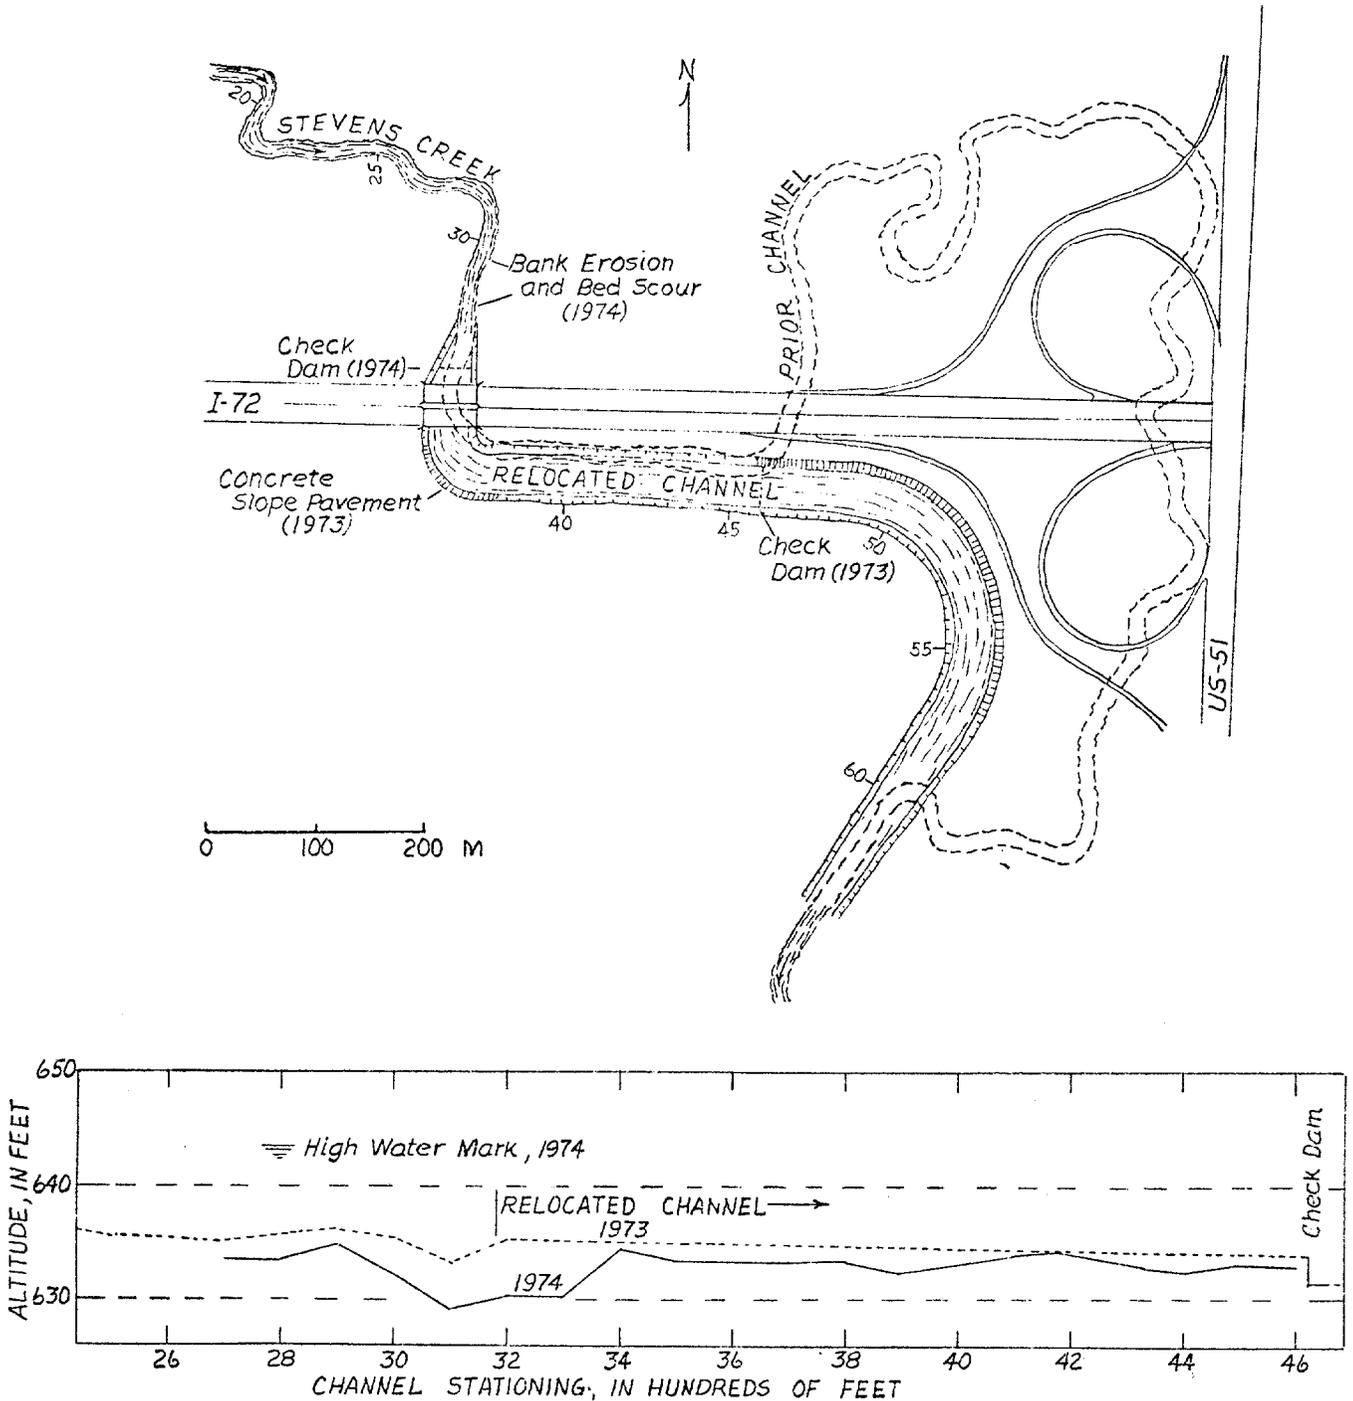
tion, amounting to about 0.6 m, extended upstream along the natural channel and downstream along the relocated channel as far as a concrete check dam. Lateral erosion also occurred at the toe of the concrete slope pavement just downstream from the bridge. Downstream from the relocation, the natural channel was apparently not much affected, as the extent of cut banks as observed in 1978 (fig. 71A ) is not significantly different from that shown on a 1965 airphoto.

Figure 70. Top, plan sketch of Stevens Creek channel relocation. Bottom, longitudinal profiles of channel bottom before and after 1974 flood.

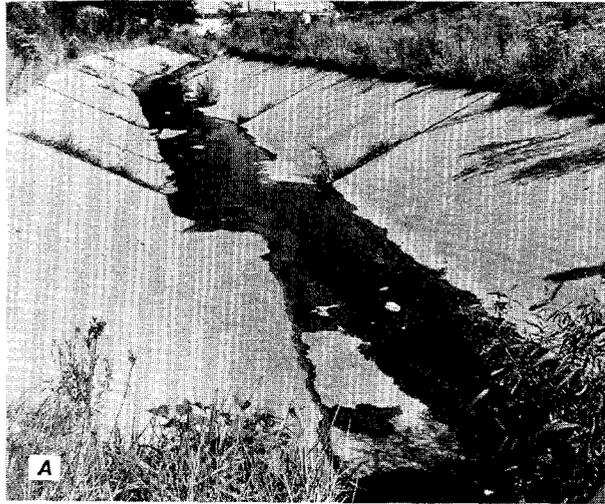
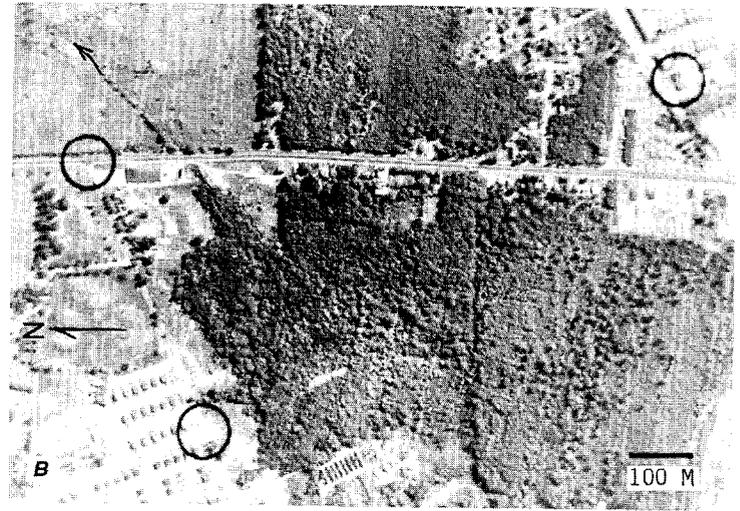
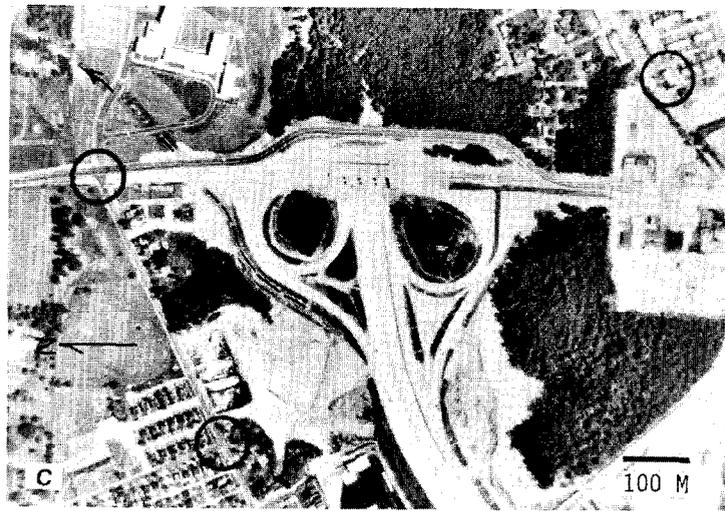
Figure 103. Tributary to Maiden Choice Branch at site 45. A, Original concrete lining of relocated channel, as photographed in 1978. Note bulging and cracking of bottom. B, Airphoto of relocation site in 1957. Reference points are circled for comparison with 1971 airphoto. (From U.S. Dept. of Agriculture). C, Airphoto of relocation site in 1971. Note bare side slope above bottom circled reference point.

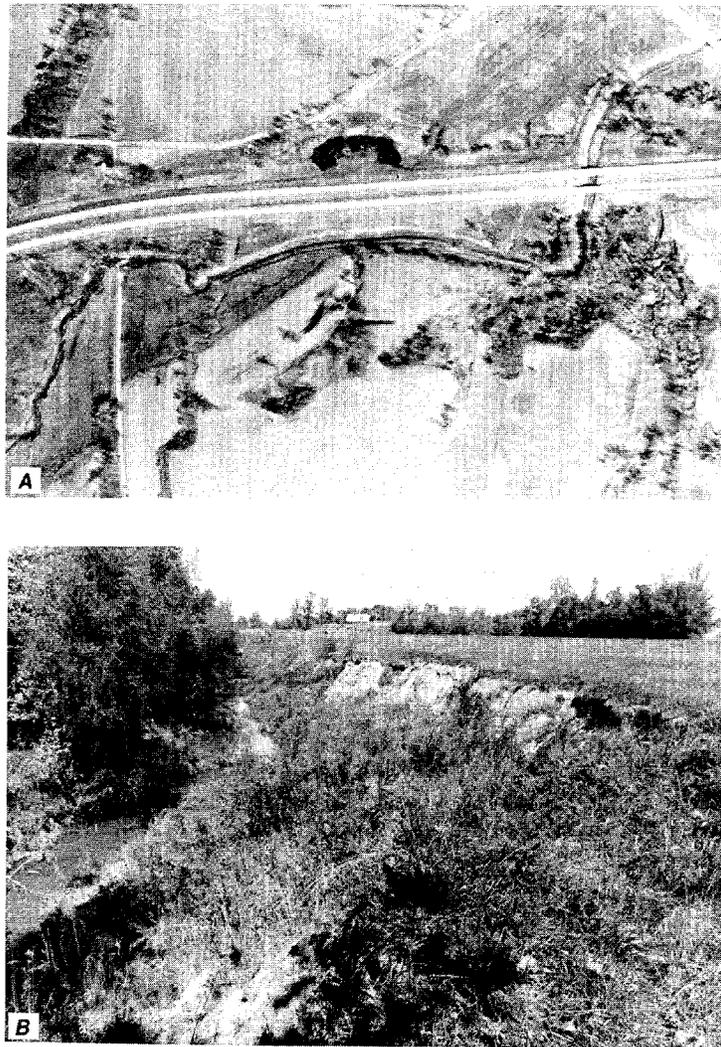
Figure 123. Ramsey Creek at site 56. A, Airphoto of channel relocation in 1965. B, Slumping of left bank, foreground, about midway along relocated channel, in 1978.

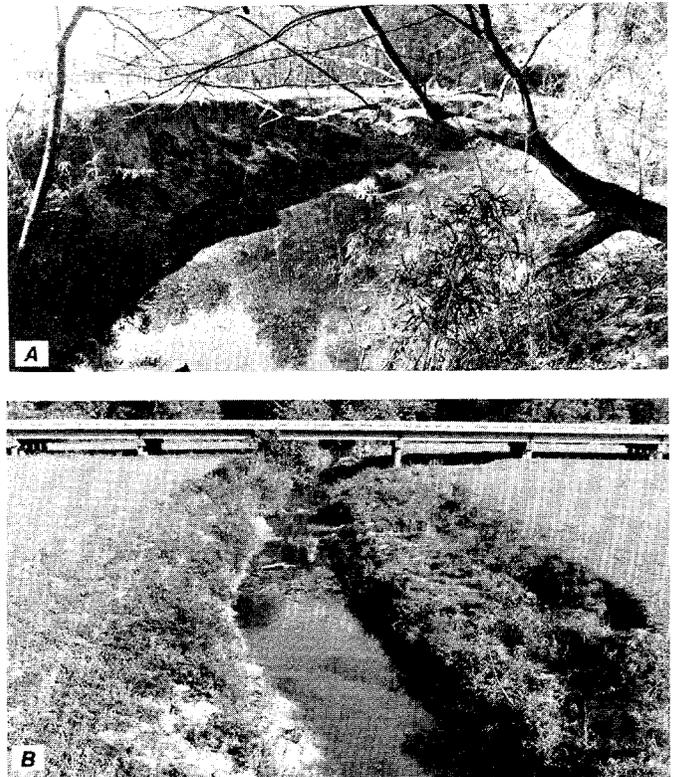
Figure 131. Turkey Creek at site 60. A, Relocated channel between interstate bridges, in 1979. B, Bank erosion at bend downstream from relocation, in 1979.

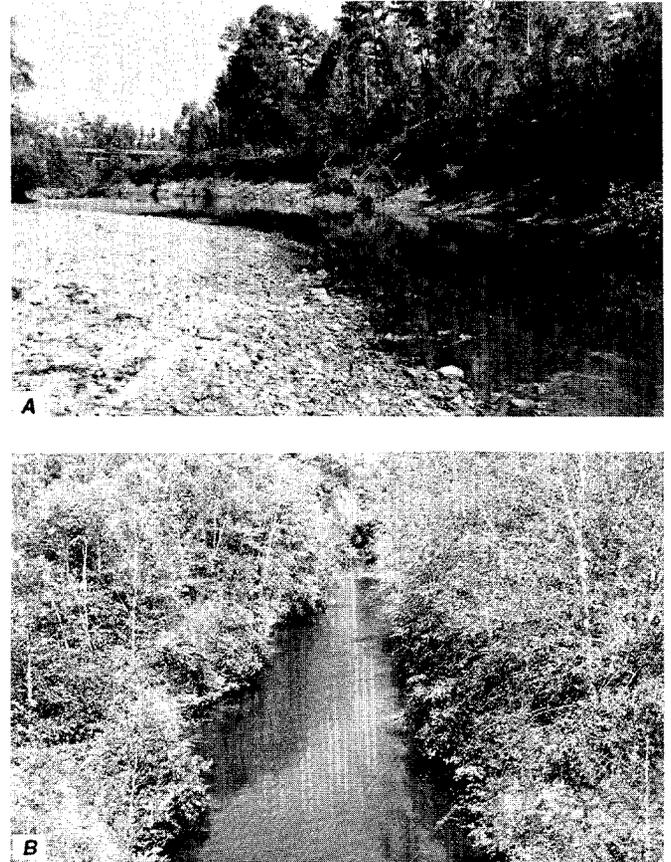
Figure 135. Tallahatta Creek at site 62. A, Relocated channel as viewed upstream from interstate bridge in 1979. B, Eroded left bank downstream from bridge, in 1979. Point bar is in foreground.

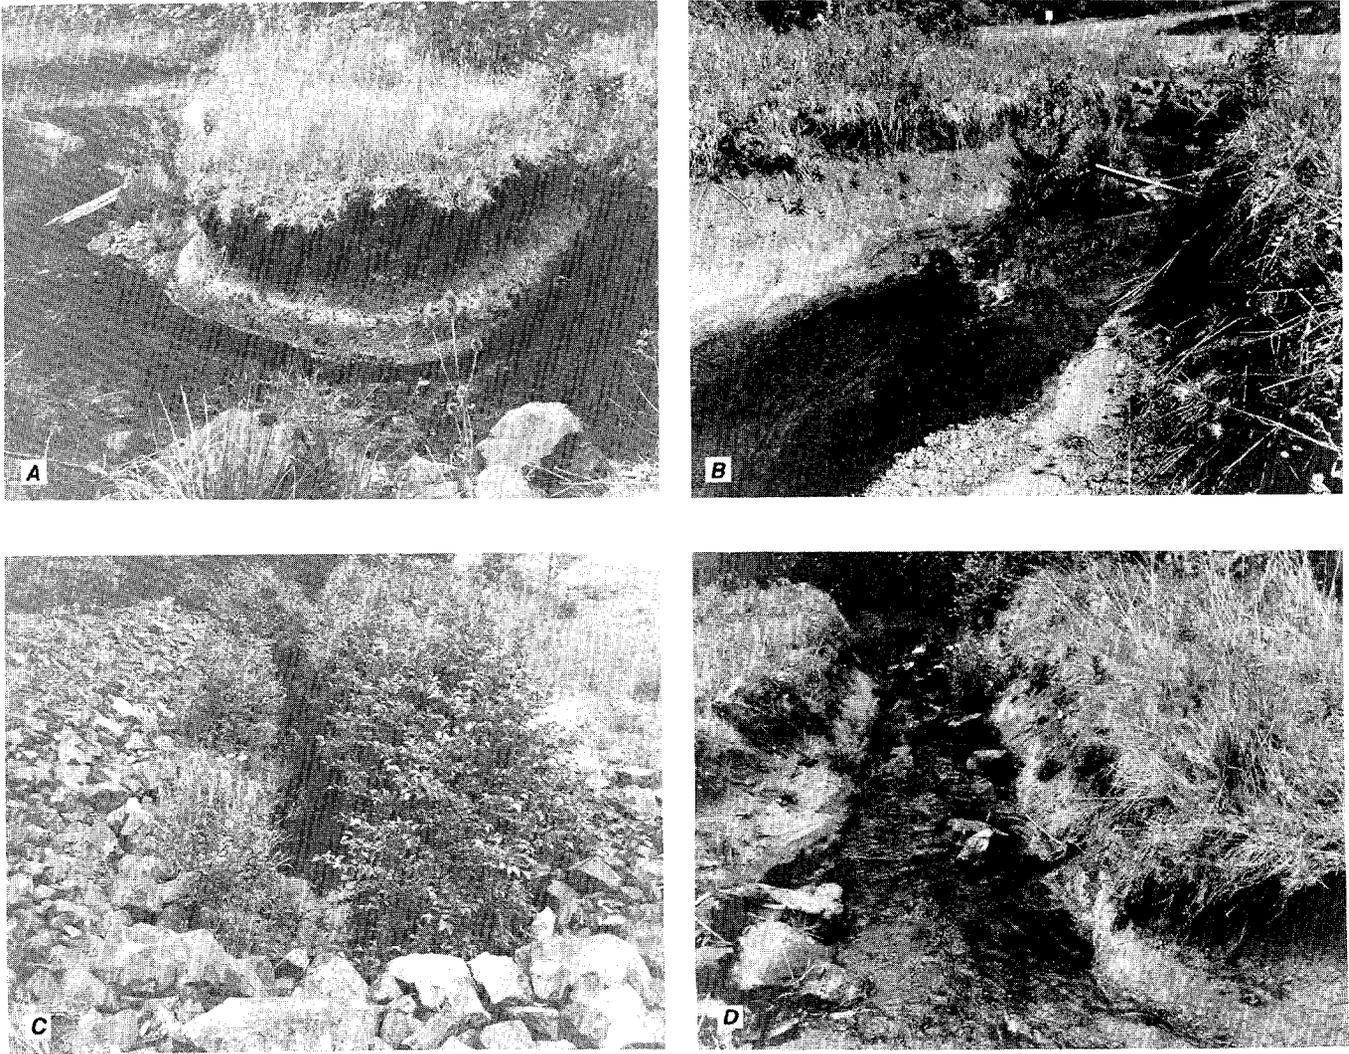
Figure 172. Gellatly Creek at site 85. A, Meander loop of relocated channel, in 1979. B, Reach downstream from apex of meander loop. Note small rapids, which may indicate degradation, and remains of introduced bed material. C, Straight reach of relocated channel. D, Downstream transport of large riprap, originally placed at apex of bend.

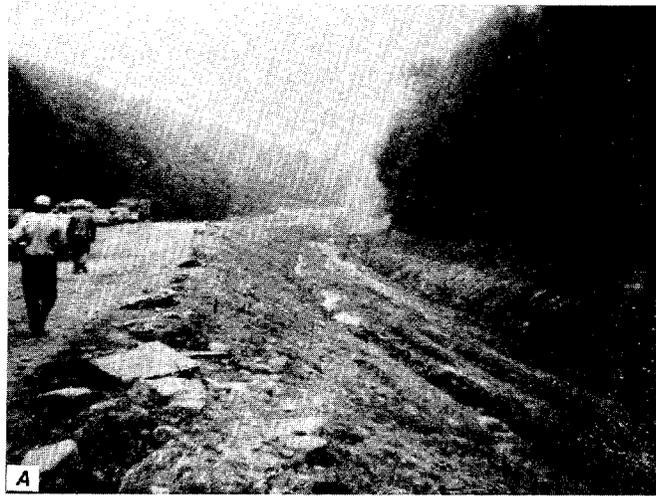
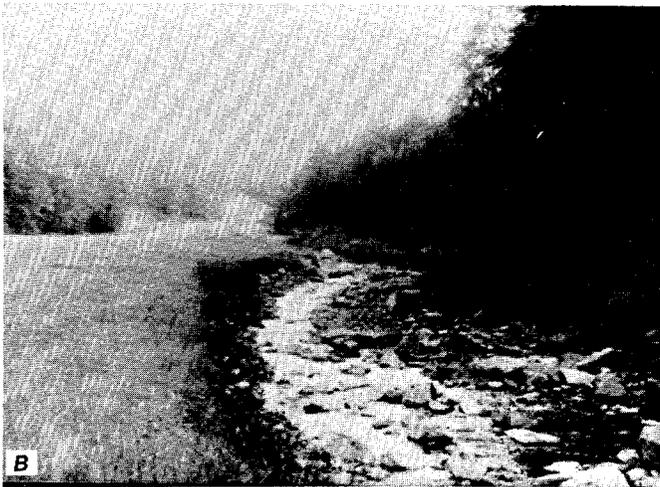
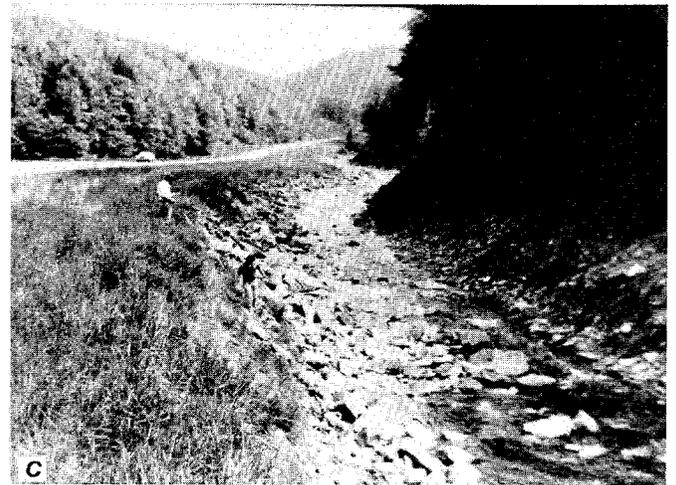
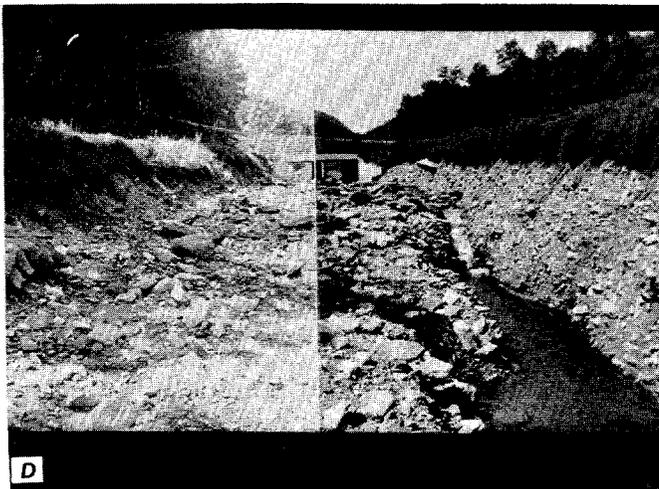
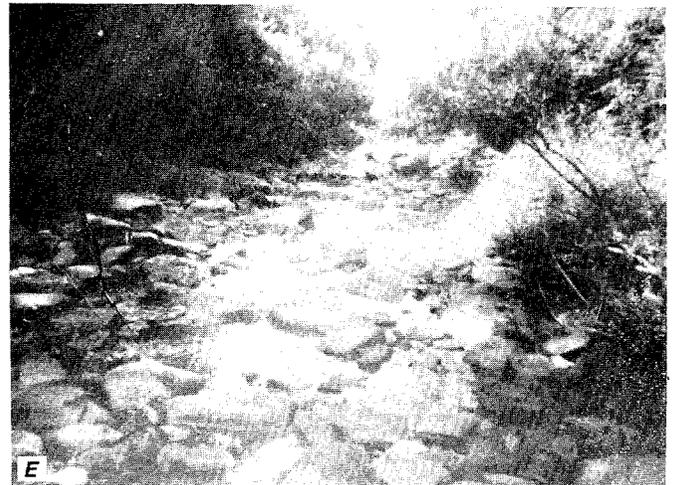
Figure 180. Wilson Creek at site 89. A, View of relocated channel during construction in 1973, looking downstream from a location below the bridge at Road 345. B, View from nearly the same location as for A, in 1974. C, View from nearly the same location as for B, in 1979. Dumped rock riprap has been placed at left bank. D, View upstream toward bridge at Road 345, in 1976. Degradation indicated by scarp in channel, at right. E, Natural channel prior to relocation. (From Pennsylvania Dept. of Transportation).

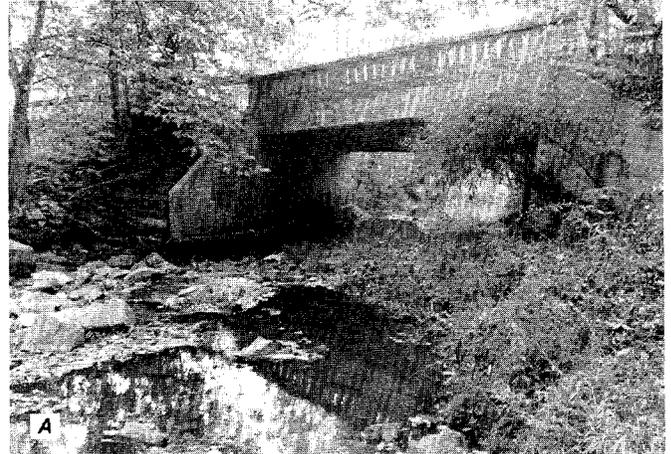
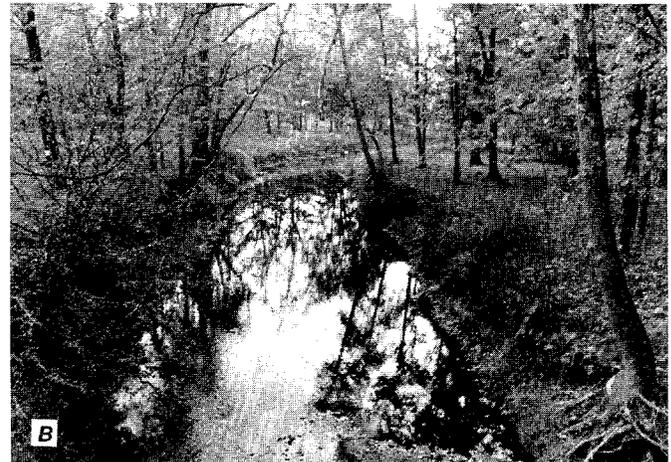
Figure 188. Black Creek at site 93. A, View downstream toward failed left bridge abutment in 1978. B, View from bridge, downstream along relocated channel, in 1978.
