# LTPP Pavement Maintenance Materials: SHRP Crack Treatment Experiment, Final Report

PUBLICATION NO. FHWA-RD-99-143

SEPTEMBER 1999

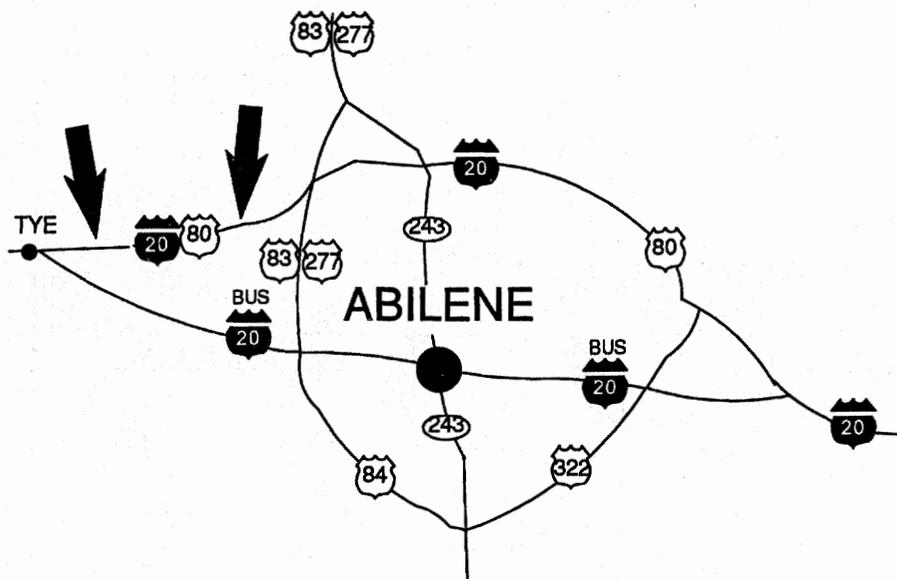
Pavement condition at the time of installation was fairly good. Transverse cracks were the only significant form of distress present. These cracks were typically about 3 mm wide and were spaced fairly regularly—between 15 and 18 m. Very little spalling and secondary cracking was observed along the transverse cracks.

Figure 3. Abilene, Texas transverse crack-seal test site.

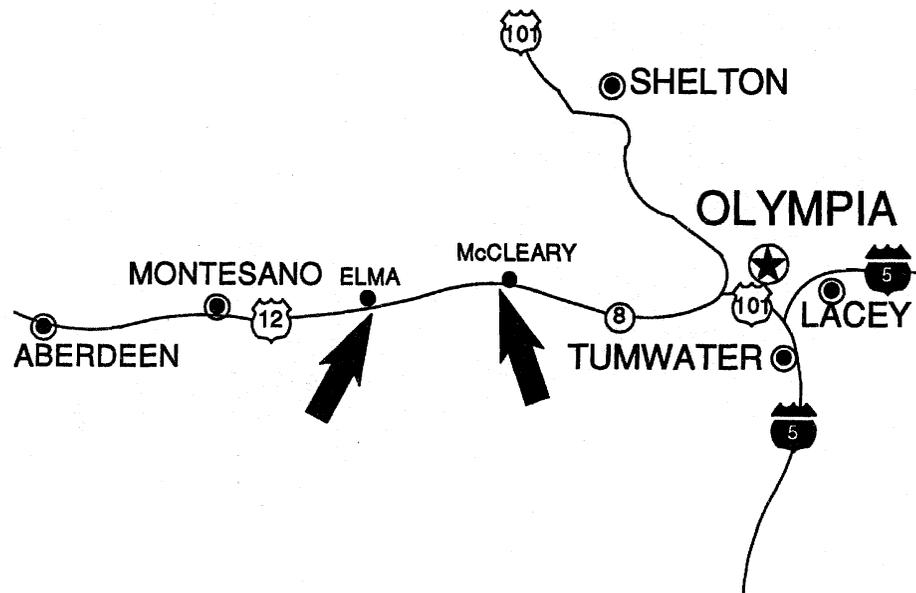
When this road was selected as a crack-seal site, overall pavement condition was fairly good. Transverse cracks were present, typically at 23 to 31 m. The cracks, ranging between 3 and 6 mm wide, were accompanied by very few spalls and secondary cracks. Some rutting was evident in the wheelpaths, but usually to depths no greater than 6 mm.

Figure 4. Elma, Washington transverse crack-seal test site.

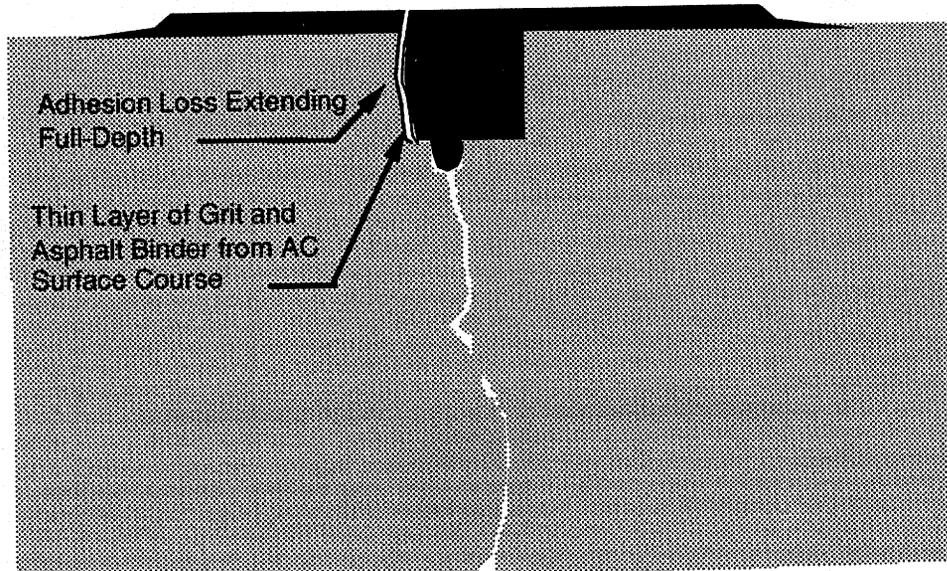
Figure 33. Illustration of full-depth adhesion loss in recessed band-aid.

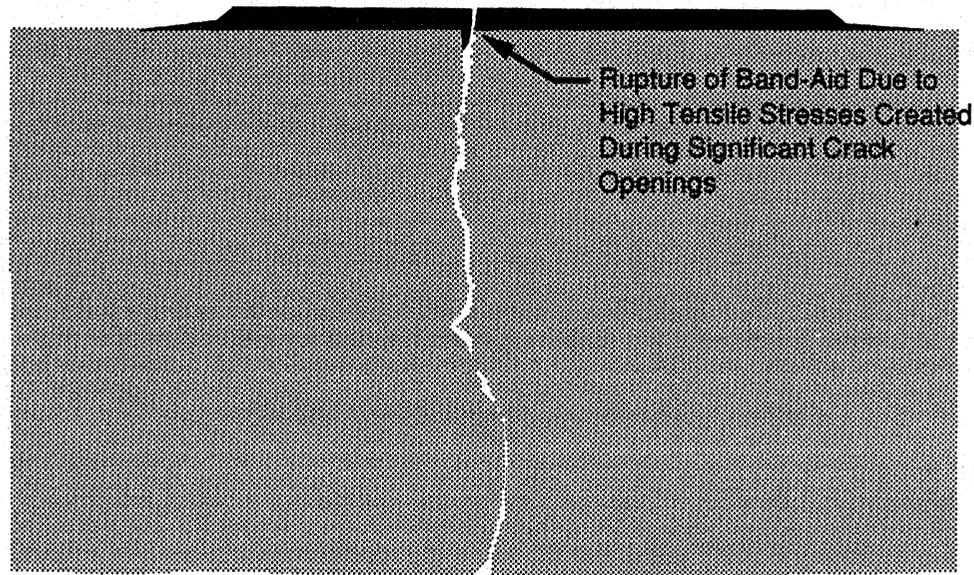
Figure 34. Illustration of full-depth cohesion loss in simple band-aid.

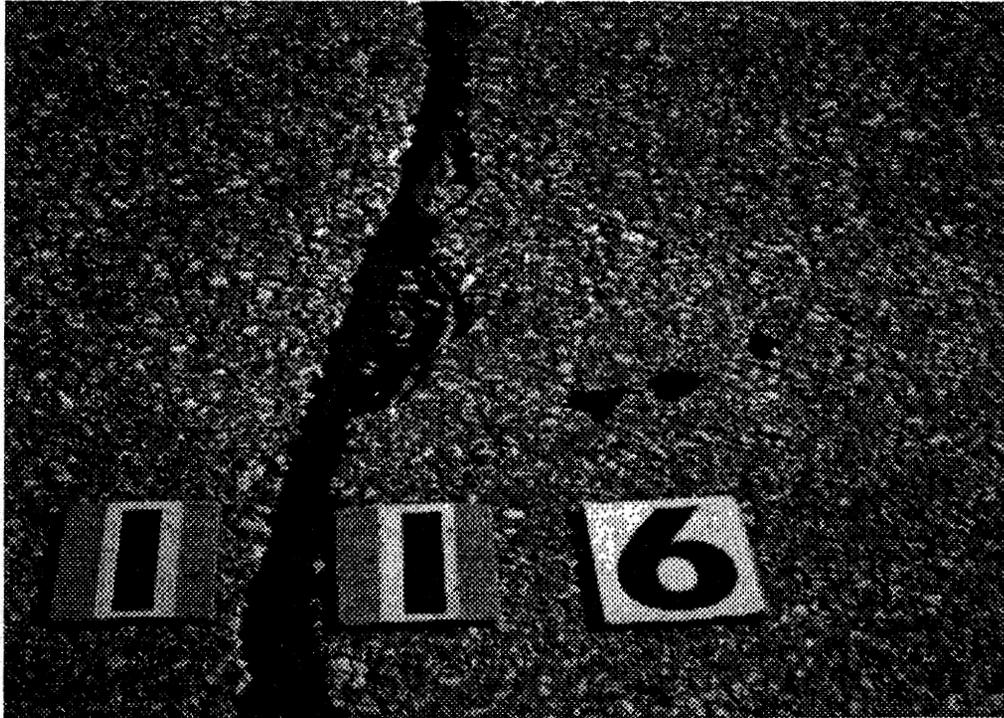
Figure 35. Typical spill and secondary crack adjacent to 890-SL silicone seal.
