Laboratory and Test-Site Testing of Moisture-Cured Urethanes on Steel in Salt-Rich Environment

FHWA-RD-00-156

DECEMBER 2000

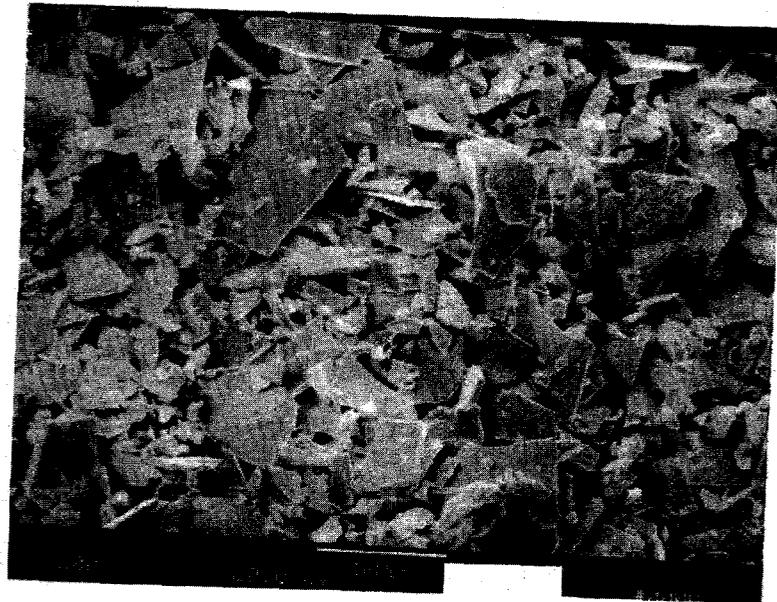
Figure 1. SEM micrograph of natural micaceous iron oxide.

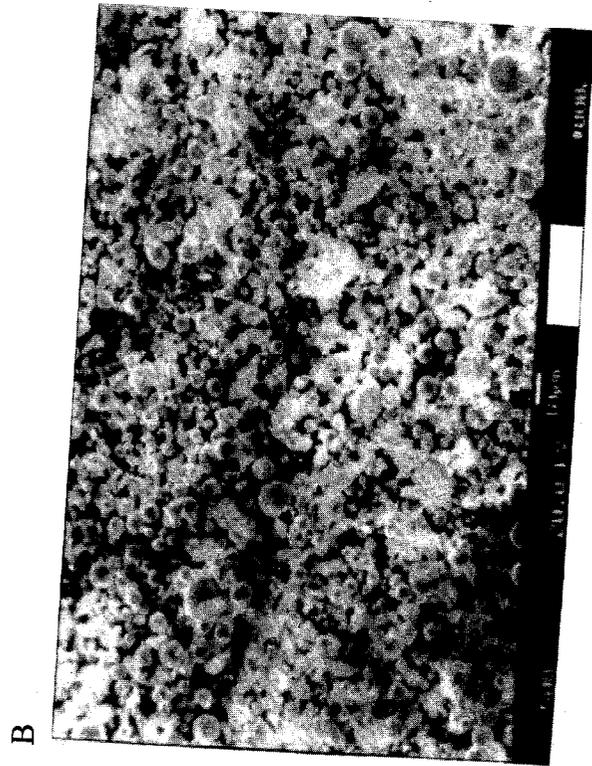
Figure 5. SEM micrographs of pigment in Primers A, B, and C.

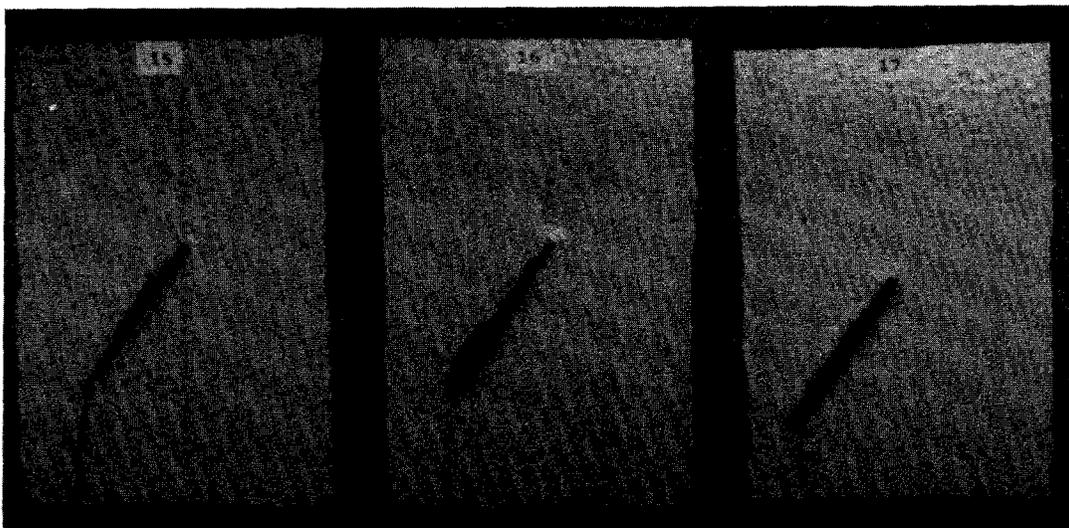
Figure 30. Coating conditions of MC-urethane System A2 over SP 3 (a) and over chloride-doped SP 3 (b) surfaces after 4,000-h laboratory test.

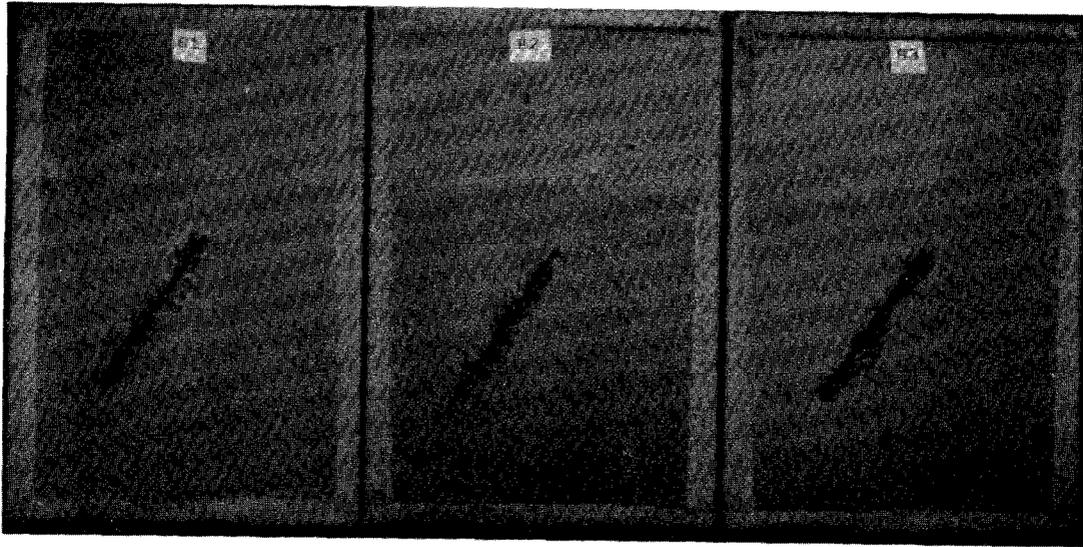
Figure 31. Coating conditions of MC-urethane System B2 over SP 3 (a) and over chloride-doped SP 3 (b) surfaces after 4,000-h laboratory test.
