# Job Site Evaluation of Corrosion-Resistant Alloys for Use as Reinforcement in Concrete

PUBLICATION NO. FHWA-HRT-06-078

JUNE 2006

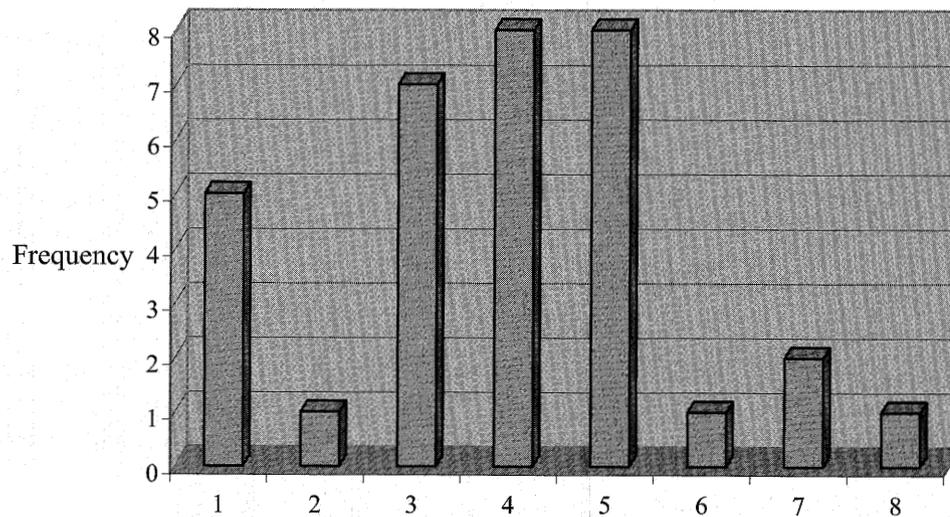
**Figure 1. Distribution of information acquisition and analysis for the IBRC projects.**

Figure 1 shows the number of projects in each of the table 1 footnote classes. This indicates that the project team visited five of the projects (Note 1 designation) and in each case, acquired samples of the innovative reinforcement. For two additional projects (FHWA Project Numbers MO-00-01 and SC-00-01), one of which was completed prior to the present study, sufficient information was provided by the respective State DOT personnel that a report was prepared. Each of these seven reports is included below as appendixes A–G. In instances where samples of the innovative reinforcement were acquired from a job site, composition and mechanical properties were determined; and in some cases accelerated corrosion tests were performed.

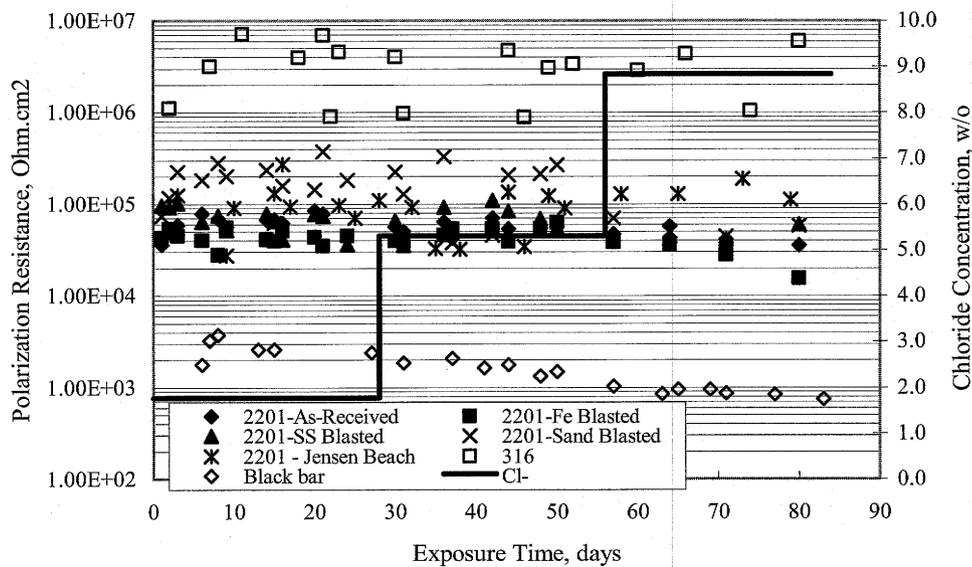
**Figure 2. Accelerated testing data for Type 2201 stainless steel specimens.**

Figure 2 shows a plot of polarization resistance (Rp) as a function of exposure time for the various Type 2201 stainless specimens along with data for black bar and Type 316 stainless for comparison. Specimens labeled according to the four surface conditions were provided directly by FDOT (see Appendix C1), whereas the specimens designated "Jensen Beach" (these were silica sand blasted) were acquired directly from the job site, where they had been stored uncovered about one kilometer inland for approximately six weeks. The data show that Rp for the Type 2201 specimens occupy a band about 1–2 orders of magnitude above that for black bar and 1–2 orders of magnitude below the Type 316. Scatter of Rp for the different categories of Type 2201 specimens is about one order of magnitude, with the silica sand and stainless steel blasted materials occupying the upper range. Also, there is a tendency beyond about 50 days for Rp to decrease with time (increasing corrosion rate).

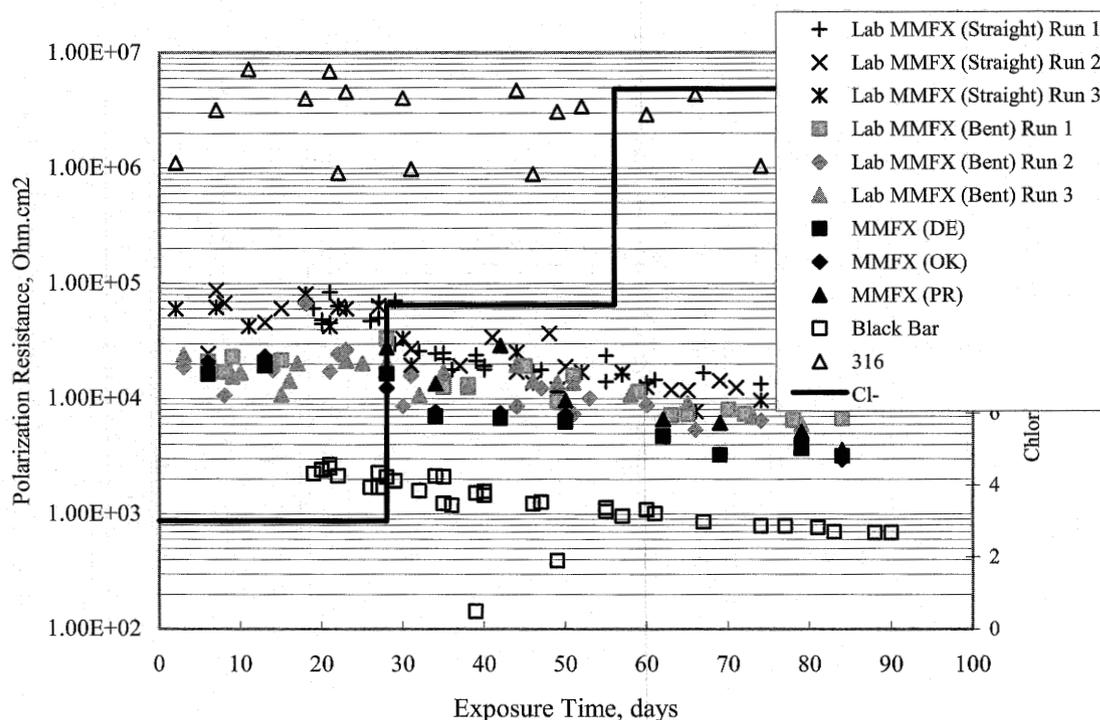
**Figure 3. Accelerated testing data for MMFX-II steel specimens.**

respectively (see table 1). The results indicate general consistency between the different job site and lab MMFX-II specimens with Rp for these being 5–10 times greater than for black bar.

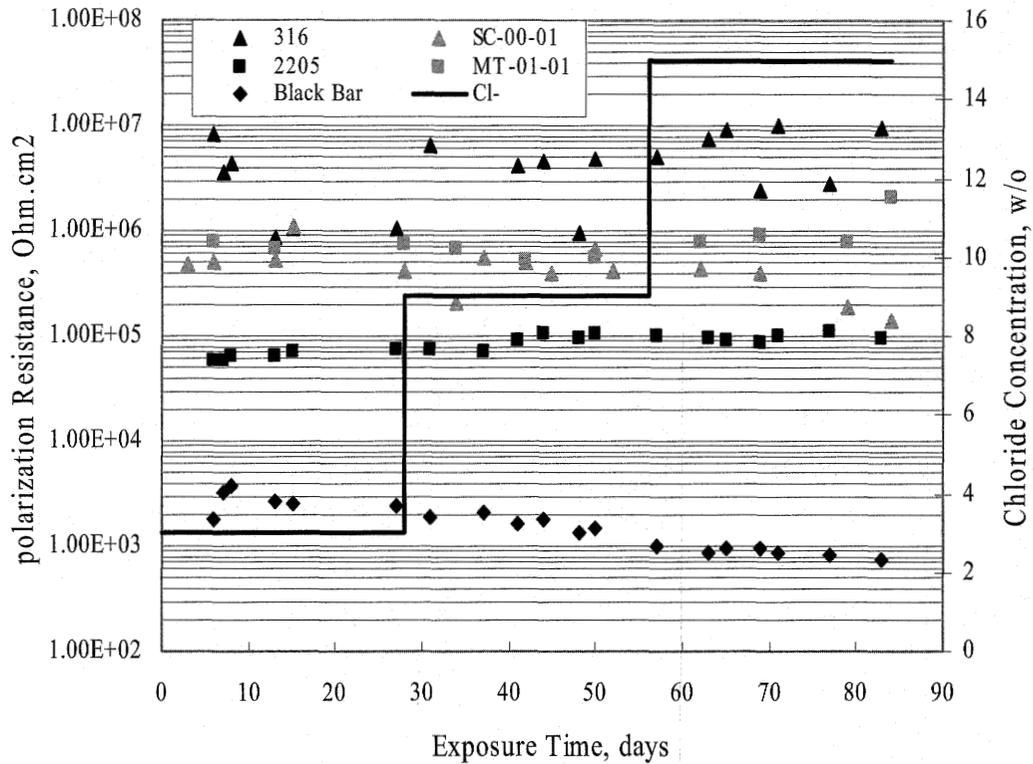
**Figure 4. Accelerated testing data for stainless steel job site bars.**

Figure 4 shows Rp versus time data for specimens prepared from project number MT-01-01 job site bars (Type 2205) and clad bars from the same heat as project number SC-00-01 (not actually from the job site). Data for the Type 316 and Type 2205 stainless that was provided directly to the project by a supplier are shown for comparison. Polarization resistance for the SC-00-01 clad bars varies from the lower range to an order of magnitude below that for the solid 316 (higher corrosion rate for the former). Results for the MT-01-01 specimens fall 3–10 times below those for the laboratory Type 2205 specimens. Thus, while data for laboratory received and job site MMFX-II bars are comparable, corrosion rate for the more corrosion-resistant job site bars was higher than for the laboratory received counterpart. These differences are being evaluated in conjunction with the companion activity.<sup>(15)</sup>

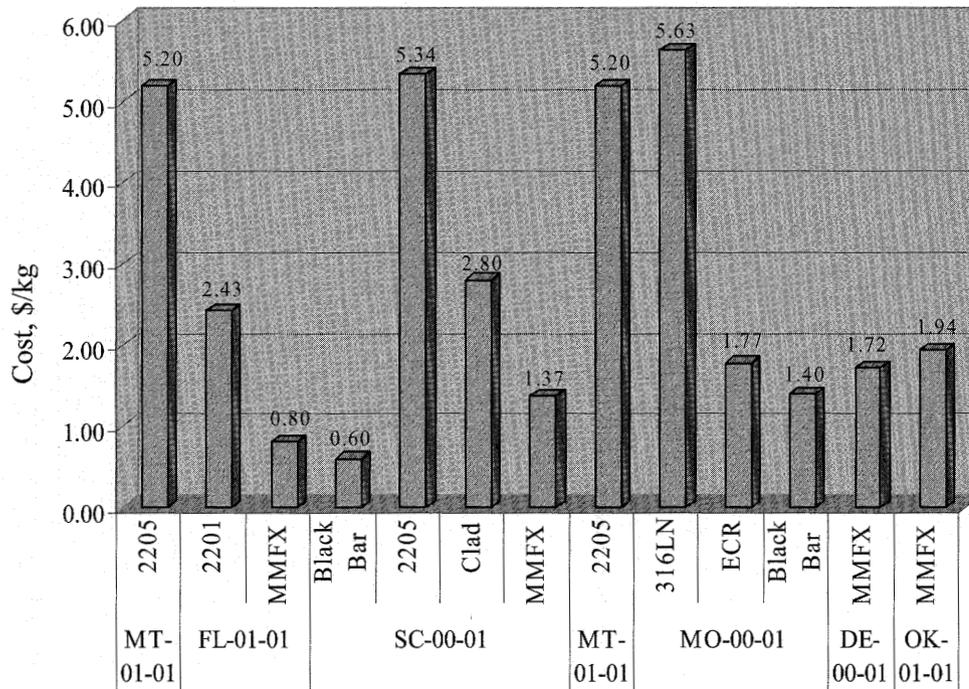
**Figure 5. Cost comparison of the various reinforcements.**

Economics are an important component of any construction materials evaluation. For the reason of evaluating this within the context of the present study, reinforcement costs were acquired for projects for which reports were issued and are presented in figure 5. This shows that the average cost for the 316 and 2205 stainlesses was \$5.34/kilogram (kg) and for the MMFX-II \$1.46/kg. These values may be misleading, however, for the following reasons:

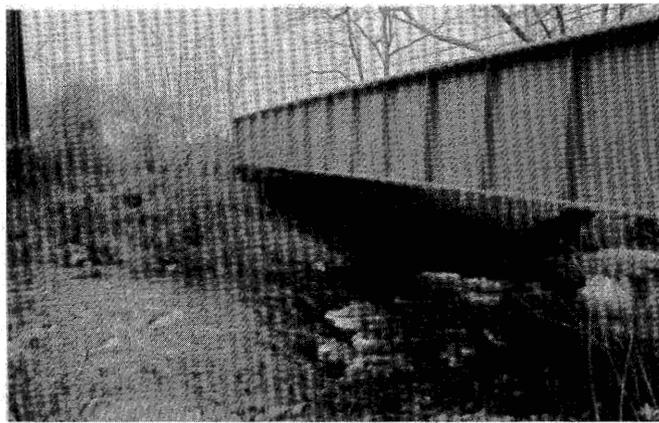
**Figure 6. Side view of Bridge No. 1-119.**

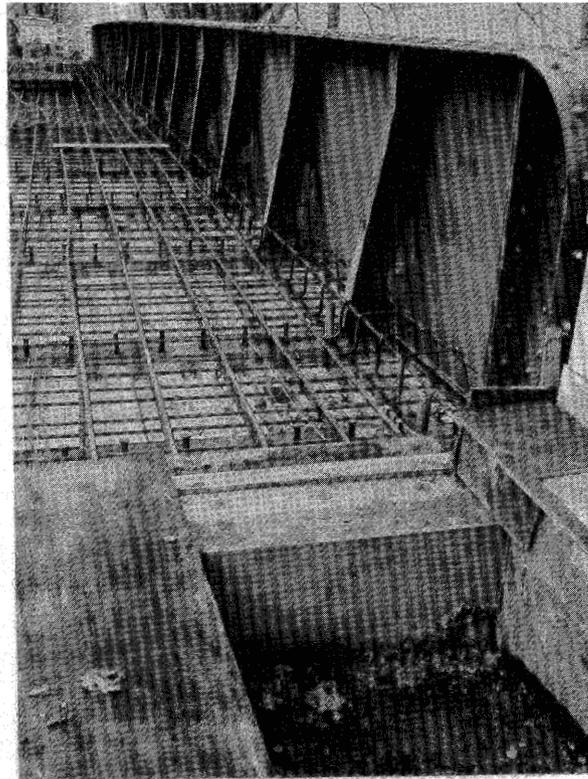
Figure 8 shows a general view of the in-place reinforcement, including that for the curb along one of the railings. Also shown are the girders and welded shear studs. Figure 9 provides a view of forming for the bulkhead at the other bridge end. A closer view of reinforcing bars and a

**Figure 8. General view of in-place reinforcement, girders with studs, curb, and bulkhead.**

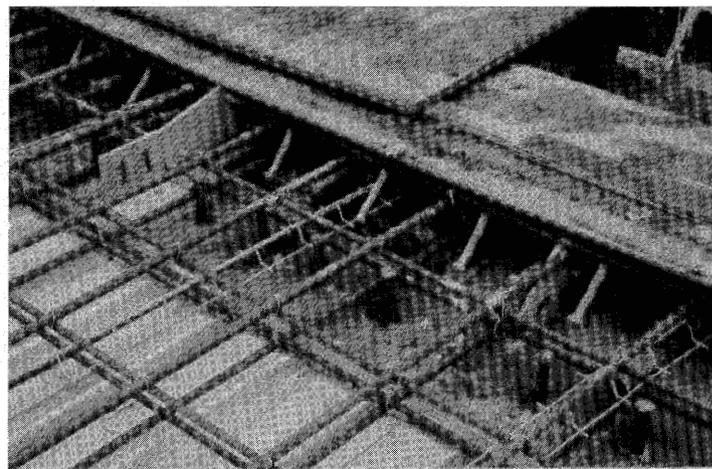
**Figure 9. Closeup view of reinforcing steel, girder with shear studs, gusset plate, and forming for bulkhead.**

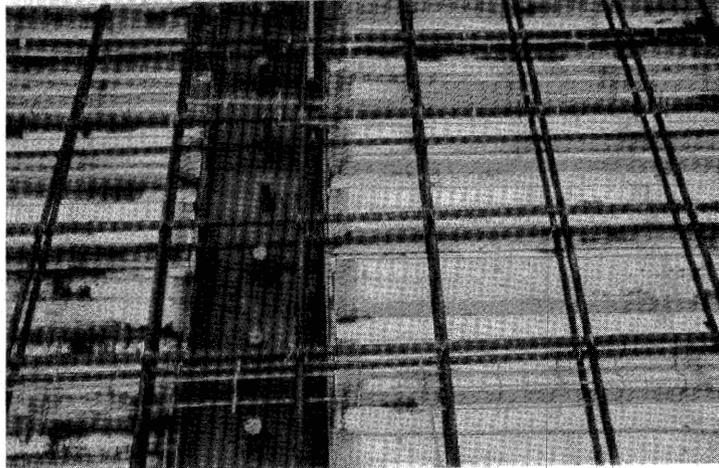
**Figure 10. Photograph of reinforcing steel and a girder with studs.**

girder with welded shear studs is shown in figure 10. The longitudinal and transverse bars are #5s, with spacing for the former being 10 inches and the latter, 12 inches. Figure 11 is also a closeup view of the in-place reinforcement showing superficial rusting. The steel had been onsite for approximately 20 days with rain having occurred during much of this time. This corrosion was judged to be less than what would have occurred with conventional uncoated black steel.

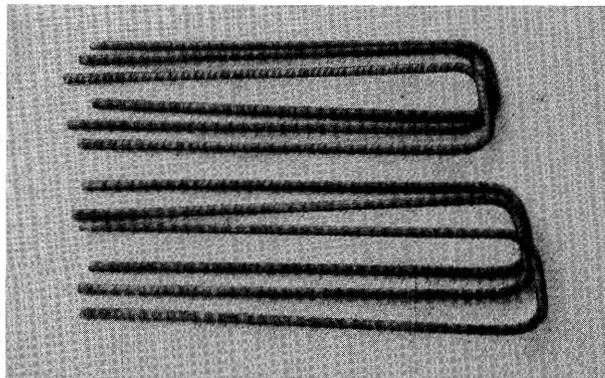
**Material Acquisition:** Six bent bar details were made available from the job storage site for testing by FAU and FDOT. Figure 12 shows a photograph of these.

**Figure 12. Photograph of MMFX-II reinforcement details acquired from the job site.**

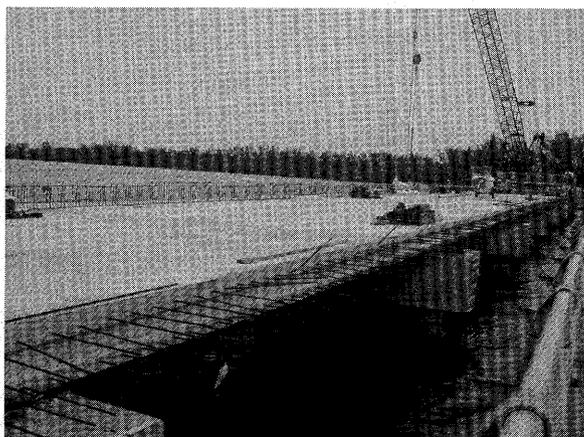
**Bridge Description:** This bridge is the eastern of two four-lane structures<sup>4</sup> in a causeway between Jensen Beach and Stuart in southeast Florida. It replaces a 50-year-old, low-profile, two-lane bridge that has badly deteriorated because of the combined effects of brackish water, near-ocean exposure, and age; it is now functionally obsolete. Figure 13 shows a perspective of what will be the two northern lanes (westbound). Construction of the southern (eastbound) lanes will start once the northern is completed. The project is scheduled for completion in March 2004. Each bent consists of four 0.6-m (24-inch) square prestressed pilings, conventionally reinforced pile caps, and 16 deck spans. These components, plus barrier and parapet walls, are reinforced with conventional steel except for eight deck spans (numbers 9–16), reinforced with MMFX-II. The deck spans are formed cap-to-cap using an assembly of plywood on transverse and then on longitudinal I-beams. The framing is pulled subsequent to concrete setting and is reused.

**Figure 13. Perspective view of replacement  
Bridge Number 890146.**

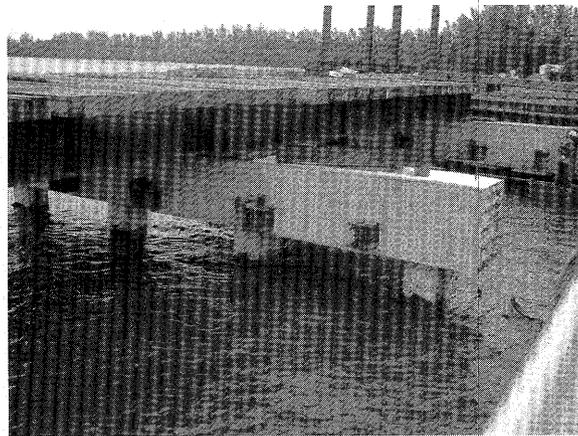
1. Driving of conventional prestressed piles.
2. Forming, steel placement, and pouring of pile caps. Figure 14 shows a view of piles and pile cap for a specific bent.
3. Deck forming, steel placement and pouring of the deck. The deck is being placed from west to east with each span being formed and poured as a separate unit.

**Figure 14. Photograph of substructure components prior to decking.**

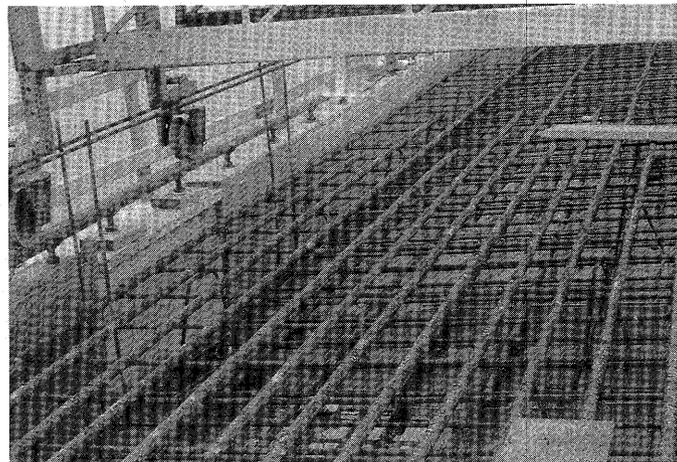
Figures 15 and 16 show photographs of the MMFX-II steel in place on the deck.

**Figure 15. Photograph of MMFX-II deck steel in place.**

**Reinforcement Specification:** At the time of construction, no national standard existed for MMFX-II reinforcing steel. In lieu of this, the manufacturer's "Product Bulletin" dated September, 2001 was employed. The eight MMFX-II deck spans require a total of 145,004 kg (319,734 pounds) of reinforcement. All longitudinal bars for both mats are #32 (metric designation) and are spaced at 165 mm in the top mat and 200 mm in the bottom. All transverse bars are #16 (metric designation) and are spaced at 300 mm in the top and 255 mm in the bottom mat.

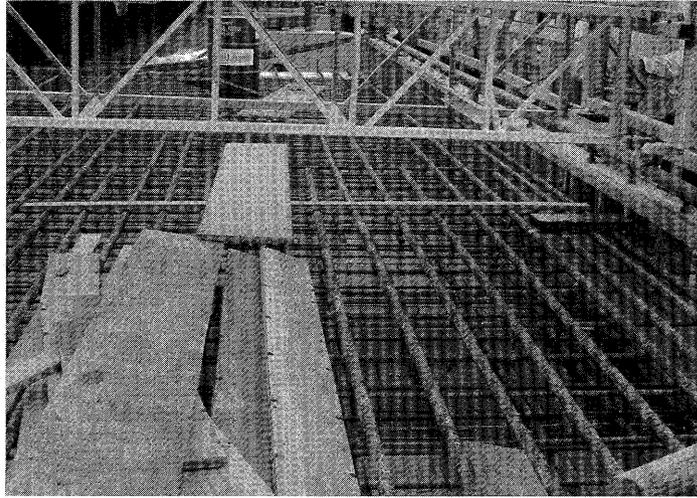
**Figure 16. Second view of MMFX-II deck steel in place.**

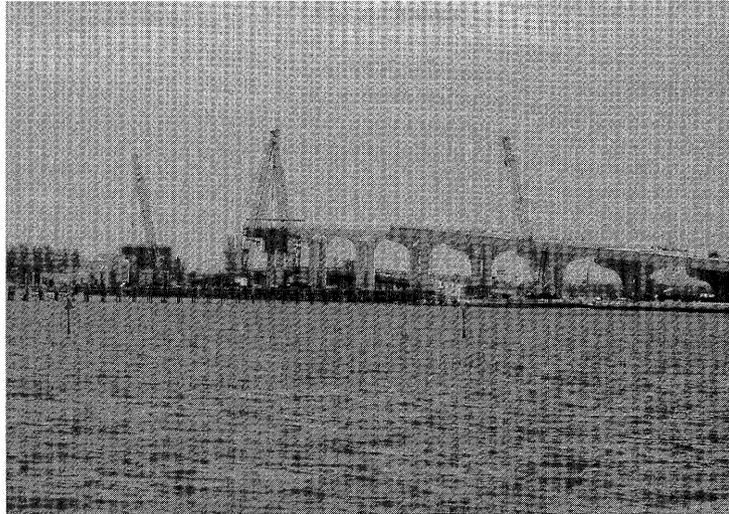
**Bridge Description:** The bridge is the center of three two-lane structures<sup>5</sup> that serve as a causeway between Jensen Beach and South Hutchinson Island on the southeast Florida coast. It is replacing a 50-year-old, low-profile, two-lane bascule bridge that has become badly deteriorated because of the combined effects of brackish water exposure and age, and is now functionally obsolete. Figure 18 shows a perspective photograph of the project which is scheduled for completion in March 2005 (note the old bridge in the background). The substructure design involves conventional, driven prestressed piles, cast-in-place footers, columns and cast-in-place hammerhead column caps. The superstructure is constructed with precast Florida bulb-tee beams and a cast-in-place deck. Unlike northern areas that employ deicing salts such that deterioration from embedded steel corrosion and concrete cracking and spalling is largely confined to the deck, it is the substructure of coastal bridges in Florida that typically experiences the greatest distress. While most of the reinforcement in this bridge is conventional bar or prestressing strand, the footer and column of two piers (numbers 11 and 12, which are just to the right of the leftmost crane in figure 18) are being constructed using Type 2201 stainless steel. The eastern bridge, the construction of which is of longer duration, will have MMFX-II reinforcement in eight deck spans.

**Figure 18. Perspective photograph of the Jensen Beach Causeway Bridge under construction.**

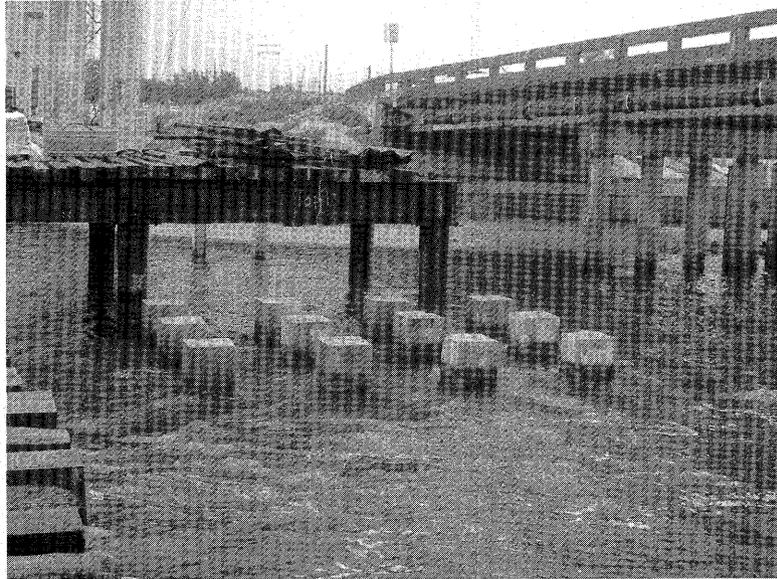
**Figure 19. Photograph of driven, cut-off prestressed piles for pier 11.**

1. Driving of conventional prestressed piles. Figure 19 shows a photograph of these, as driven, for the number 12 pier.
2. Cut prestressed pilings to grade.
3. Placement of 203-mm (8-inch) thick seal slab and associated footer formwork.
4. Placement of footer reinforcement. Figure 20 shows a photograph of this in progress for the footer of pier number 11, and figure 21 does the same for pier number 12.
5. Pouring of footer concrete.
6. Placement of prefabricated column reinforcement cage.
7. Placement of column formwork.
8. Pouring of column concrete.
9. Placement of hammerhead cap form.
10. Placement of cap steel.
11. Pouring of cap concrete.
12. Placement of Florida bulb-tee beams.
13. Deck placement.

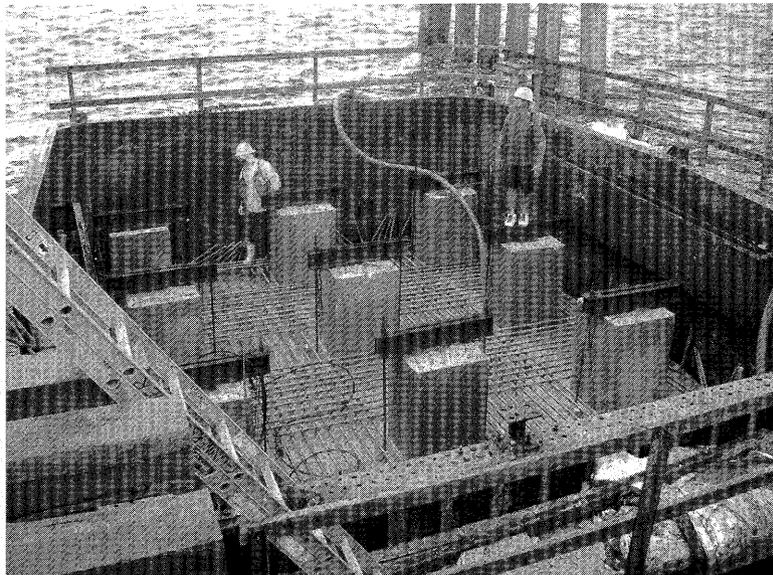
**Figure 20. Photograph of formwork, piles, and reinforcement being placed in the footer of pier number 12.**

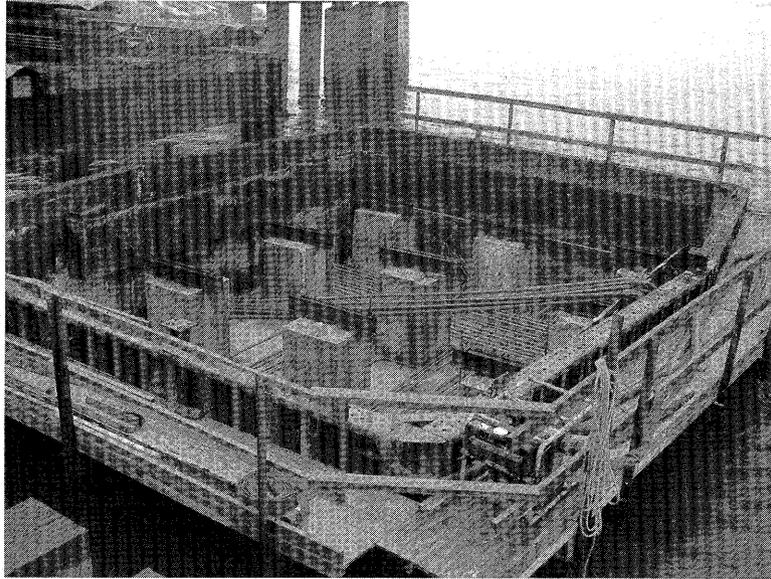
**Figure 21. Photograph of formwork, piles, and reinforcement being placed in the footer of pier number 12.**

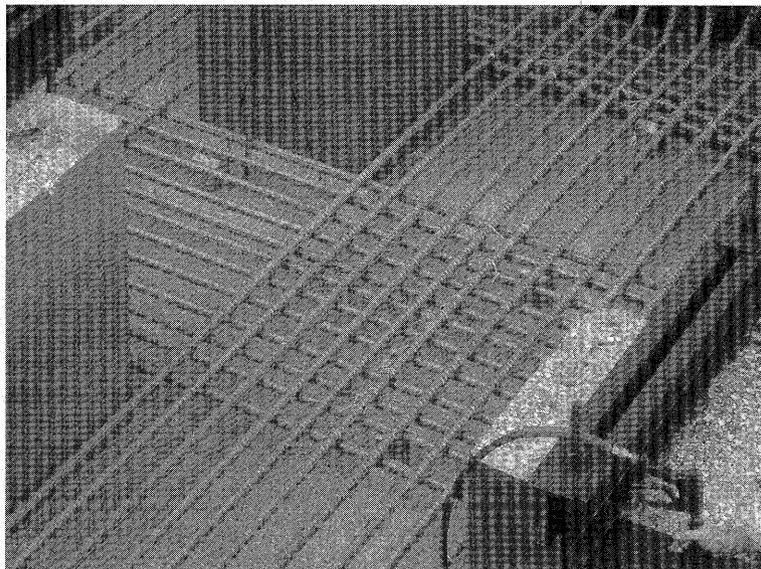
**Figure 22. View of 2201 ss in place at the base of the footer formwork.**

Figure 22 shows a closer view of the in-place 2201 bars at the bottom of the footer for pier number 12. The threaded conventional steel bars and support I-beams upon the piles remain in place, but the black bars will be isolated from the 2201 prior to concrete pouring. The tie wire is also stainless steel (type unknown).

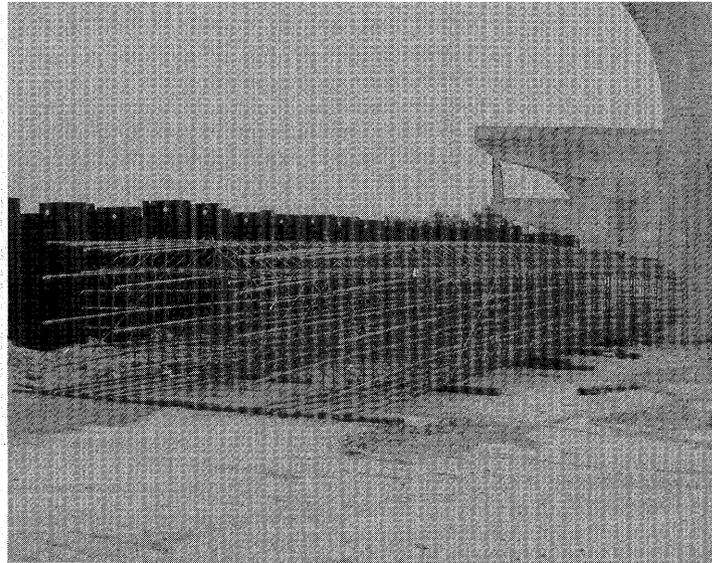
Figure 23 shows a perspective view of the reinforcement cage for column number 11 as fabricated prior to placement. At the time of this photograph, the cage had been in this position for approximately six weeks. Figure 24 is a closeup view of a portion of the cage showing the

**Figure 23. Photograph of 2201 ss reinforcement cage for the column of pier number 11.**

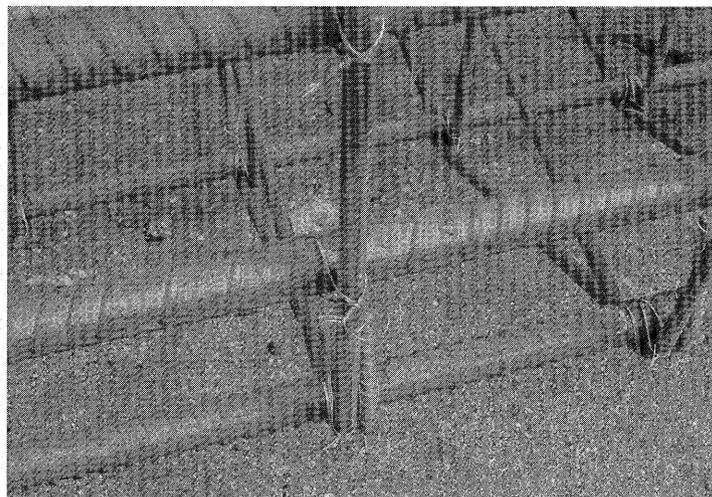
bars to be generally excellent condition. Figure 25 shows a conventional bar reinforcing steel cage for a hammerhead column cap that had been exposed for approximately the same length of time as the column cage (figures 23 and 24). Here, rusting over the whole surface is apparent.

**Figure 24. Closeup view of a portion of the 2201 ss reinforcing bars in the column cage prior to placement in pier number 11.**

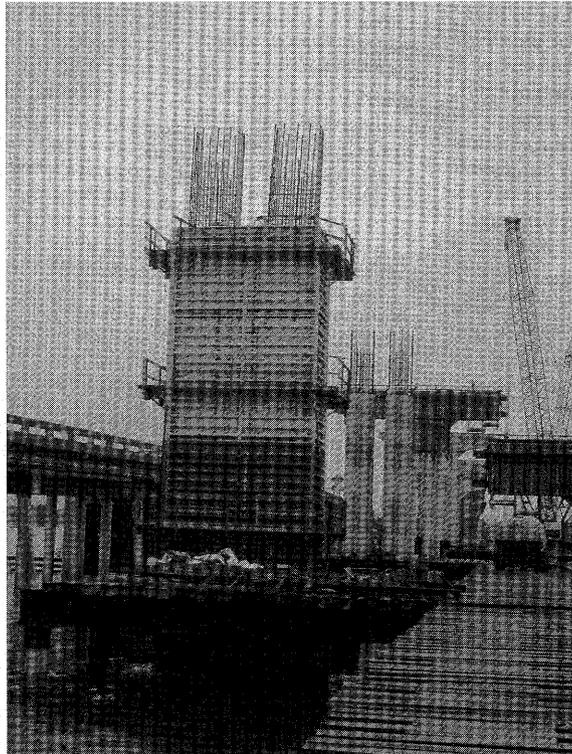
**Figure 26. Photograph of pier number 11 column formwork and 2201 ss cage in place.**

Figure 26 shows a photograph that was taken several weeks after the ones above of the column steel and forms of pier number 11 in place.

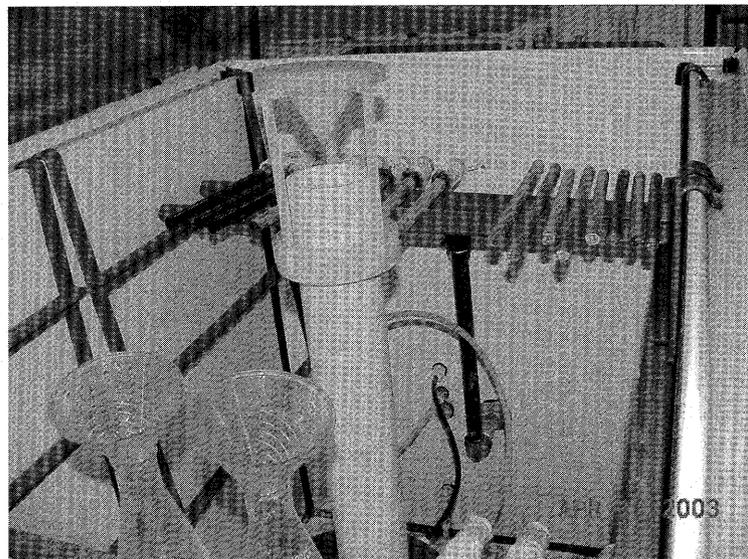
**Figure 27. Bars positioned in salt fog chamber.**

Half of the bars for each set were pickled per ASTM A380, "Standard Practice for Cleaning, Descaling, and Passivation of Stainless Steel Parts, Equipment, and Systems," Table A1.1 "Acid Descaling (Pickling) of Stainless Steel," Code B, followed by scrubbing with plastic fiber brush in hot running tap water. The bars were exposed in salt spray tank for 3 days positioned horizontally as shown in figure 27.

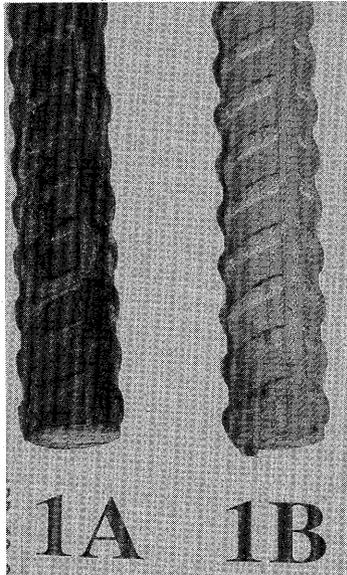
**Figure 28. Bars 1A and 1B.**

- Bar 1A: Shot blasted with carbon steel, 98 percent area corroded, heavy corrosion
- Bar 1B: Shot blasted with carbon steel and pickled, 3 percent area corroded, light corrosion.

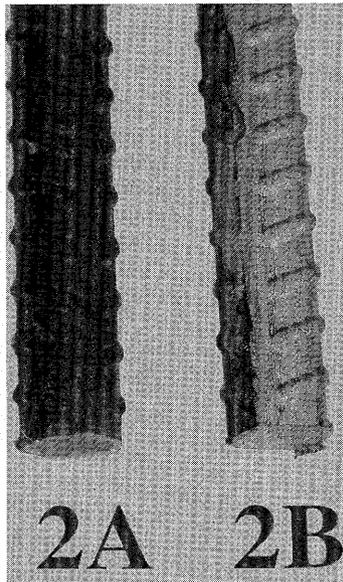
**Figure 29. Bars 2A and 2B.**

- Bar 2A: Plain, 98 percent area corroded, heavy corrosion.
- Bar 2B: Plain pickled, 2 percent area corroded, light corrosion.

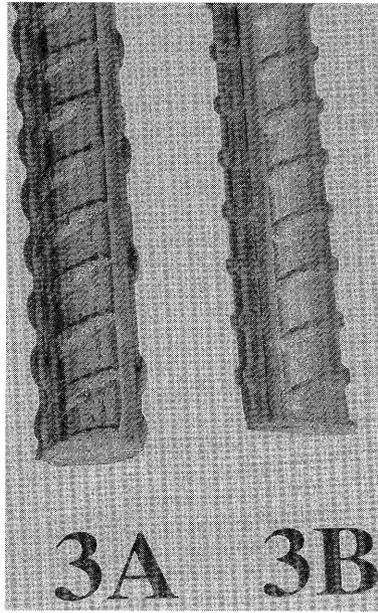
**Figure 30. Bars 3A and 3B.**

- Bar 3A: Sand blasted with silica sand, 5 percent area corroded, light corrosion.
- Bar 3B: Sand blasted with silica sand and pickled, 1 percent area corroded, light corrosion.

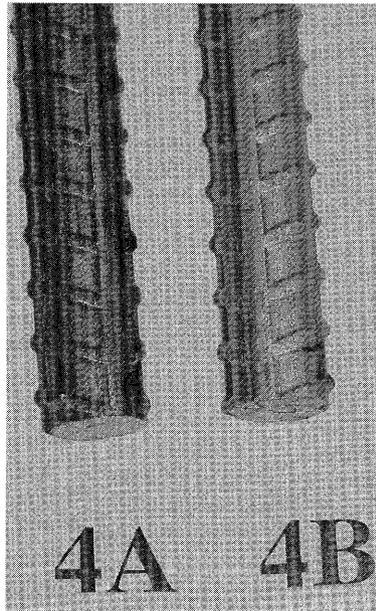
**Figure 31. Bars 4A and 4B.**

- Bar 4A: Shot blasted with stainless steel, 50 percent area corroded, light corrosion.
- Bar 4B: Shot blasted with stainless steel and pickled, less than 1 percent area corroded, light corrosion.

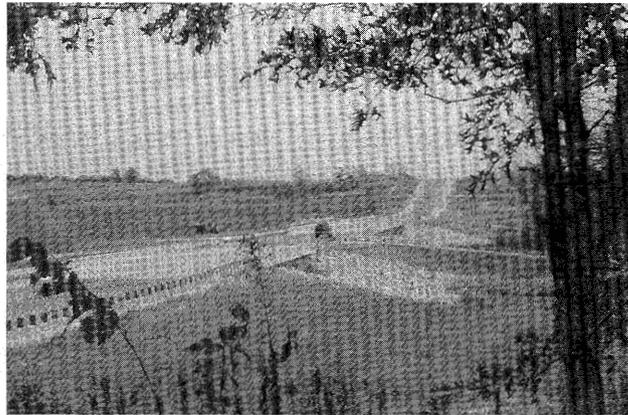
**Bridge Description:** The new bridge is one of a sequential pair, where the companion bridge (Bridge Number A6060) is approximately 600 feet east of the bridge in question. Bridge Number A6059 consists of a reinforced concrete slab that was formed conventionally. Bridge Number A6060, on the other hand, employed permanent precast prestressed structural form panels and a cast-in-place topping between the external girders. The slab overhang from the external girders was conventionally formed. ECR was employed for the companion bridge. Roadway width and girder spacing are the same for the two bridges, but span length and skew differ. Both bridges were opened to traffic in June 2001. Figure 32<sup>7</sup> provides a perspective view of the two bridges, and figure 33 shows a profile of one of the two. Figure 34 provides a view of the stainless steel reinforcement, as placed in the deck of Bridge Number A6059. A report detailing the bridges and planned comprehensive evaluation program is available from Missouri DOT (MoDOT).<sup>(20)</sup>

**Figure 32. General view of the Route 6 bridges.**

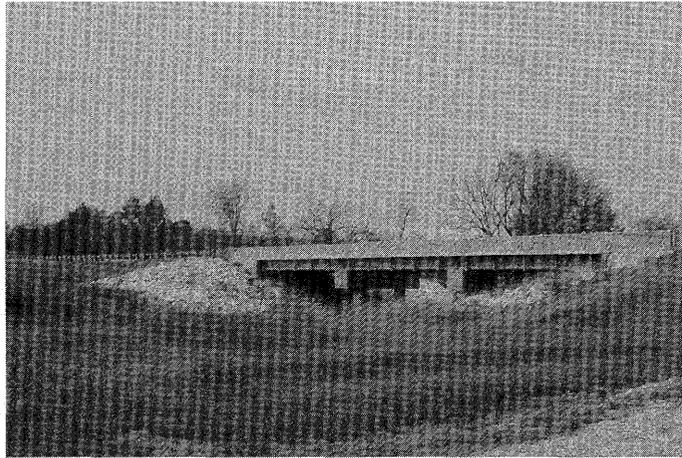
**Figure 33. Side view of Bridge Number 6059.**

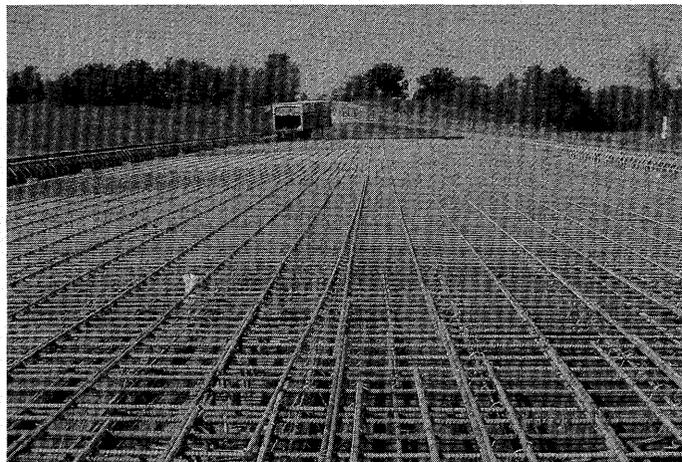
**Figure 34. View of bridge deck with stainless steel in place.**

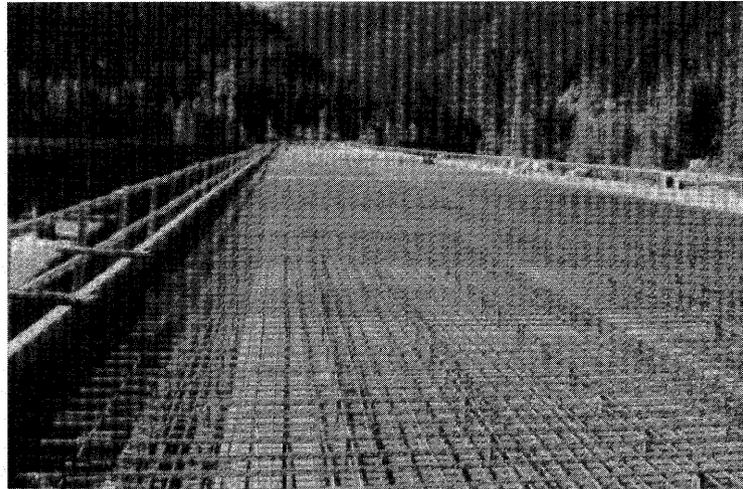
**Figure 35. View of deck with stainless steel reinforcement placement in progress.**

**Construction Sequence:** The four piers were formed and poured during the second half of 2001, and the deck was placed in June and July 2002. The site was visited on June 24, 2002, at which time approximately two-thirds of the reinforcement had been placed. Figure 35 shows a photograph of the deck at that time.

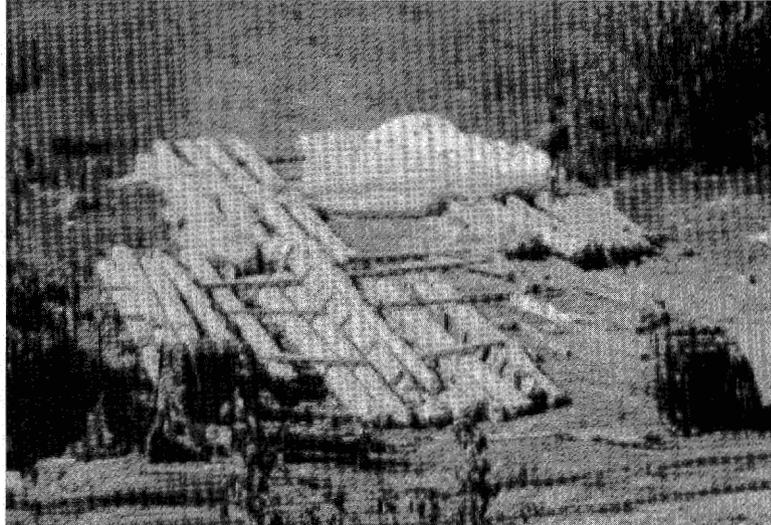
**Figure 36. Photograph of bundled/wrapped bars at the job site.**

**Job Site Storage:** Two truckloads arrived at the job site on June 13, 2002, and the remaining three truck loads during the week of June 17. These were off-loaded onto wooden 2-ft by 4-ft supports on the ground. Figure 36 shows a photograph of this storage. The storage time was short, as placement commenced shortly after delivery. Packaging and covering are described below. No problems were encountered in connection with delivery and storage.

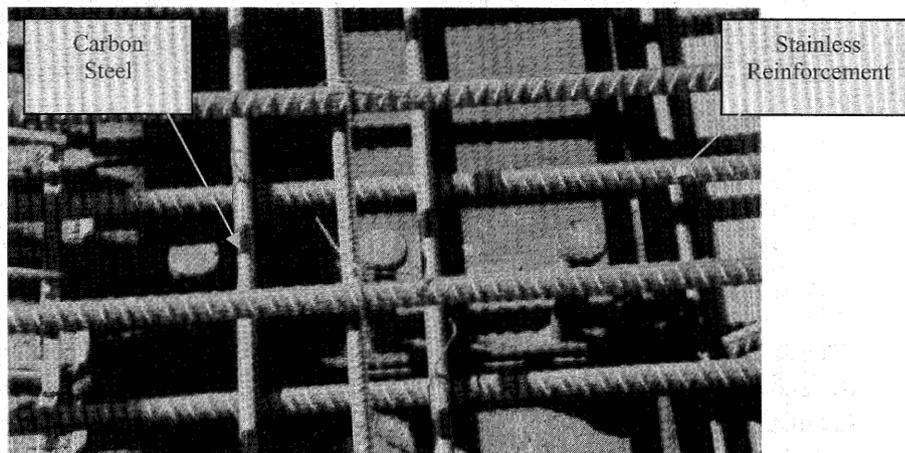
**Figure 37. View showing carbon steel shear studs protruding through bottom mat of stainless steel reinforcement.**

**Presence of Carbon Steel:** Shear studs on the top girder flanges are carbon steel. Figure 37 shows how these penetrate the bottom mat of stainless steel. The specification requires that there be no contact between the studs and reinforcement. This was accomplished using plastic caps over the studs. These had not been placed at the time on this site visit, and so they do not appear in figure 37. Stainless steel in the structure backwalls is tied to black bar.

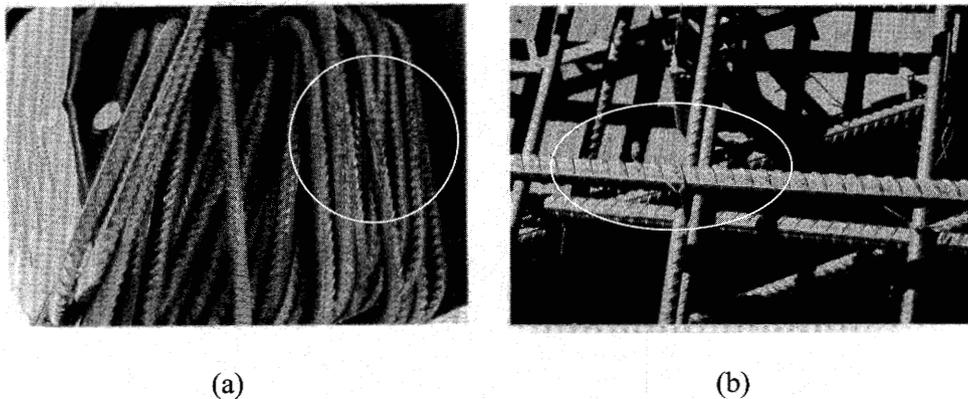
**Figure 38. Examples of rust spots on reinforcement:  
(a) bundled bent bars in opened cardboard container and  
(b) straight reinforcement in place.**

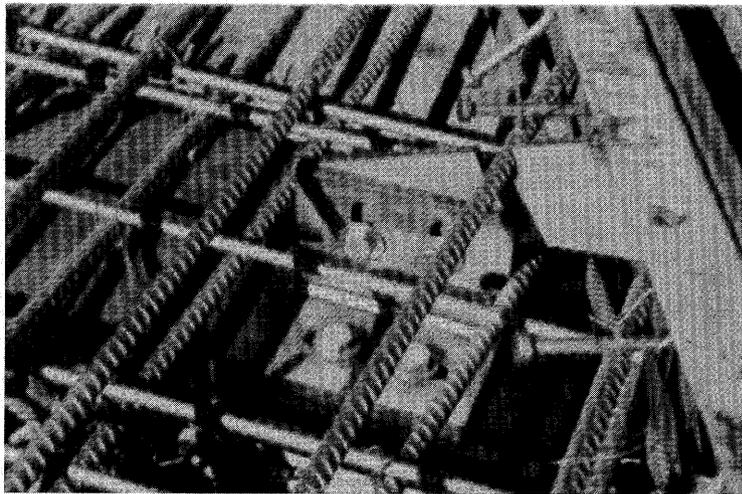
3. Procurement of the expansion joint guard angles was expensive because, first, the manufacturer treated this as a special order and, second, they were not used to fabricating stainless steel. The guard angles arrived at the site packaged with carbon steel bands. Figure 40 is a view of a guard angle in place.
4. Placement of the stainless steel rebar was estimated to have taken 1.5–2 times longer than for conventional steel. This resulted because stainless steel chairs were not available as epoxy-coated ones are for ECR, and reinforcement had to be tied with

**Figure 40. View of a guard angle adjacent to an expansion joint.**

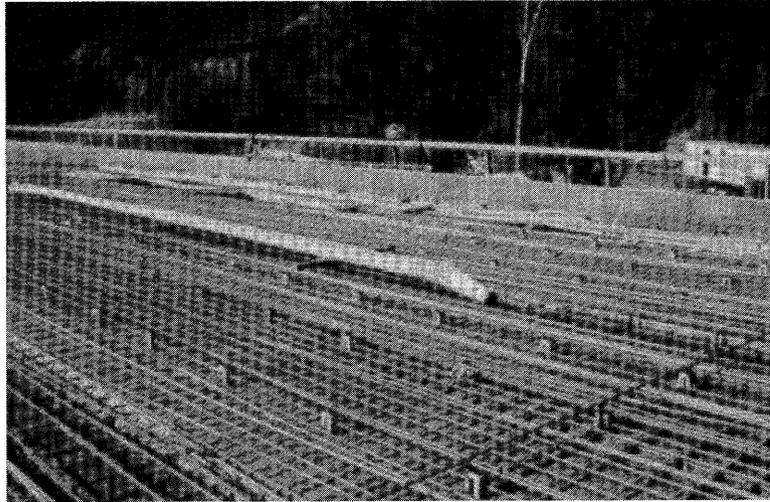
wire individually to each plastic chair. Figure 41 shows an array of chairs on the deck in preparation for placement of the top mat (see figure 35 also), and figure 42 shows a closeup view of a completed placement area where both the top and bottom bars are tied with wire to a chair. This difficulty should be overcome as stainless steel reinforcement use becomes more common, at which time stainless steel or plastic chairs should be available.

**Figure 41. Array of plastic chairs to which bars from both mats are tied.**

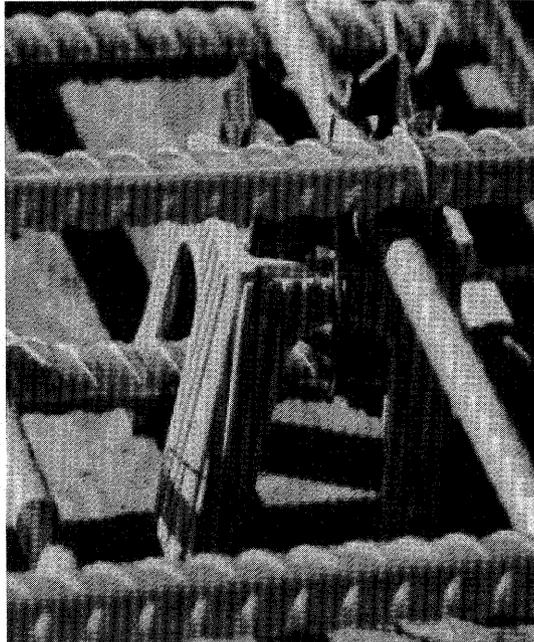
**Figure 42. Closeup view of a plastic chair to which bars are tied.**

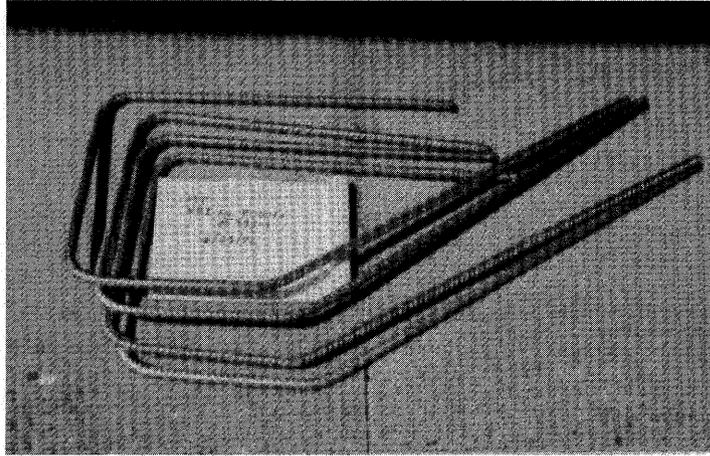
**Material Acquisition:** Four bent bar details were made available from the job site for testing by FAU and FDOT. Figure 43 shows examples of these.

**Figure 43. Examples of stainless steel reinforcement details acquired from the job site.**

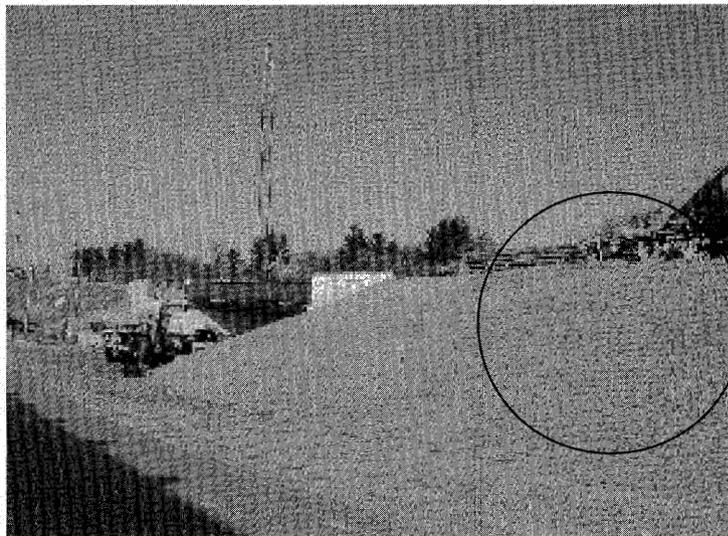
**Figure 44. General view of the Brown Avenue Bridge under construction.**

**Construction Sequence:** At the time of the site visit (May 6, 2004), only the girders were in place on the Brown Avenue Bridge as noted above in conjunction with figures 44 and 45. Construction was more advanced at Frontage Road as explained below. Figure 46 shows a general view of the galvanized bar placement on the Frontage Road deck.

**Job Site Storage:** The galvanized steel for both bridges was delivered in plastic wrapping just prior to the placement schedule for the Frontage Road Bridge. Figures 47 and 48 show views of bar storage at this latter site. A distant view of bars at the Brown Avenue Bridge was indicated in figure 44, and figures 49 and 50 show closer views of straight and fabricated bars, respectively, at this location.

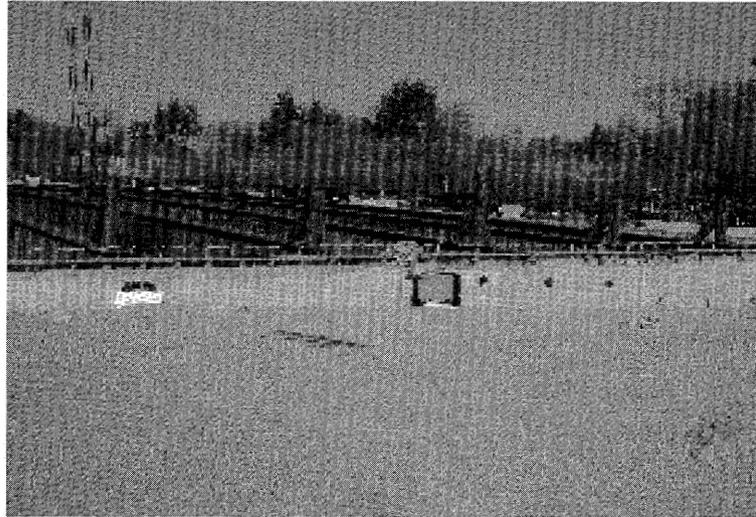
**Figure 45. View of the in-place girders on the Brown Avenue Bridge.  
Note ECR extending from the top of the backwall.**

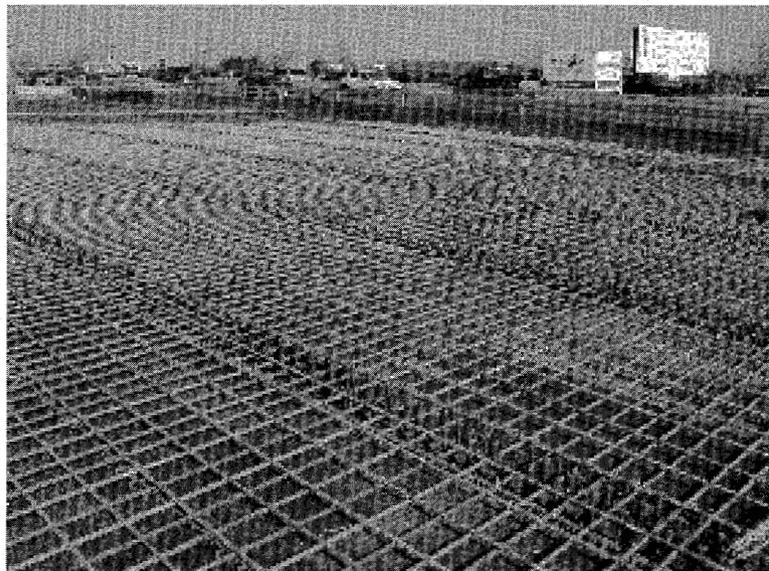
**Figure 46. In-place galvanized reinforcement  
on the Frontage Road Bridge deck.**

**Presence of Carbon Steel:** Shear studs on the top girder flanges are carbon steel. A distant view of these can be seen in figure 46, and figure 51 provides a closer view. While no instances of electrical contact between the two metal types were apparent, this could inadvertently occur. Because potential of galvanized steel can be active to passive black steel, a corrosion cell could be established.

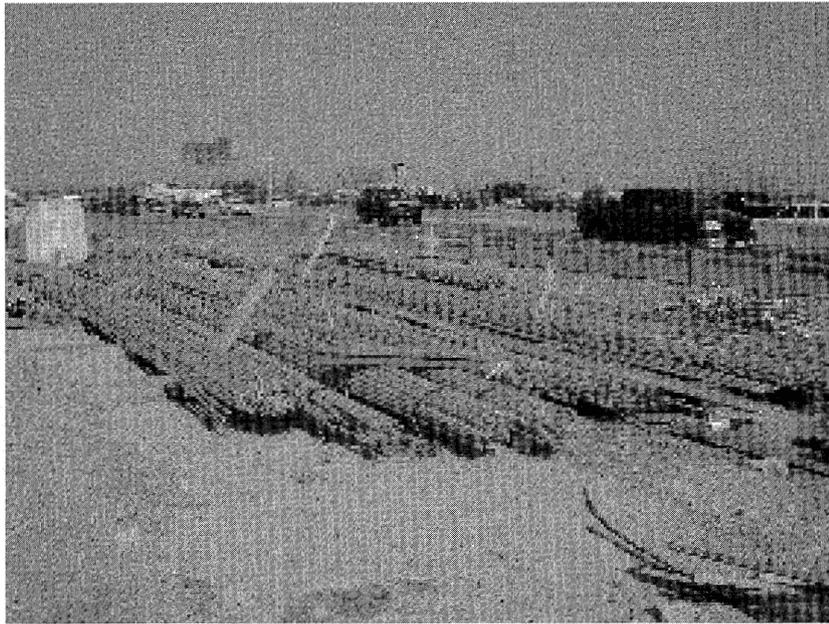
**Figure 47. Bundled/wrapped bars at the Frontage Road job site.**

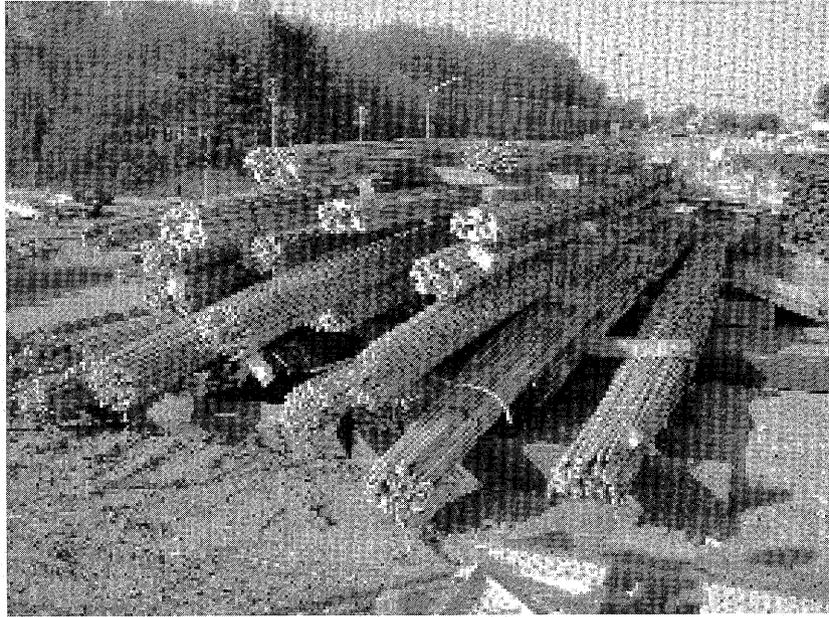
**Figure 49. Stored galvanized bars at the Brown Avenue Bridge job site.**

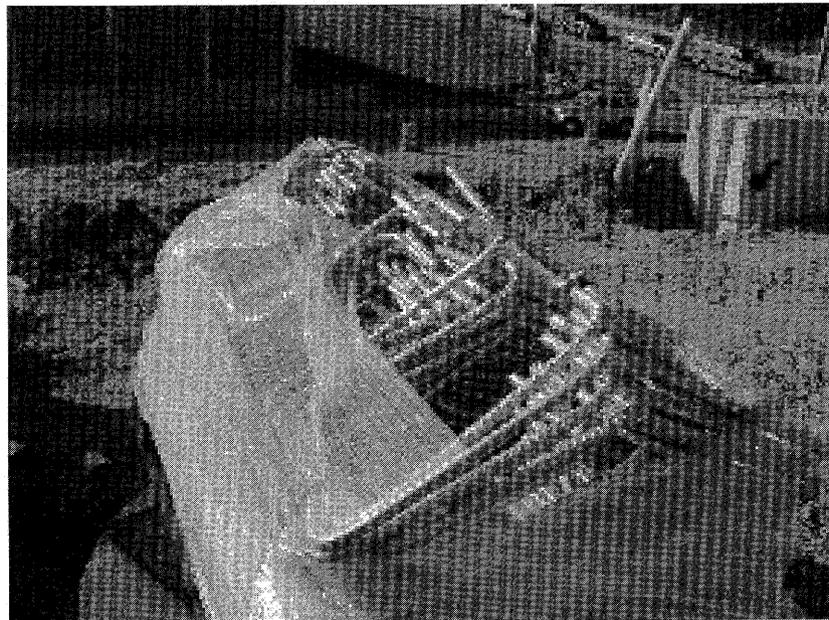
**Figure 50. As-delivered galvanized bars at the Brown Avenue site after pulling back the plastic wrap.**
