# Job Site Evaluation of Corrosion-Resistant Alloys for Use as Reinforcement in Concrete

PUBLICATION NO. FHWA-HRT-06-078

JUNE 2006

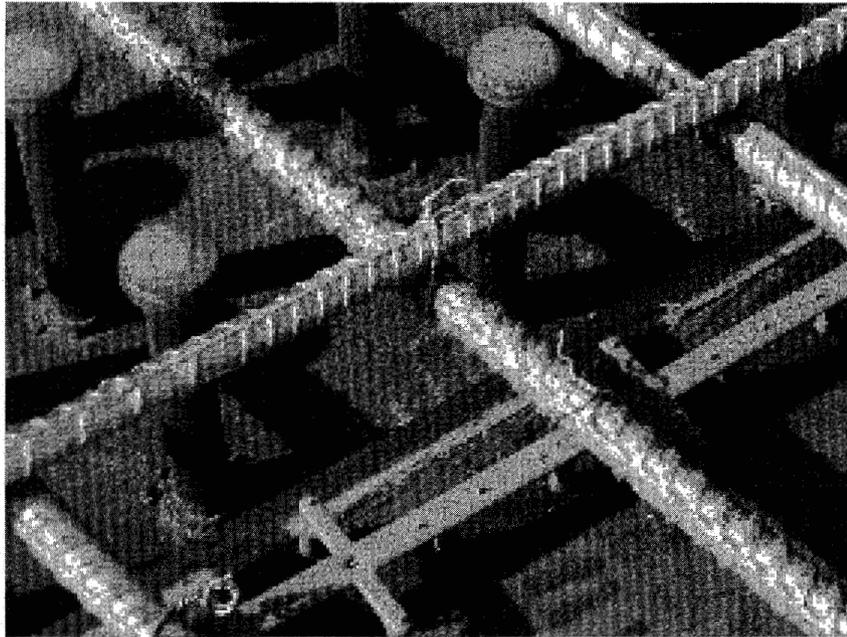
**Presence of Carbon Steel:** Shear studs on the top girder flanges are carbon steel. A distant view of these can be seen in figure 46, and figure 51 provides a closer view. While no instances of electrical contact between the two metal types were apparent, this could inadvertently occur. Because potential of galvanized steel can be active to passive black steel, a corrosion cell could be established.

**Figure 51. Closeup view of the in-place galvanized reinforcement relative to carbon steel studs.**

3. Many of the as-delivered galvanized bars had a brown-greenish surface deposit. Examples of this can be seen on some of the bars in figure 51, and a closer view is shown in figure 52. This caused delays and additional effort in that the contractor was told to remove the deposits to the extent possible. It was later determined that the deposits were residuals from a chromate pretreatment. It is not unexpected for such "lack of prior experience" problems to arise with innovative reinforcement.

2. The potential galvanic corrosion problem that could arise from the galvanized reinforcement contacting the carbon steel studs that project from the top of girders was mentioned above.

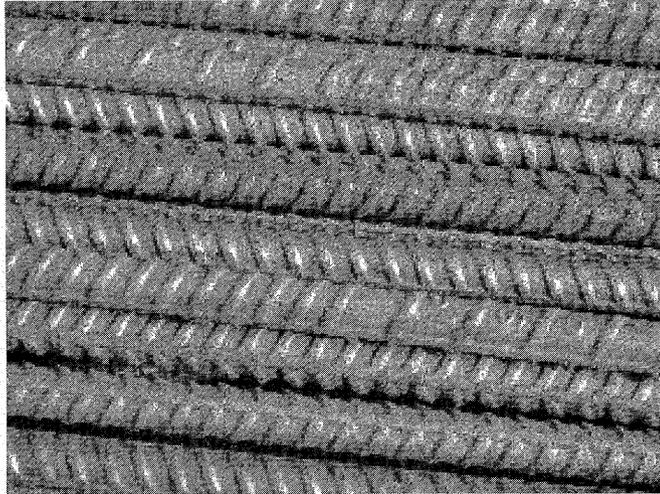
**Figure 52. Deposits on galvanized reinforcing bars.**

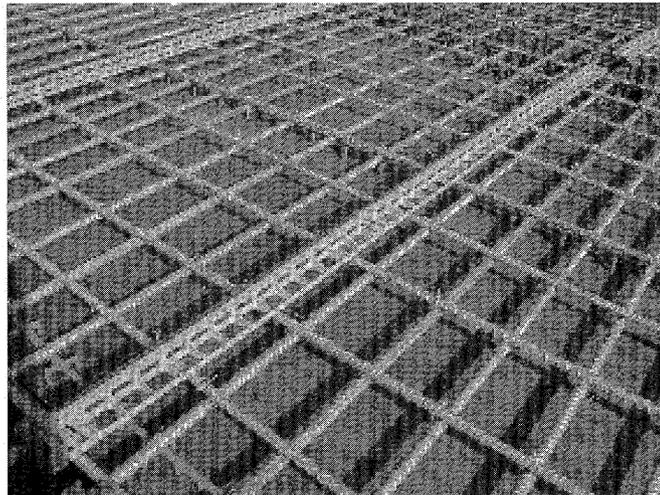
4. A concern was expressed that concrete cracking along the plastic mat spacers could occur because the openings in these may be too small to pass the coarse aggregate as the concrete is placed. Figure 53 shows a spacer in place. This, of course, is not related to the use of innovative reinforcement.

**Figure 53. In-place bottom galvanized rebar mat with plastic mat spacer.**

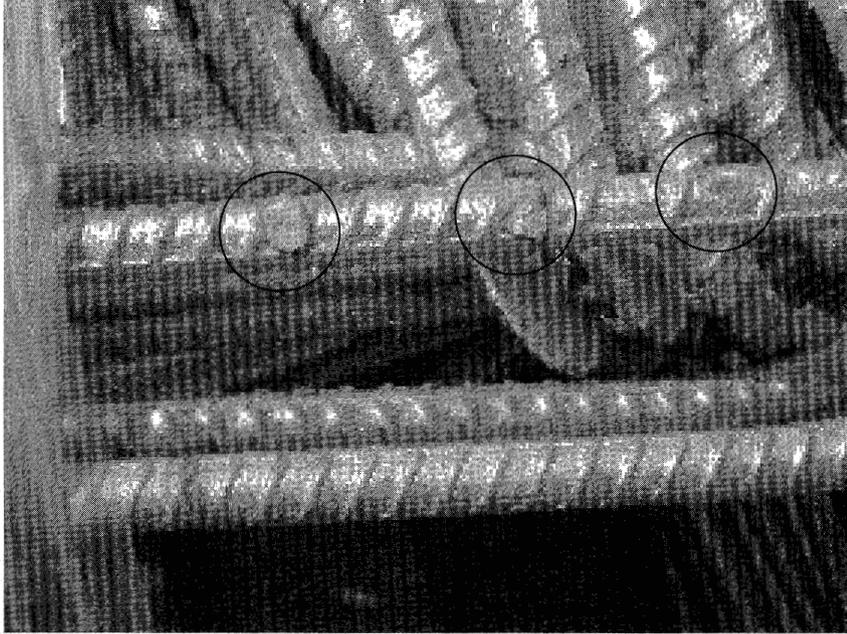
**Figure 54. Examples of disbonding of the galvanized layer on fabricated bars for the Brown Avenue Bridge.**

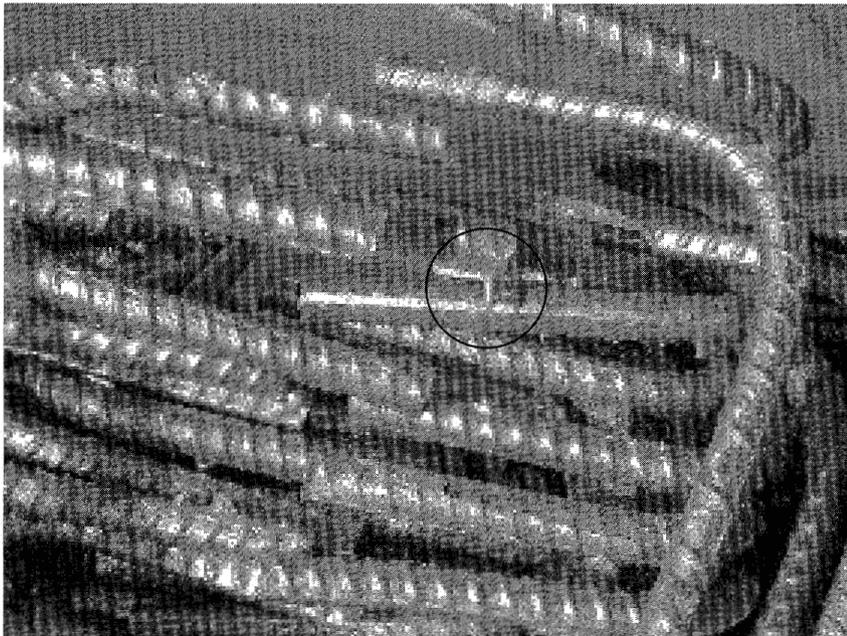
**Figure 55. Galvanized layer disbonding and icicle on reinforcing bars. Examples of disbonding are also apparent.**

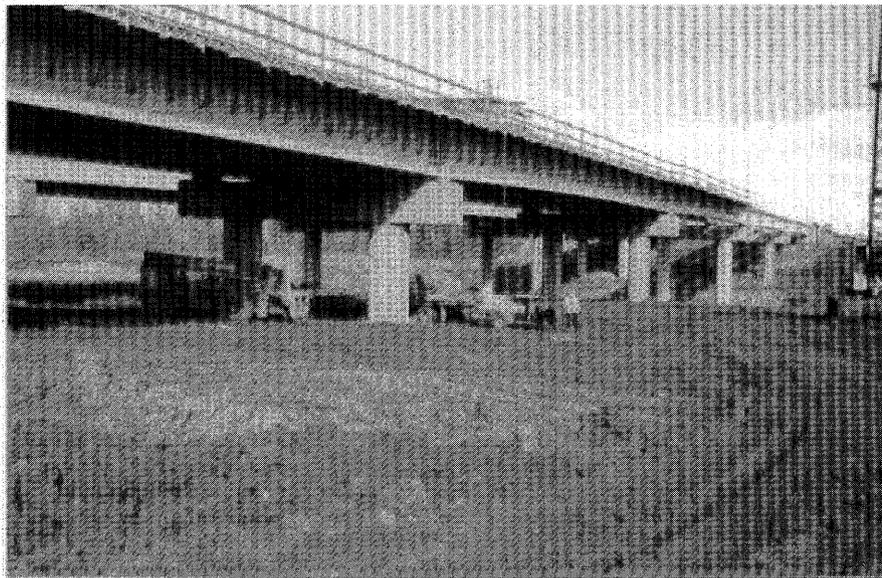
**Figure 56. General view of the I-35 northbound bridge.**

**Bridge Description:** The new bridge comprises the two northbound lanes at the above location. The southbound bridge of the same design was completed one year earlier and employed epoxy-coated reinforcing steel. Overall length of the bridge is 200 m (657 ft) and total width 12.3 m (40.4 ft) and consists of five spans on four piers with 1.80 m (5.90 ft) diameter drilled shafts with cast-in-place caps and bulb-tee prestressed concrete beams. Deck design was by the empirical method. Initially, stainless steel clad reinforcement was specified; but because of delivery problems, this was changed to MMFX-II. Figure 56 shows a general view of the bridge at the time when the deck was being formed.

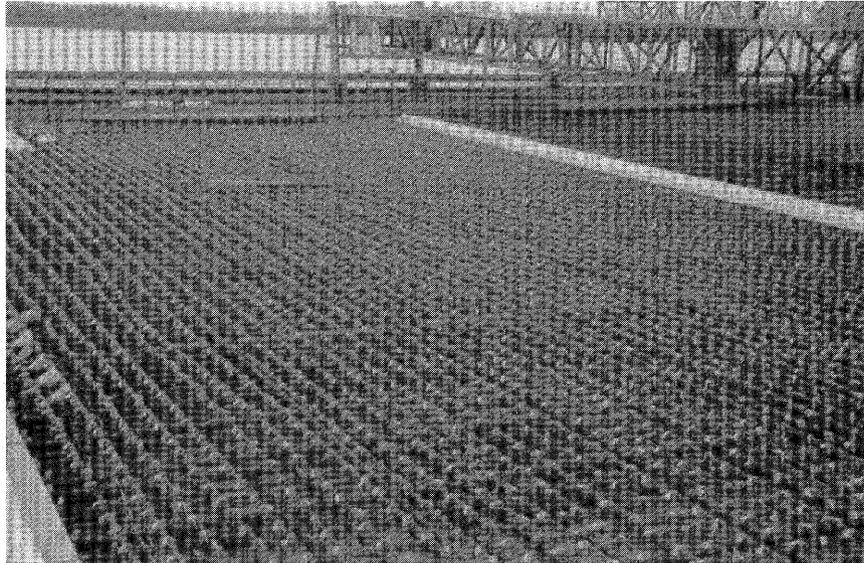
**Figure 57. In-place deck reinforcing steel.**

**Construction Sequence:** The deck was placed from south to north with each span being formed and poured as a separate unit. Figure 57 shows a perspective view of the as-formed deck reinforcing steel as seen from east to west across span 1. Figure 58 provides a closer view, including an ECR spacer that separates the two mats and reinforcing steel from a girder. Figure 59 shows the tie-in of the parapet wall reinforcing steel to the deck. Slab thickness is 8 inches and the reinforcement is comprised of #4 and #5 bars. Cover over the top steel is 2.4 inches.

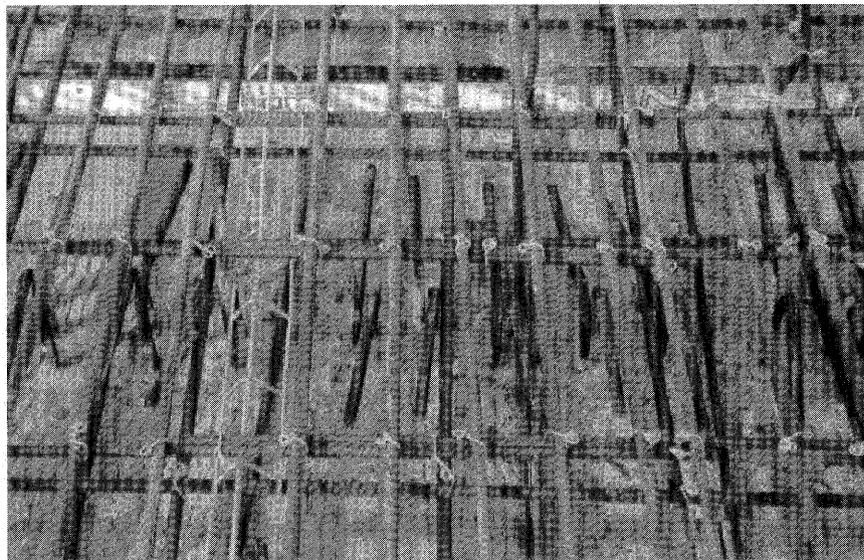
**Figure 58. Closeup view of MMFX-II deck reinforcing steel.**

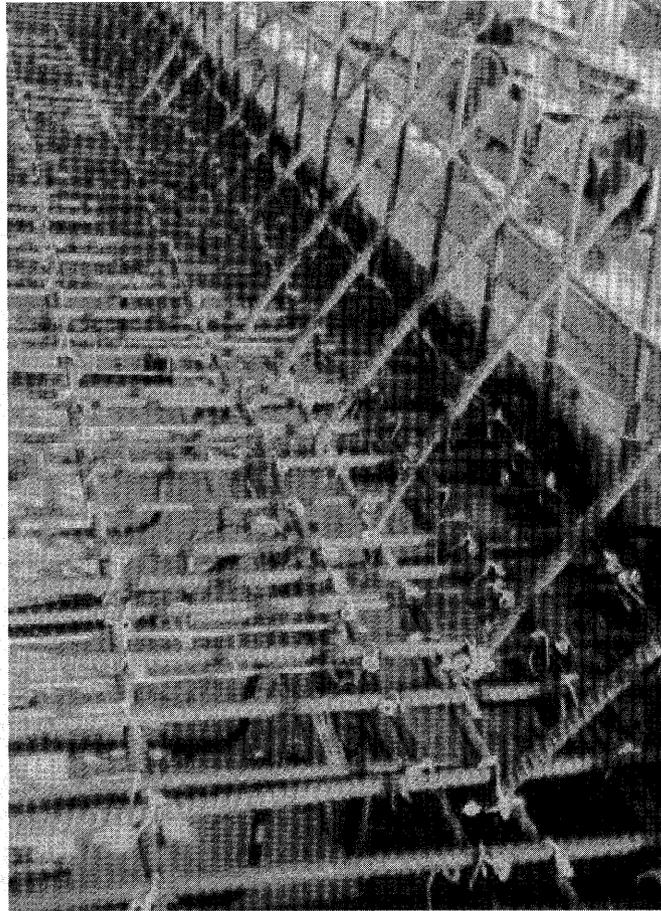
**Figure 59. Reinforcing steel as placed in the deck and parapet wall.**

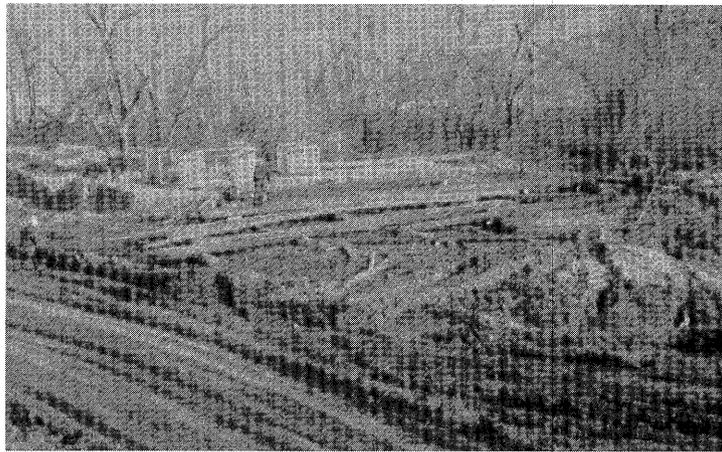
**Figure 60. Perspective view of steel storage site.**

**Job Site Storage:** The steel was delivered via truck and stored uncovered outdoors on timbers. A crane was employed to move the steel to the deck, where it was placed by hand. Figure 60 shows a perspective view of the storage location, and figure 61 provides a closeup view.

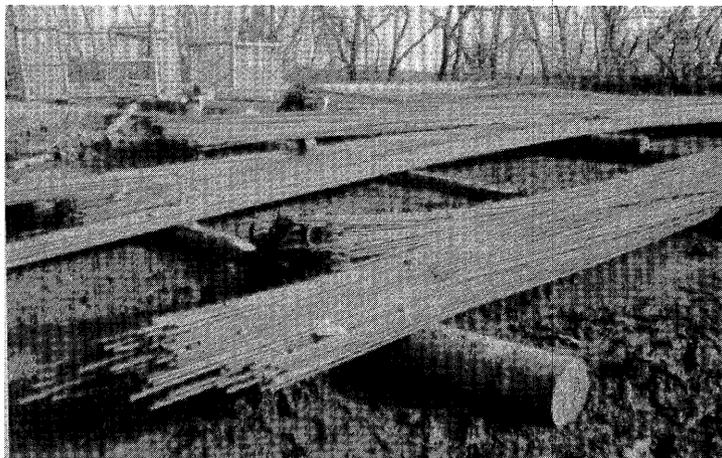
**Figure 61. Closeup view of stored bars on timbers at job site.**

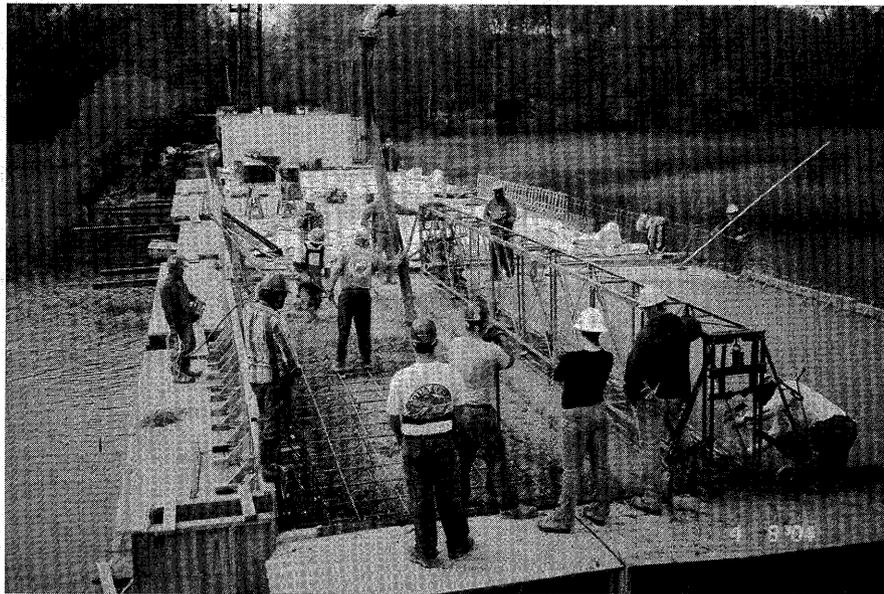
**Figure 62. General view of the bridge under construction.**

**Bridge Description:** The bridge is two lanes with the substructure consisting of six conventional prestressed piling bents with cast-in-place pile caps. These support five 28- by 30-ft reinforced concrete deck spans (total length 150 feet). Figure 62 provides a perspective view of the bridge under construction. The five spans, designated 1–5, extend generally from north to south and, along with the barrier parapets, were placed with, respectively, black bar with discrete

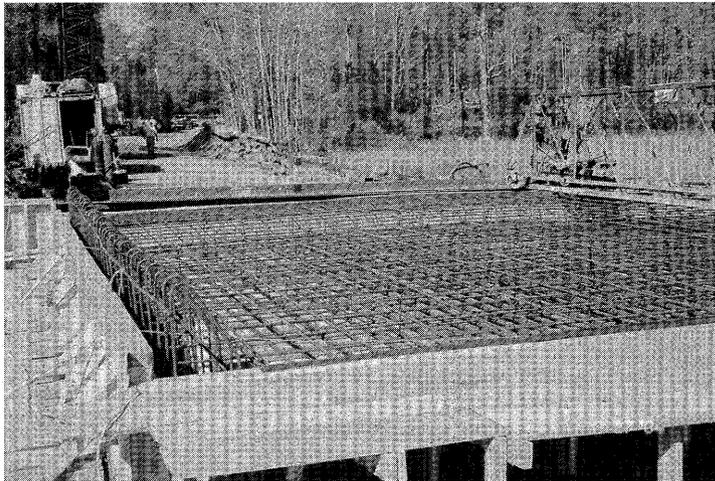
**Figure 63. View of MMFX-II placement in span 5.**

**Construction:** Figures 63–67 show various aspects of the deck steel placement and concrete pouring.

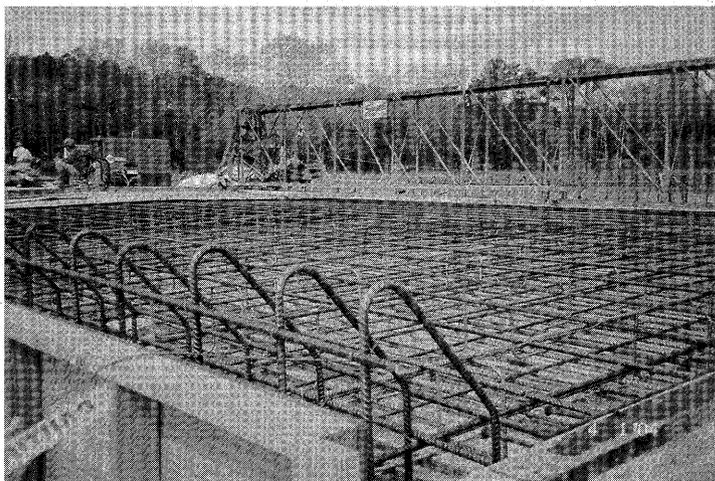
**Figure 64. View of 2205 stainless steel placement in span 2.**

**Presence of Carbon Steel:** Carbon steel A25 dowels extend into the deck slabs from the backwalls. An example of these can be seen in the right foreground of figure 64. The specification calls for these to be wrapped with roofing felt, rubber, or another seepage-proofed compressible material to allow 0.25 inches of compressible material between the concrete and dowel. As such, electrical contact between the dowels and reinforcement was avoided.

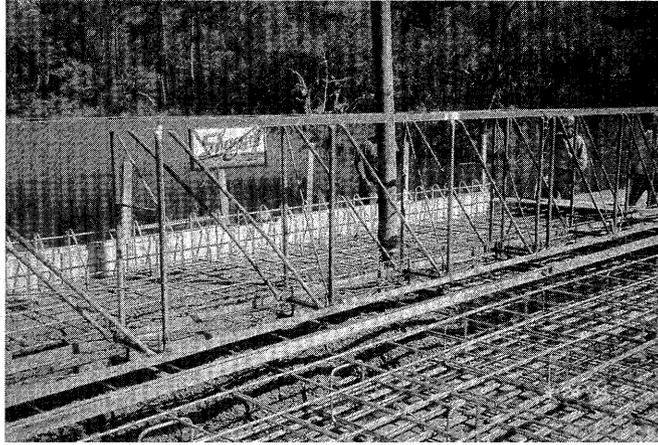
**Figure 65. View of in-place clad stainless in span 3.**

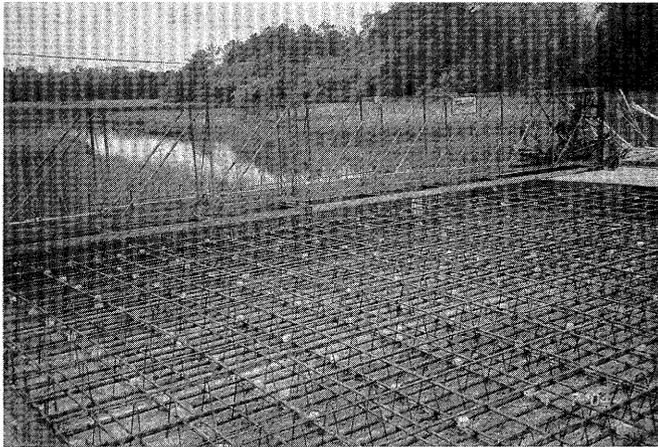
**Figure 66. View of in-place black bars (span 1) along with discrete galvanic anodes.**

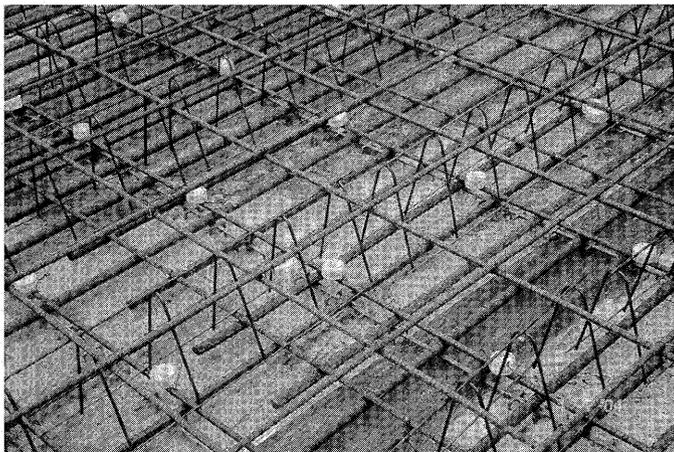
**Figure 67. Closeup view of discrete galvanic anodes on in-place span 1 black bars.**
