Guardrail Testing Program

Final Report

Publication No. FHWA-RD/FLP-90-087
May 1990

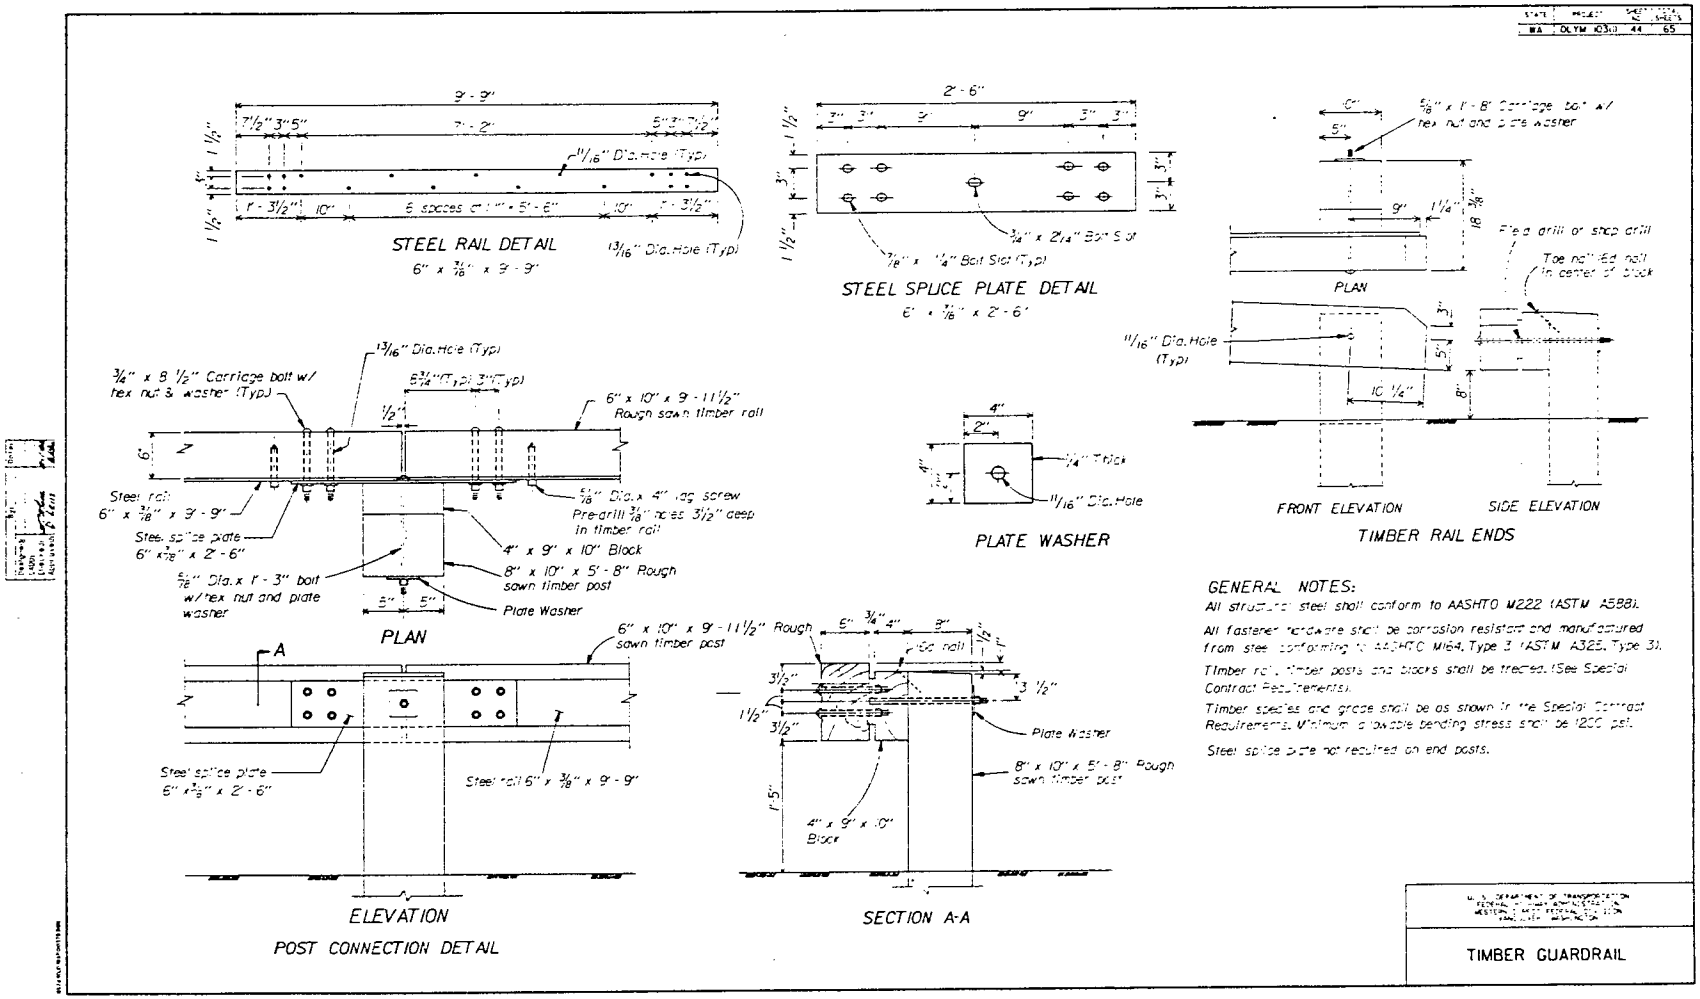
Figure 3. Standard wooden guardrail system design.

In October 1987, a 4500-lb (2043-kg), 60 mi/h (26.8 m/s), 25 degree test (NCHRP 230 test 10) was conducted on the system shown in figure 3. The vehicle was redirected at 10 degrees and with a speed reduction of 36 mi/h (16.1 m/s). Furthermore, the vehicle tire snagged on the first post past the impact point, two posts were pushed back 8 to 10 in (0.20 to 0.25 m). The rail pocketed and the wooden portion snapped. The steel portion maintained its structural integrity. This test met the evaluation criteria of NCHRP 230. However, the rail could be improved. This section proposes improvements to the present system, compares it with a standard W-beam system, and provides new designs.

A flaw with this rail system is that the vehicle bumper pushes under the rail and the front tire snags on one or more posts. Based on test analysis, it appears that approximately 3 in (0.08 m) of tire snag occurred. Another flaw with this timber guardrail system is the snapping of the rail under bending stress.

Two recommendations are made to alleviate these flaws. First, the rail should be thickened from 6 in (0.15 m) to 7 in (0.18 m). Using Mc/I calculations where $I = 1/12\ (b)(h)^3$, the 17 percent increase in rail thickness provides a 36 percent increase in bending resistance for the wood alone. This is a much easier and cheaper approach to stiffening the rail than to decrease the post spacing. A decrease in post spacing increases the installation time and labor cost significantly while thickening the rail by 1 in (0.03 m) has a negligible effect on installation time. This 1 in (0.03 m) generates an additional inch of blocked out space between the rail face and the post, lowering the potential for snag. Furthermore, a 1-in (0.03-m) increase in the rail thickness uses less wood material when compared to decreasing the post spacing from 10 ft (3.0 m) to 8 ft (2.4 m) for a 12-in by 10-in by 7-ft (0.30-m by 0.25-m by 2.1-m) post. From an economical standpoint, money is better spent in enlarging the rails than increasing the number of posts.

The second recommendation is to increase the blockout distance from 4 in (0.10 m) to 6 in (0.15 m). Thus, the total post/blockout distance (including rail thickness) will be increased from 10.75 in (0.27 m) to 13.75 in (0.35 m). This additional 3 in (0.08 m) should help to eliminate snagging and result in cleaner redirection and higher redirection speeds.

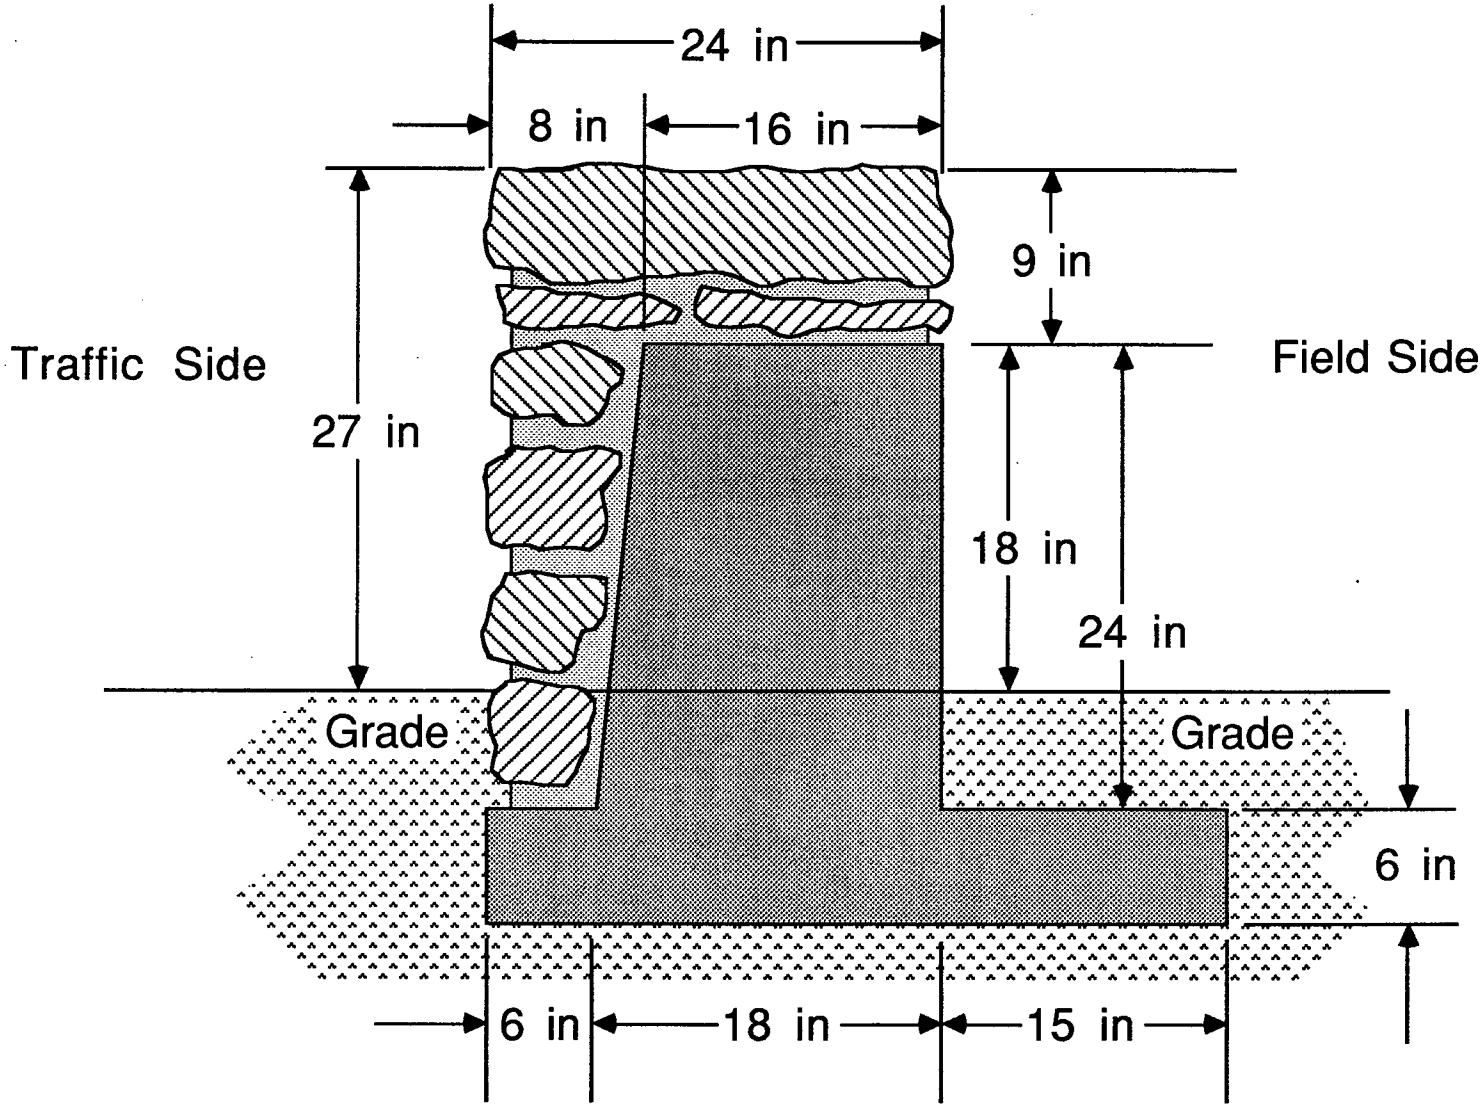
Figure 6. Stone masonry guardwall system.

As summarized in the full-scale test section, task E, the stone masonry guardwall was structurally inadequate under NCHRP 230 test 10 conditions. 15 ft (4.6 m) of coping stone was knocked 5 ft (1.53 m) behind the wall, 4 ft (1.22 m) of coping stone was angled back, and a one-piece coping stone was dislodged. Given that standard bumper heights for large sedans are 18 in (0.46 m) at the bumper center and the core height is 18 in (0.46 m) above ground level, the weakest point of the system is at the vertical impact point. The following recommendations are made to improve this design:

- Improve the masonry to core top shear resistance by providing a 4-in wide by 4-in (0.10-m by 0.10-m) deep keyway in the center of the top of the precast core. Vertical dowels can also be used to strengthen the system, however these are not felt to be necessary.

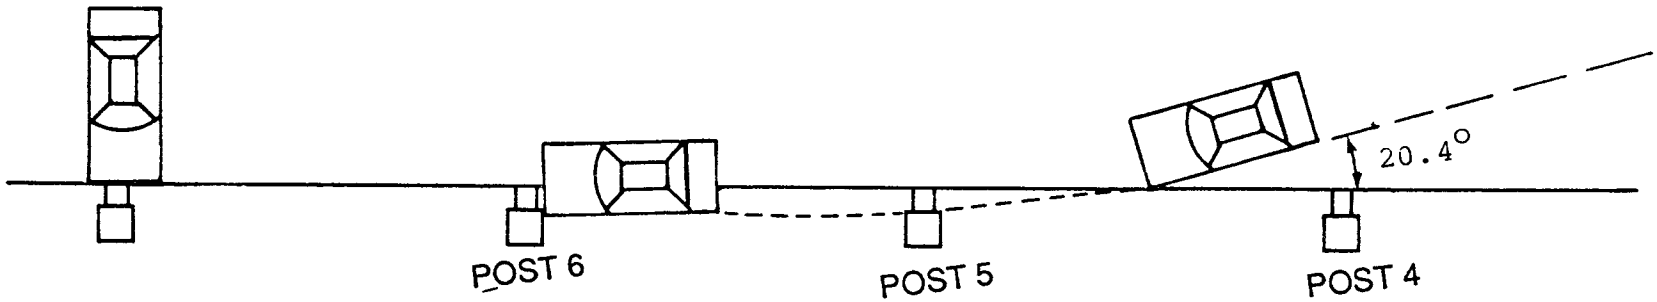
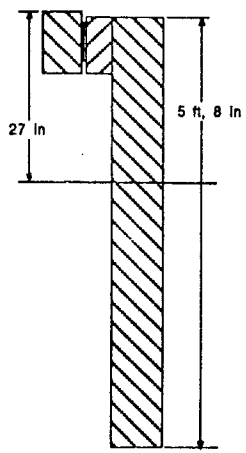
Figure 15. Test summary, test 1818-5-1-87.

During the crush of the vehicle left front fender, the first downstream post (post 5) pushed back, allowing the vehicle tire to ride under the rail. The car continued downstream into post 6, which did not deflect. The post and connecting rail section blew out due to the force of this impact. The rail ends disintegrated and the post completely rotated out of the ground. The impact with the post caused most of the damage to the left front corner of the vehicle. The impact with the post caused the vehicle to yaw while continuing downstream. The vehicle remained in contact with the rail for 15 ft (4.6 m). The vehicle came to rest centered on post 7, at a 95 degree angle to the rail.

Tire scrub was found on the underside of the rail and on post 5. The rail sections at posts 4 through 8 were laterally displaced and debris was thrown up to 60 ft (18 m) behind the rail system.

14. Test Results Conclusion: Vehicle was not smoothly redirected by the rail. The vehicle underrode the guardrail and snagged severly on post 6. Test was not successful.

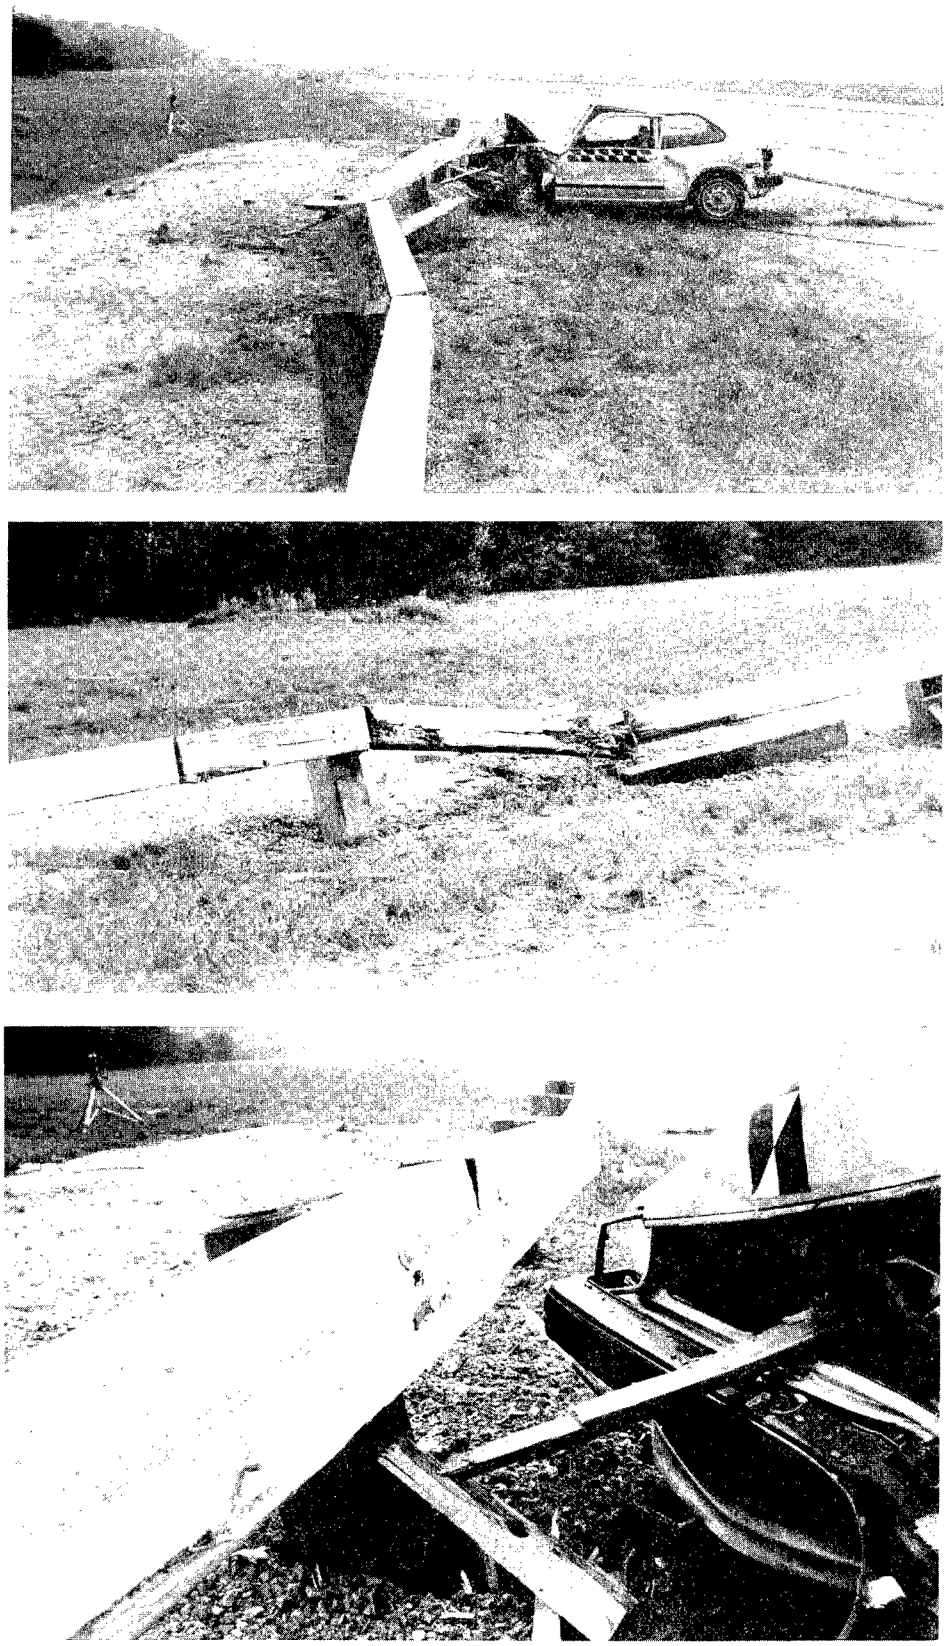
Figure 18. Posttest photographs of guardrail system, test 1818-5-1-87.

Due to the severe impact that occurred at post 6, the splice plate and all connection hardware were bent or sheared. The fifth rail and the sixth post and blockout were severely damaged. Posttest photographs of the guardrail are shown in figure 18.

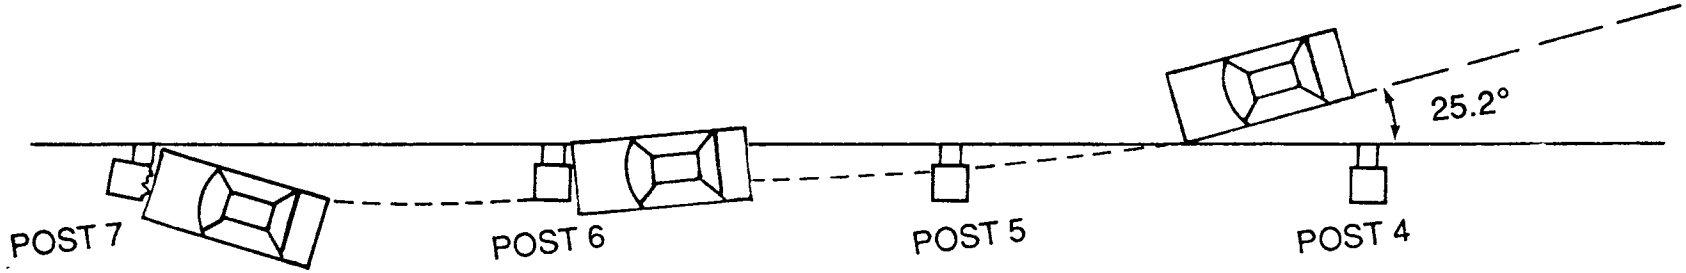
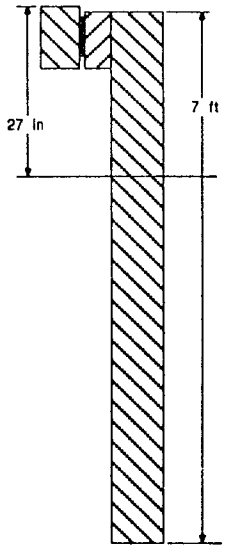
Figure 23. Test summary, test 1818-5-2-87.

During the crush of the vehicle left front fender, the first downstream post (post 5) broke, allowing the vehicle tire to ride under the rail. The car continued downstream into post 6, which also broke. Prior to impacting post 6, all four of the 0.75-in (0.019-m) bolts sheared off at the upstream splice plate of rail 5. Upon impacting post 6, the post bolt pulled out of the post. Thus, rails 5 and 6 were free to move on the upstream end. They rotated 180 degrees and came to rest parallel with rails 7 and 8. The vehicle continued downstream and impacted post 7. The impact with the post caused the vehicle to yaw while continuing downstream. The vehicle remained in contact with the rail for 15 ft (4.6 m). The vehicle came to rest centered on post 7, at a 25 degree angle to the rail. Impacts with posts 6 and 7 caused most of the damage to the left front corner of the vehicle.

14. Test Results Conclusion: Vehicle was not smoothly redirected by the rail. The vehicle underrode the guardrail. The guardrail failed at post 6. Vehicle squarely impacted post 7. Test was not successful.

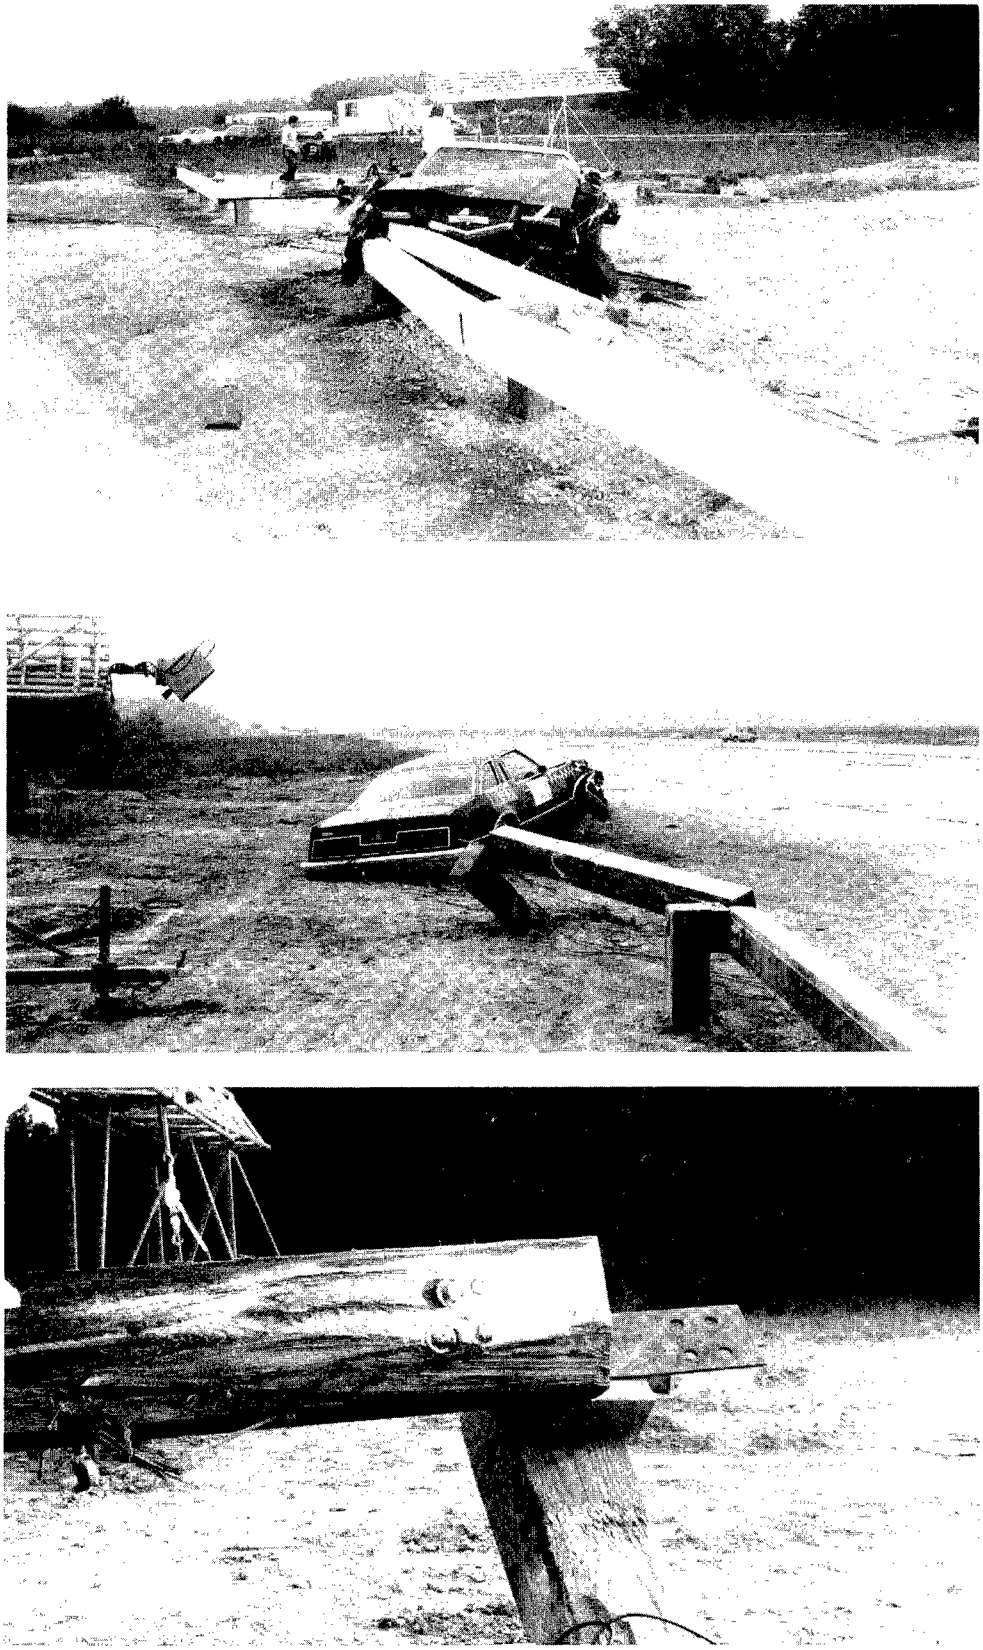
Figure 26. Posttest photographs of guardrail system, test 1818-5-2-87.

Due to the failure of the posts and the connection hardware at post 5, a significant amount of damage occurred. Posts 5, 6 and

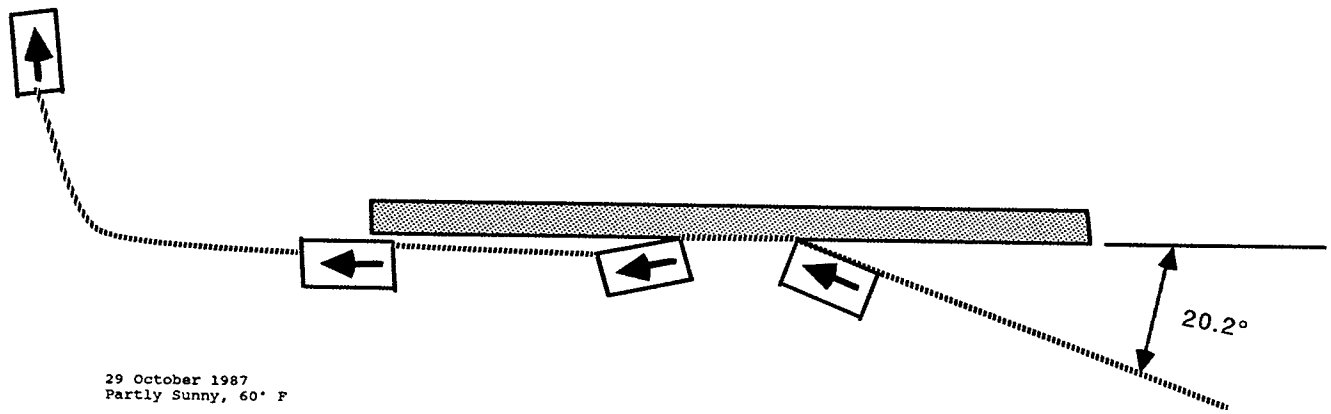
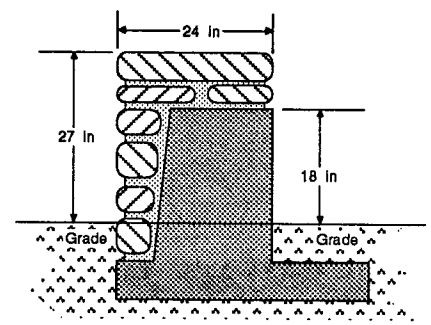
Figure 31. Test summary, test 1818-5-3-87.

Vehicle damage occurred mainly to the right front fender, grill and bumper. The front right tire rim was damaged from impacting the wall, resulting in a flat tire. The passenger side door was wedged outward and the windshield was shattered on the passenger side due to the impact from the dummy. Windshield fragments were thrown 35 to 40 ft (10.7 to 12.2 m) behind the guardwall. Posttest photographs of the vehicle are shown in figure 33.

14. Test Results Conclusion: Vehicle was redirected by the guardwall at 44.0 mi/h and 4.5 degrees. Because the vehicle did not intrude or come to rest in the adjacent traffic lanes, the vehicle slowdown criteria does not apply. Negligible damage was done to the guardwall.

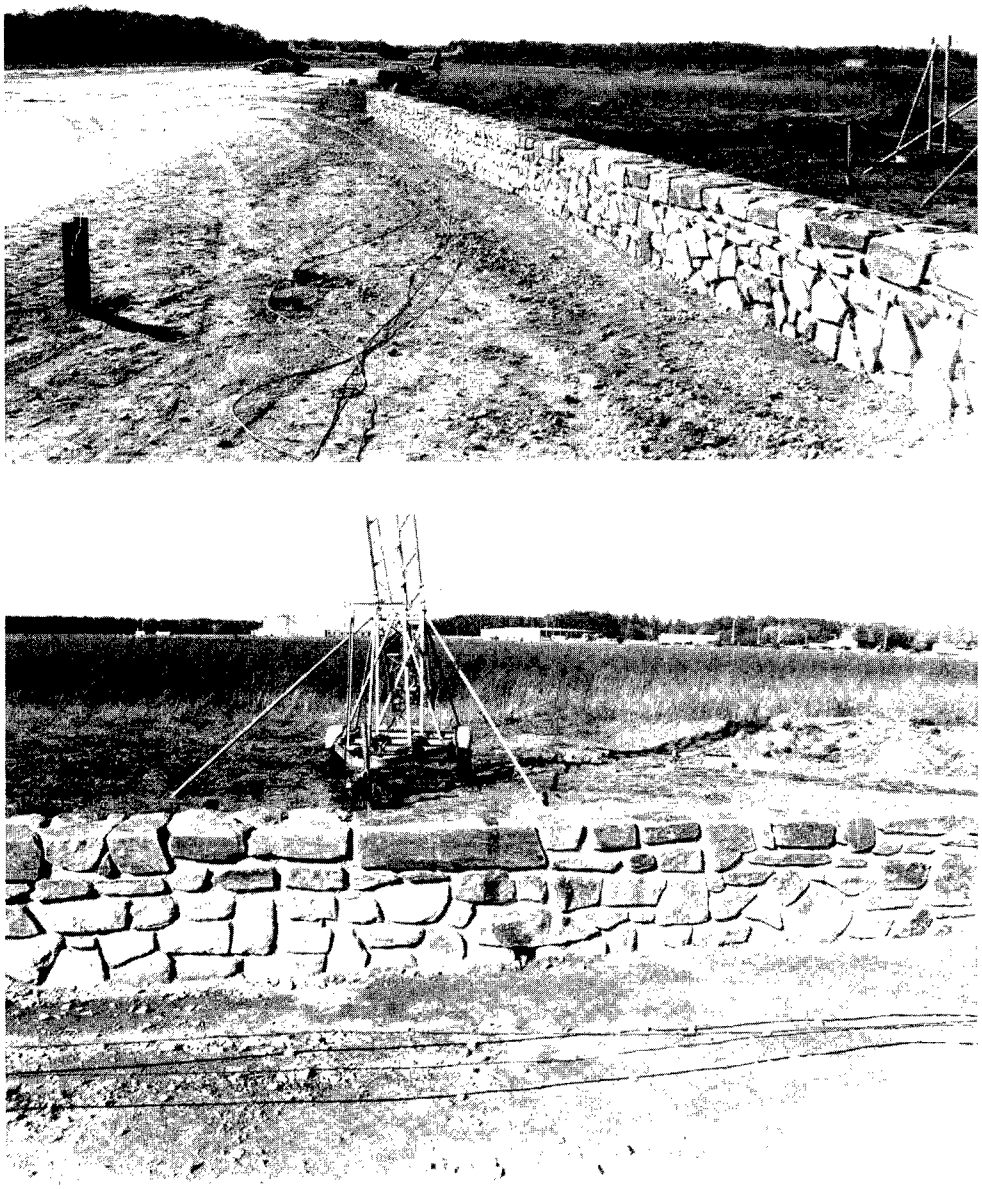
Figure 34. Posttest photographs of guardwall system, test 1818-5-3-87.

Upon impact, the front of the vehicle was deformed and skewed toward the non-impact side. The right front corner of the vehicle continued to crush. The vehicle rode up on top of the wall, knocking off approximately 15 ft (4.6 m) of coping stone.

A second test was conducted on the rough stone masonry guardwall system after modification of the system. The core was raised to

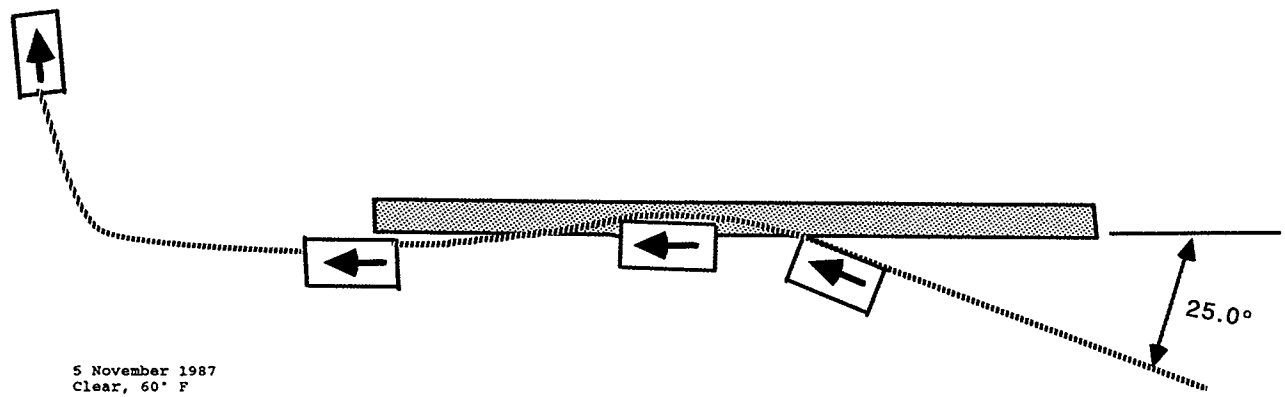
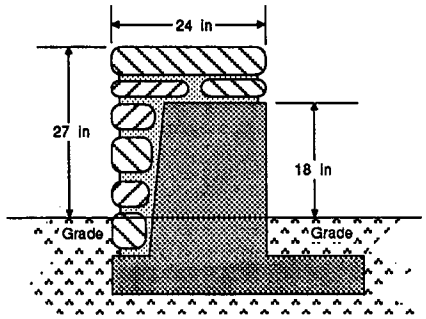
Figure 39. Test summary, test 1818-5-4-87.

Vehicle damage occurred mainly to the right side of the car. The right front fender, grill, bumper, rear quarterpanel, and vehicle steering and suspension were damaged significantly. The two right wheels were damaged from impacting the rail thus, resulting in flat tires. The passenger side door was wedged outward and the windshield was shattered on the passenger side due to the impact from the dummy. Posttest photographs of the vehicle are shown in figure 41.

14. Test Results Conclusion: Vehicle rode up on guardwall and was redirected. Significant damage occurred to guardwall - 20 ft of coping stone knocked off top of wall. Vehicle was redirected by the guardwall at 36.4 mi/h and 4 degrees. Because the vehicle did not intrude or come to rest in the adjacent traffic lanes, the vehicle slowdown criteria does not apply.

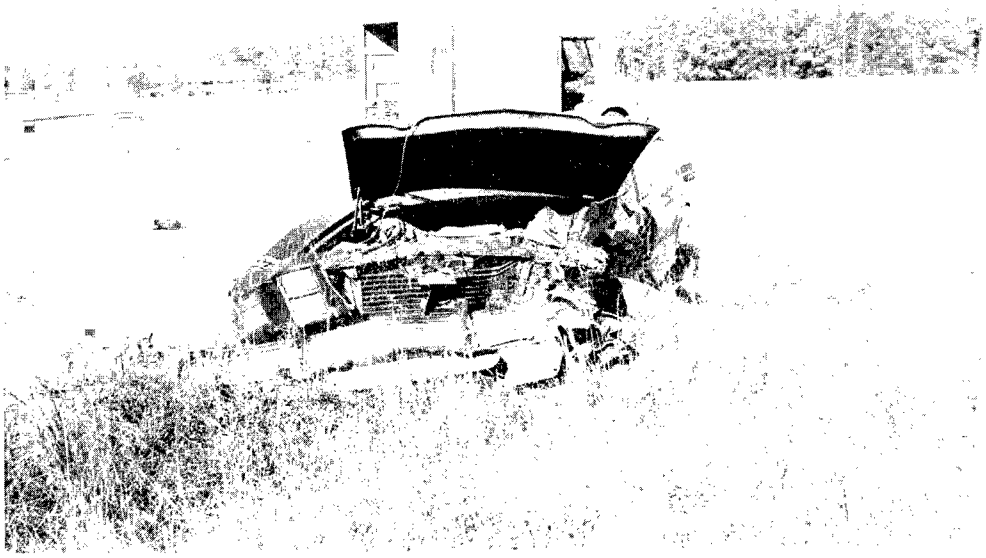
Figure 56. Posttest photographs of test vehicle, test 1818-5-6-87.

Vehicle damage occurred mainly to the left front fender, grill bumper, and suspension/steering. The front left wheel was damaged from post snagging causing the tire to deflate. The driver side door was wedged outward. The windshield and the drivers side window glass were shattered. Posttest photographs of the vehicle are shown in figure 56.

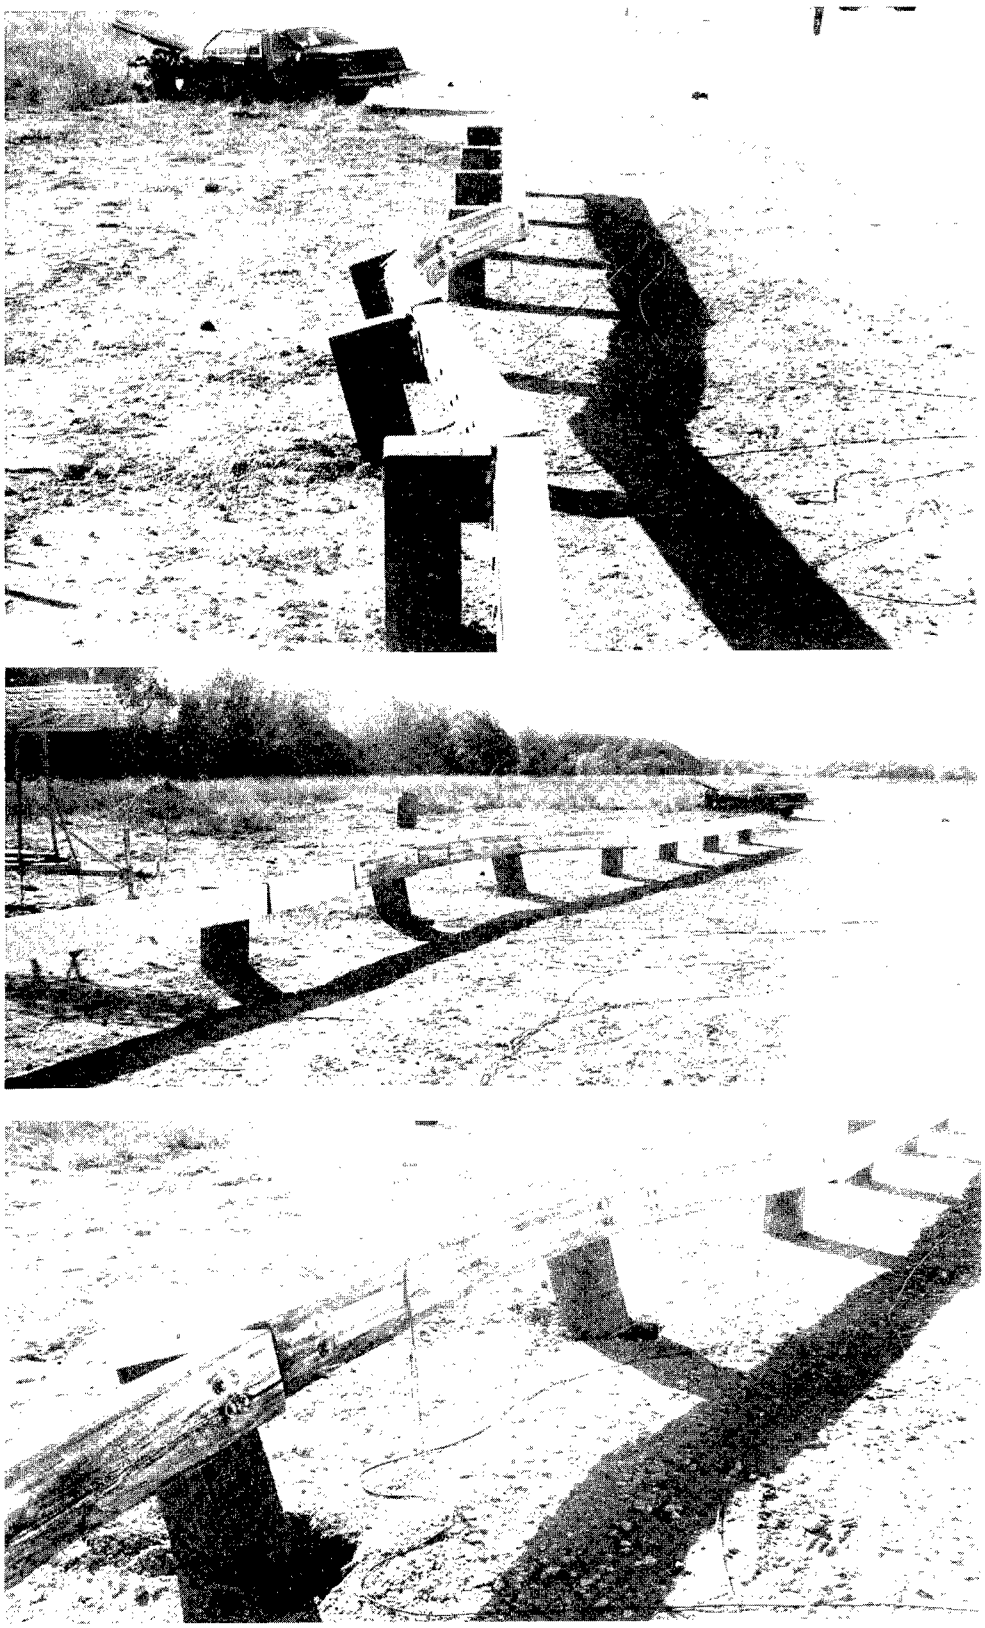
Figure 57. Posttest photographs of guardrail system, test 1818-5-6-87.

Damage to the guardrail system was minimal. The 6 in by 10 in (0.15 m by 0.25 m) timber part of the fifth rail snapped due to pocketing of the vehicle. There was a 16 in (0.41 m) long crack at the trailing end of rail 4. This crack was mostly cosmetic. A 0.5-in (0.013-m) strip of wood was torn off the front corner of post 6. The blockout of post 6 was cracked throughout its entire length. Posttest photographs of the guardrail are shown in figure 57.

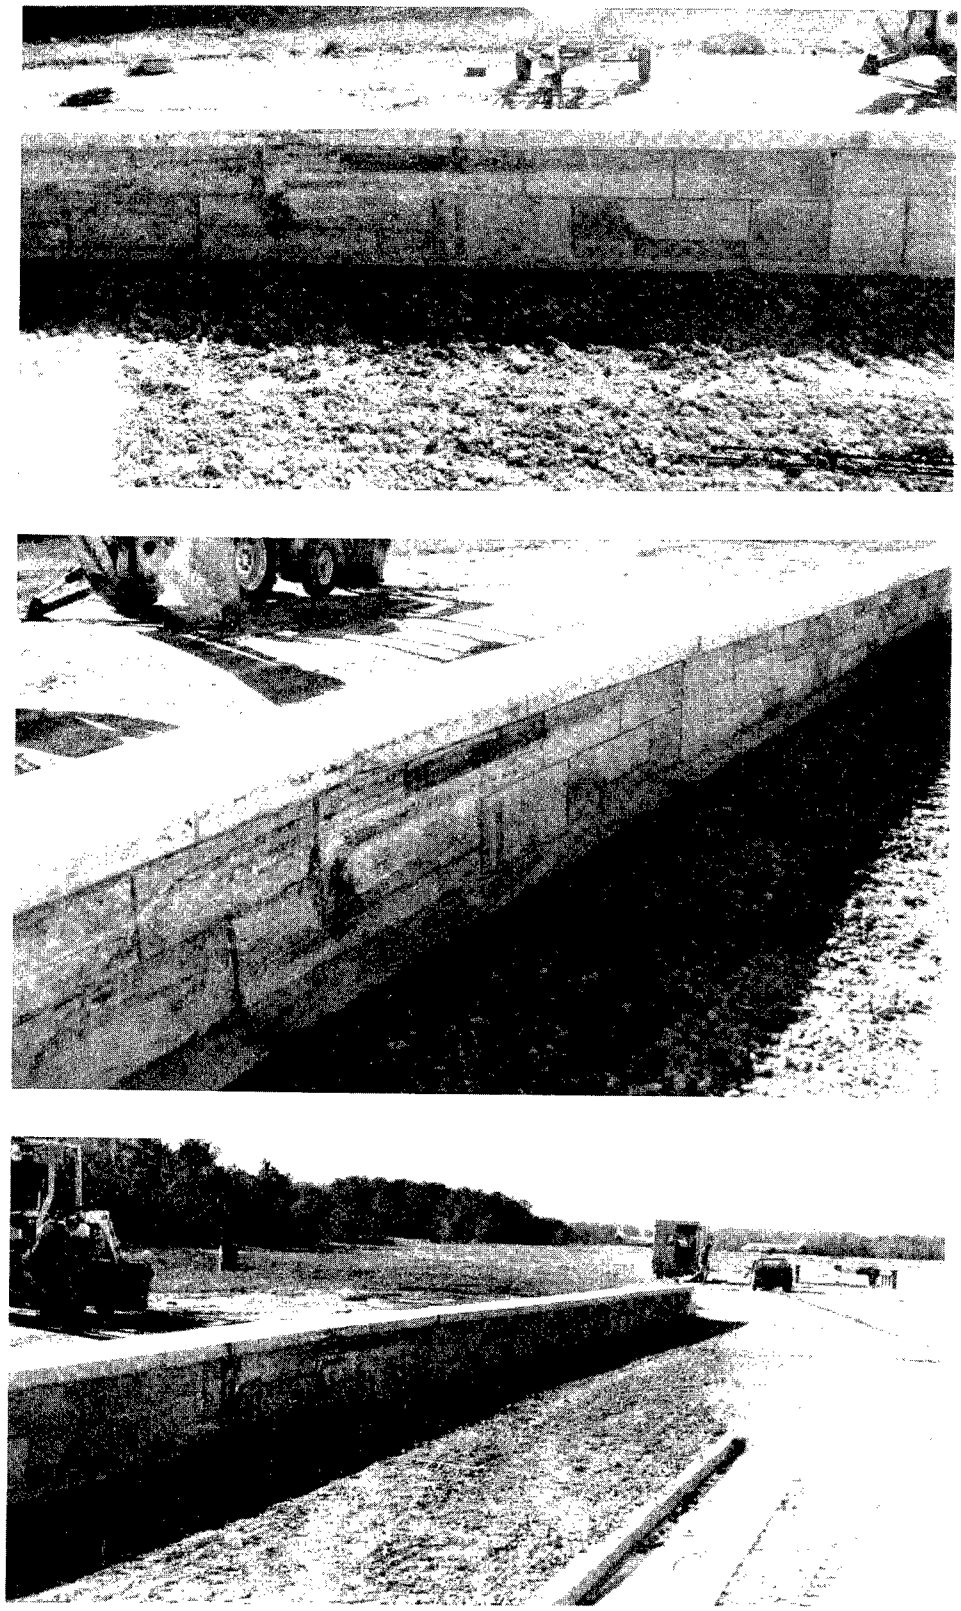
Figure 65. Posttest photographs of median barrier system, test 1818-7-88.

This barrier performed well. The vehicle was redirected. Some light marring of the concrete occurred at the impact point. The barrier showed no permanent deformation. Posttest photographs of the median barrier are shown in figure 65.

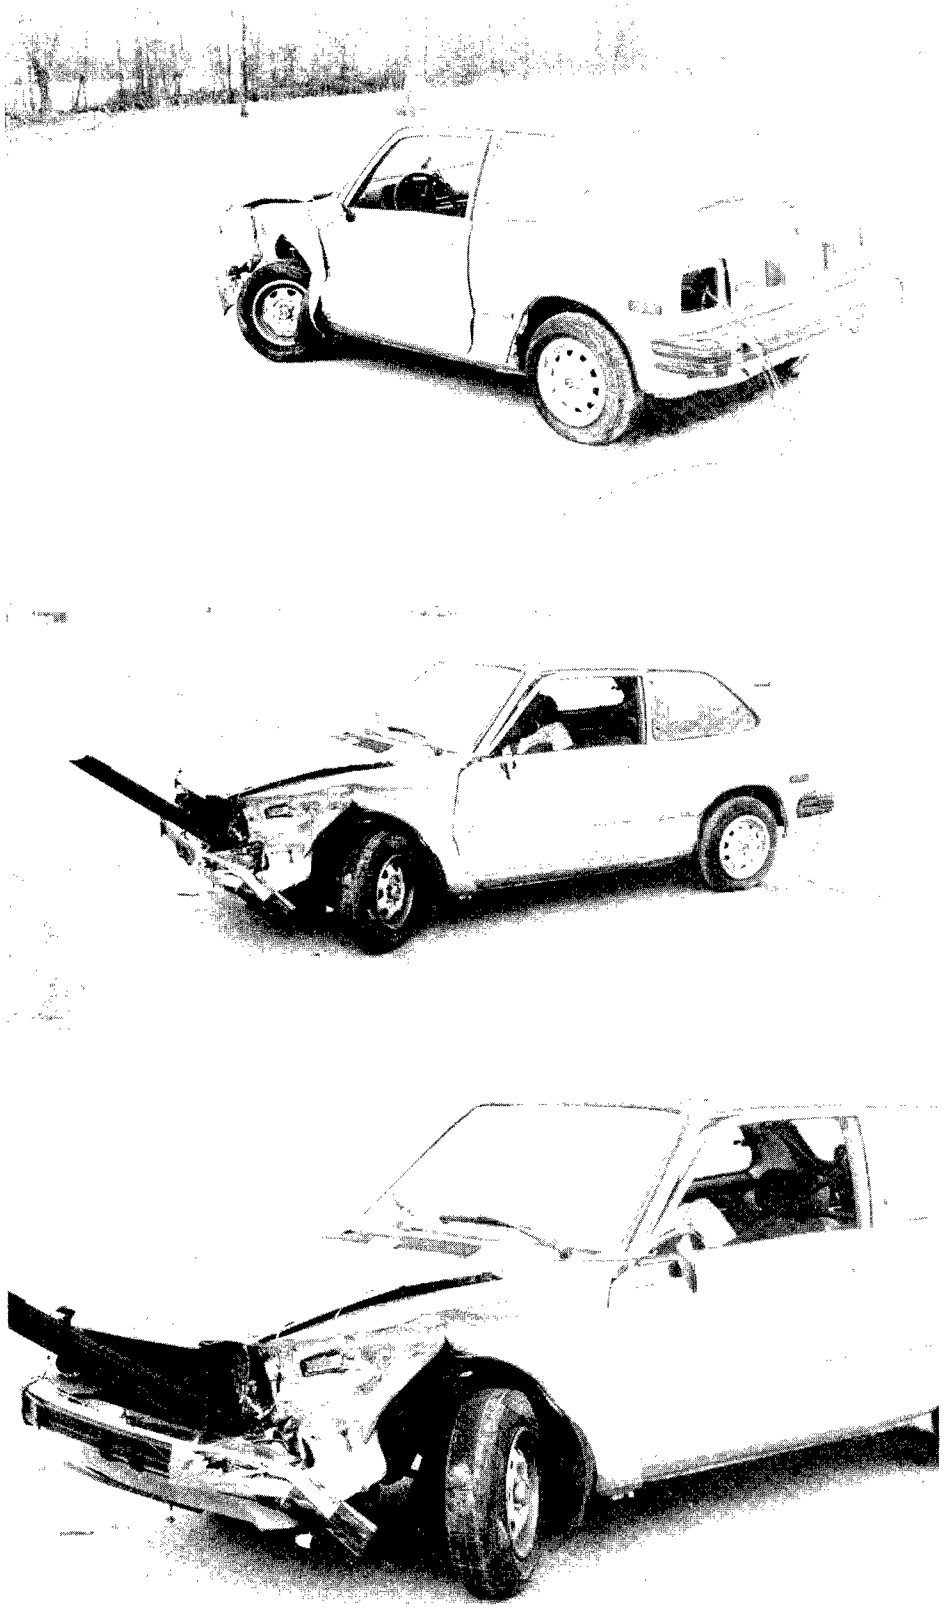
Figure 72. Posttest photographs of test vehicle, test 1818-8-88.

Vehicle damage occurred mainly to the left side of the car. The left front fender, grill, bumper, and drivers door were damaged significantly. Posttest photographs of the vehicle are shown in figure 72.

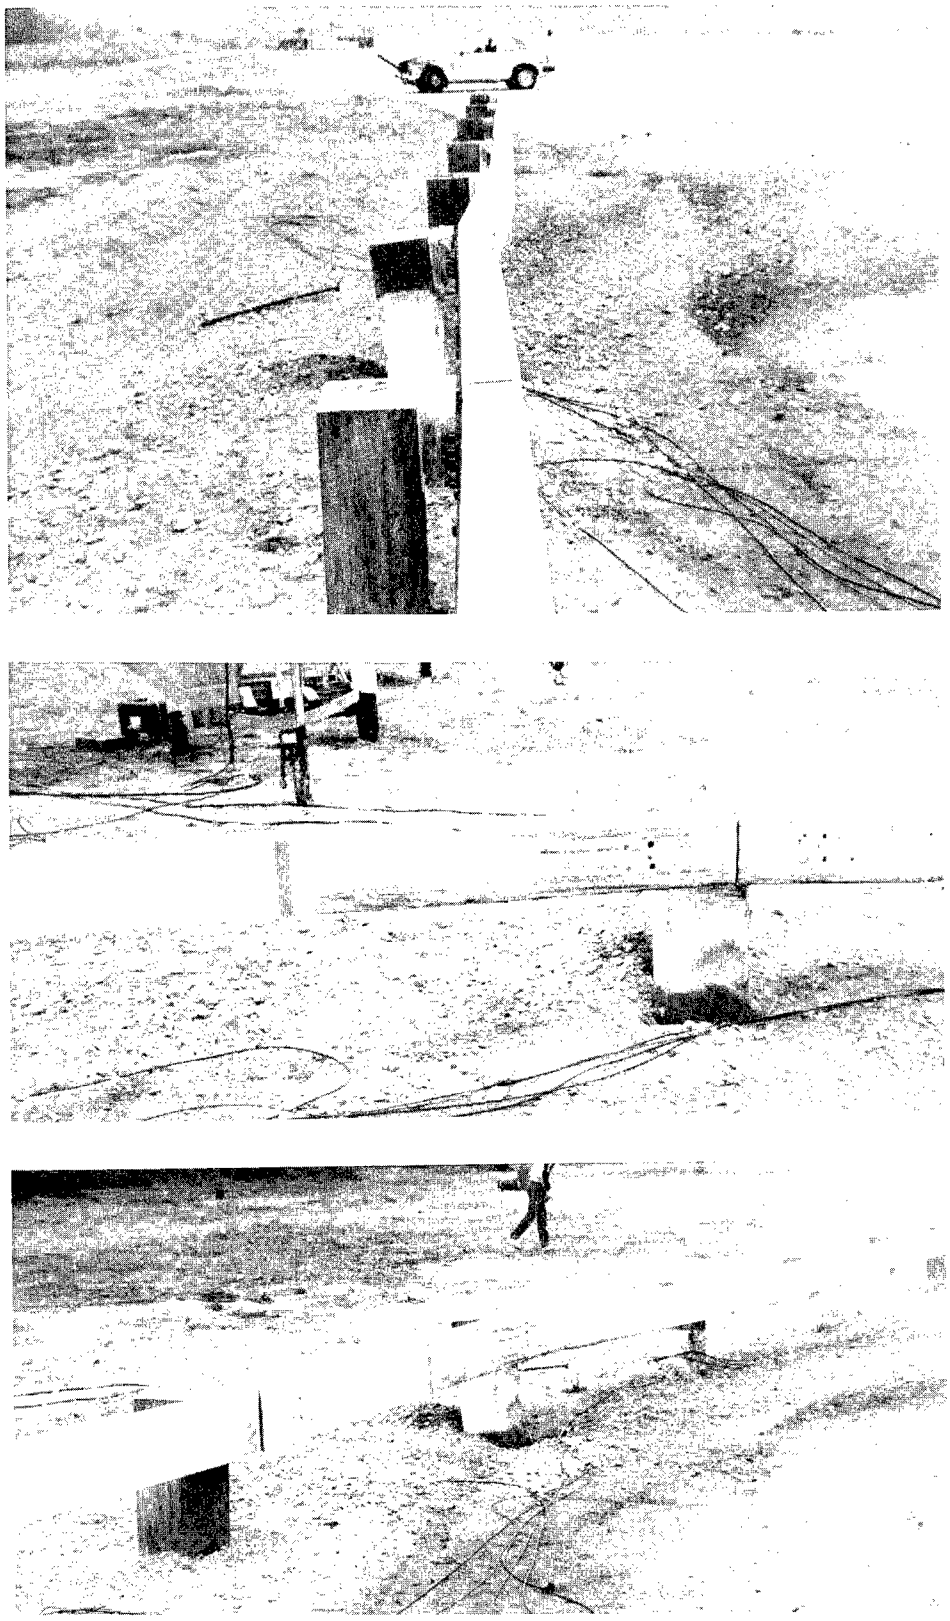
Figure 73. Posttest photographs of guardrail system, test 1818-8-88.

This guardrail performed well. The vehicle was redirected. There was tire scrub on the front of post 5 and the front and side of post 6. Post 6 was impacted by the vehicle front wheel. The bottom of the rail showed tire scrub for 18 ft (5.5 m) (from 2 ft (0.61 m) past impact to midspan of rail 6). The rail at post 5 was pushed back approximately 8 in (0.20 m) dynamically and 5 in (0.13 m) statically and was pushed up approximately 5 in (0.13 m) dynamically and 2.5 in (0.06 m) statically. A portion of the push back and lift were actually rail and splice twist. Posttest photographs of the guardrail are shown in figure 73.

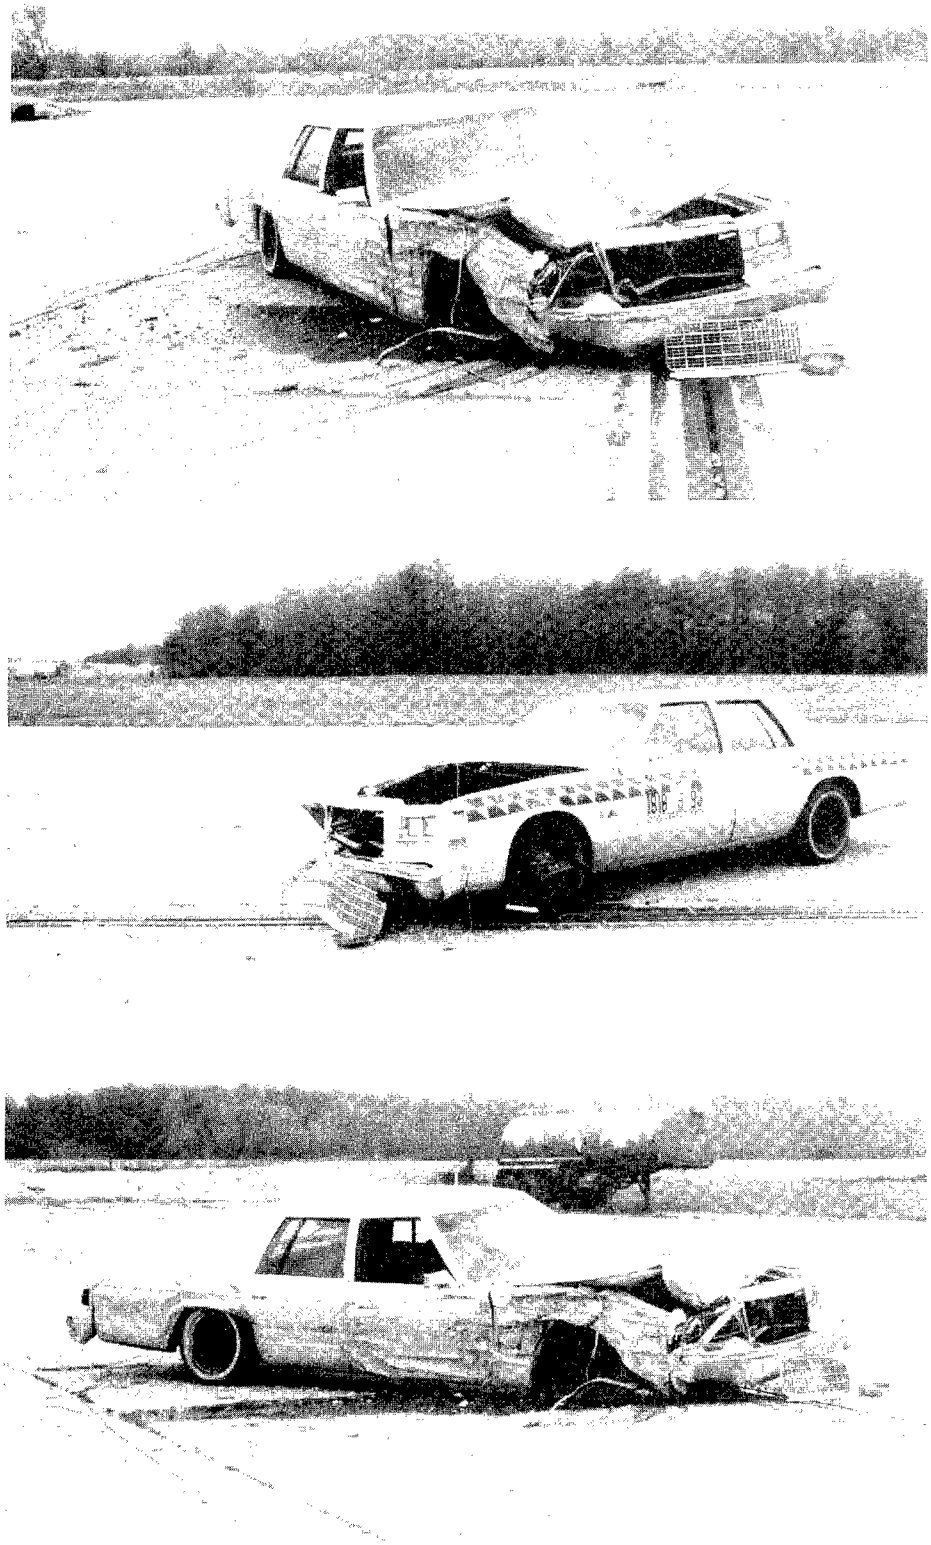
Figure 80. Posttest photographs of test vehicle, test 1818-9-90.

Damage occurred to the grill, front bumper, hood and entire right side of the vehicle. The passenger side door was pushed out due to the impact of the passenger dummy. Posttest photographs of the vehicle are shown in figure 80.

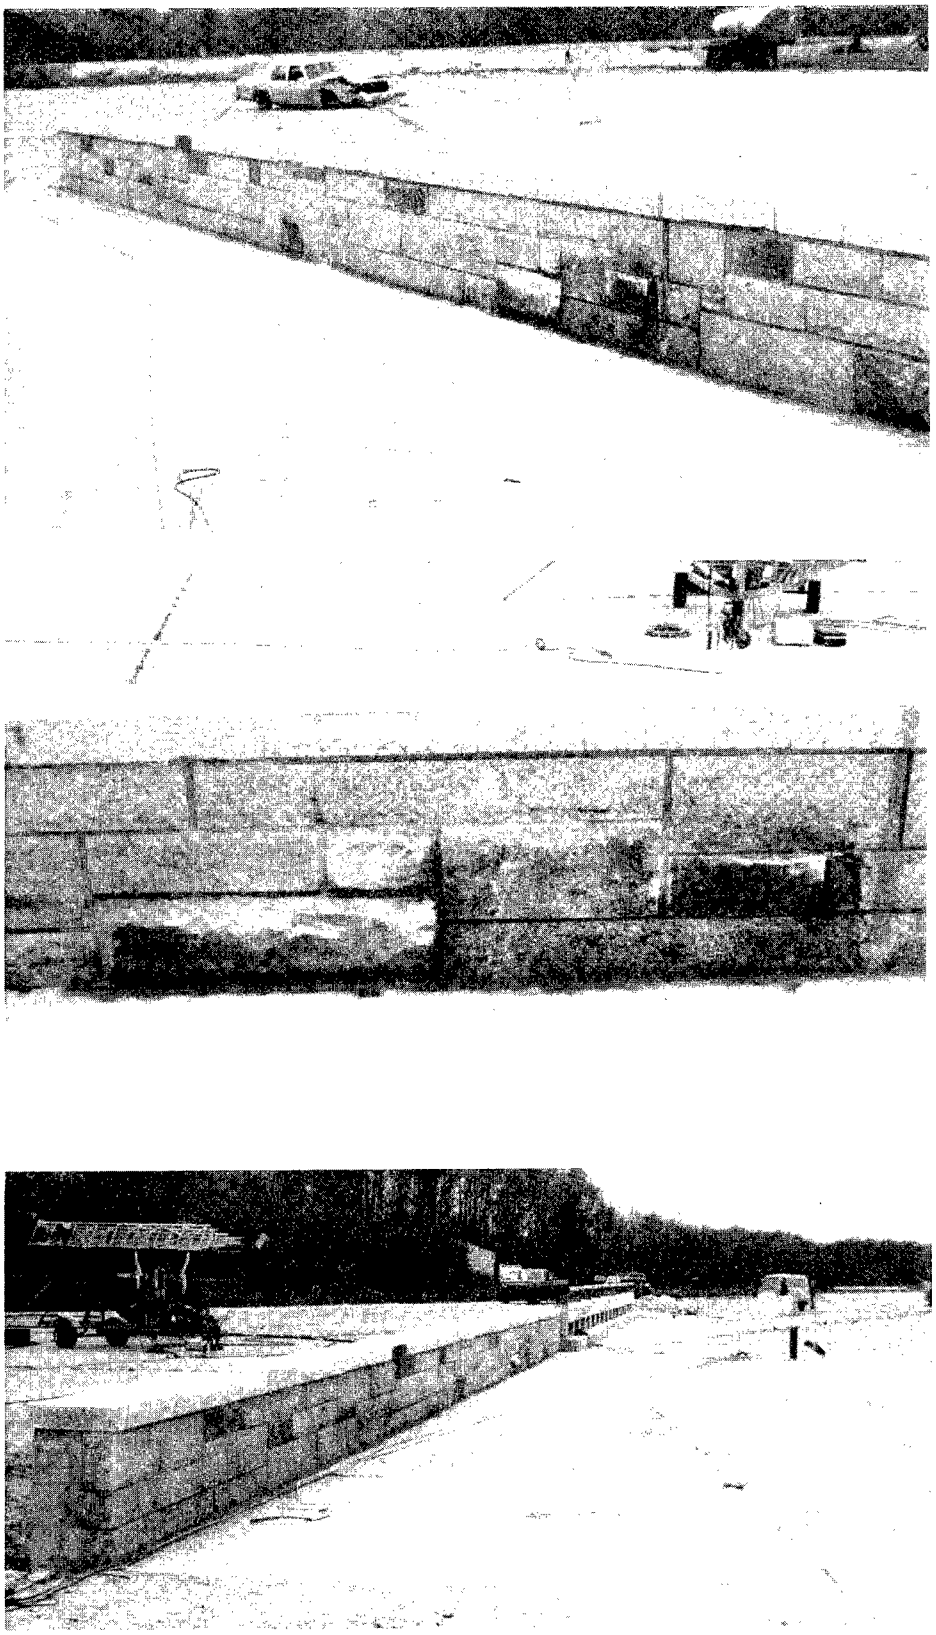
Figure 81. Posttest photographs of bridge rail system, test 1818-9-90.

The bridge rail showed only minor scuffing for the 15 ft (4.6 m) that the vehicle was in contact. Other than this scuffing, there was no damage to the bridge rail. Posttest photographs of the bridge rail are shown in figure 81.
