Guardrail Testing Program

Final Report

Publication No. FHWA-RD/FLP-90-087
May 1990

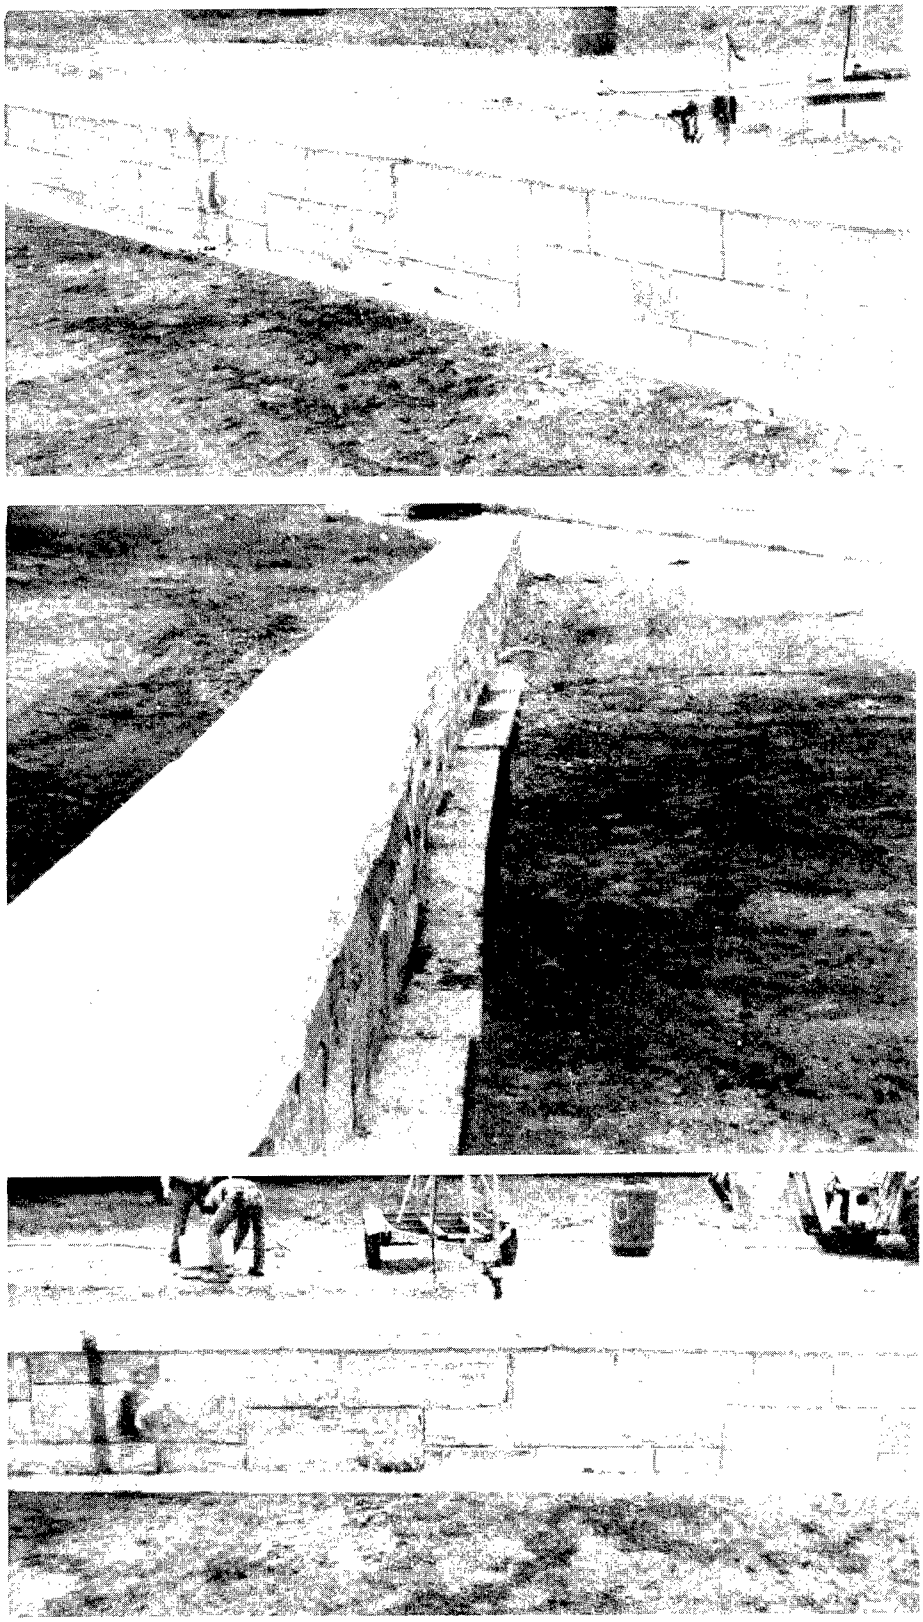
Figure 89. Posttest photographs of median barrier system, test 1818-12-88.

rotated back out of the line of the barrier approximately 3 in (0.08 m). Statically, the sections were also pushed back slightly. The maximum push back occurred at the section joint downstream of impact and was measured to be 3 in (0.08 m). Posttest photographs of the median barrier are shown in figure 89.

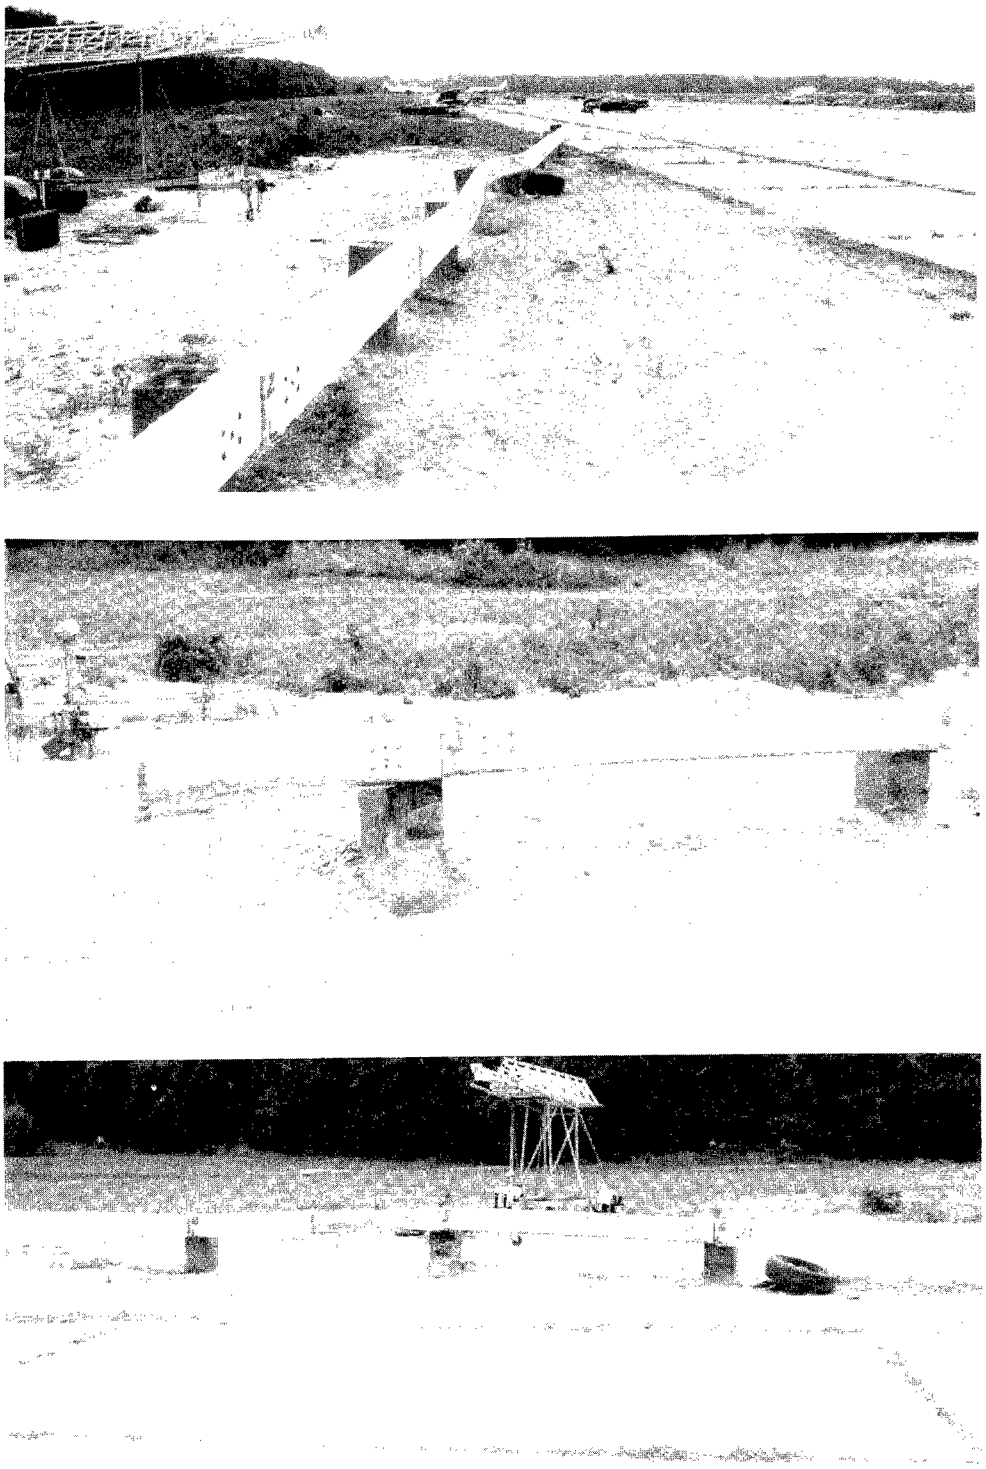
Figure 97. Posttest photographs of guardrail system, test 1818-14-88.

This guardrail performed adequately. The vehicle getting under the rail caused the rail to rise. The left front wheel of the vehicle was torn from the car in the impact with post 5. Posts 4 and 6 were pushed back 1 in (0.03 m) and post 5 was pushed back 5 in (0.13 m). Posttest photographs of the guardrail are shown in figure 97.
