LTPP Maintenance and Rehabilitation Data Review, Final Report

PUBLICATION NO. FHWA-RD-01-019

FEBRUARY 2001

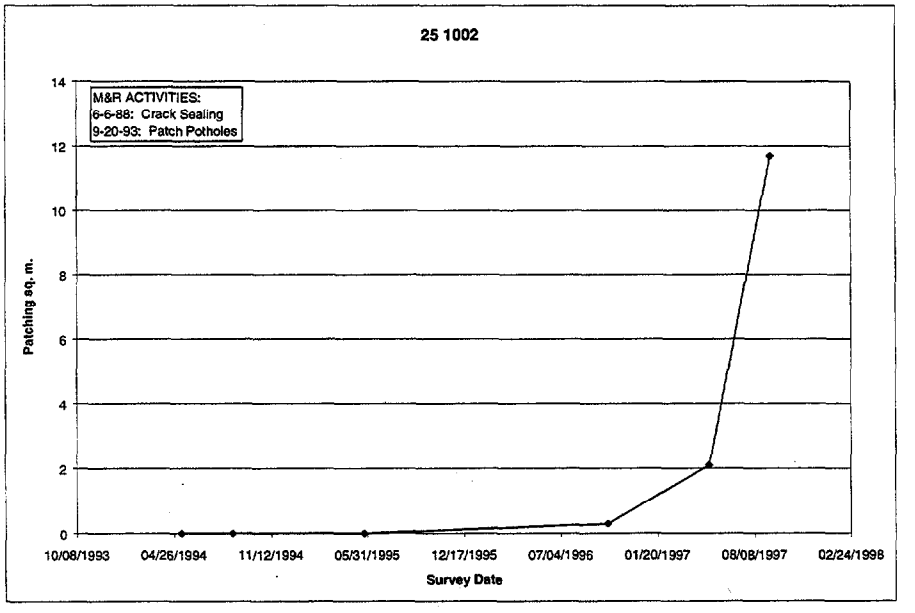
Figure 5. Discrepancy noted for test section 251002 – no area of patching recorded on 4/26/94 after potholes were patched on 9/20/93.

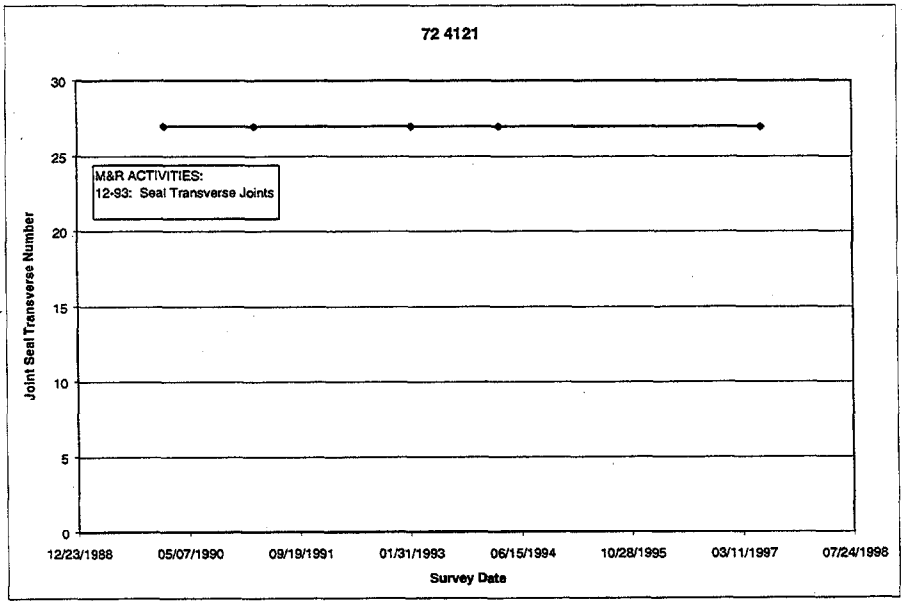
Figure 6. Discrepancy noted for test section 724121 – no increase in the number of transverse joints sealed after additional transverse joints were sealed in December 1993, as recorded in the LTPP database.

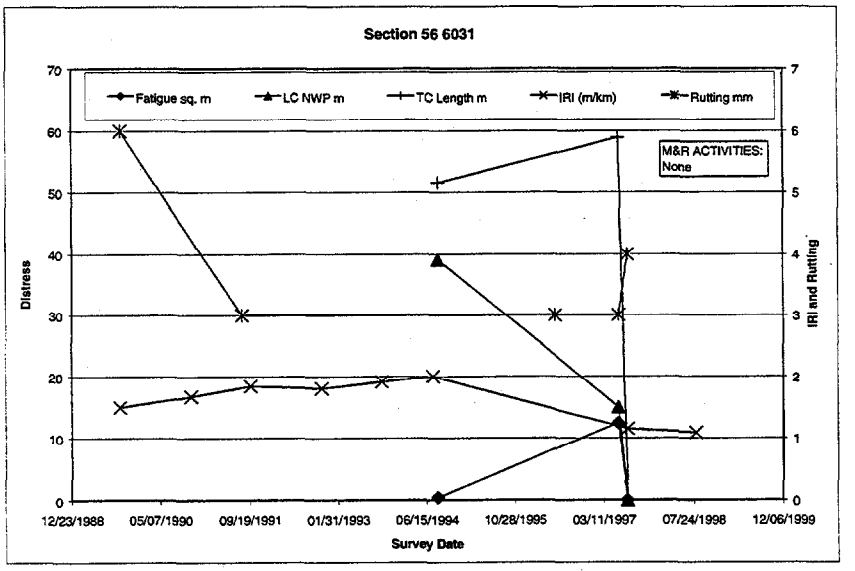
Figures 10 and 11 are examples of improvements in performance of test sections for which no M&R activity was recorded (i.e., a type 2 anomaly). Figure 10 shows that; although an early April 1997 observation of test section 566031 (an HMA-surfaced pavement) showed fatigue cracking, longitudinal cracking in the wheel path; and transverse crack lengths, none were present during the late April 1997 distress survey. During the same period, there was a corresponding slight decrease in the calculated IRI value, but a slight increase in the measured rut depths. Although no M&R activity was recorded near these survey dates, some type of surface repair likely occurred to eliminate the cracking.

Figure 10. Time-series data for various performance indicators for HMA-surfaced test section 566031 that has no M&R activities recorded in the LTPP database.

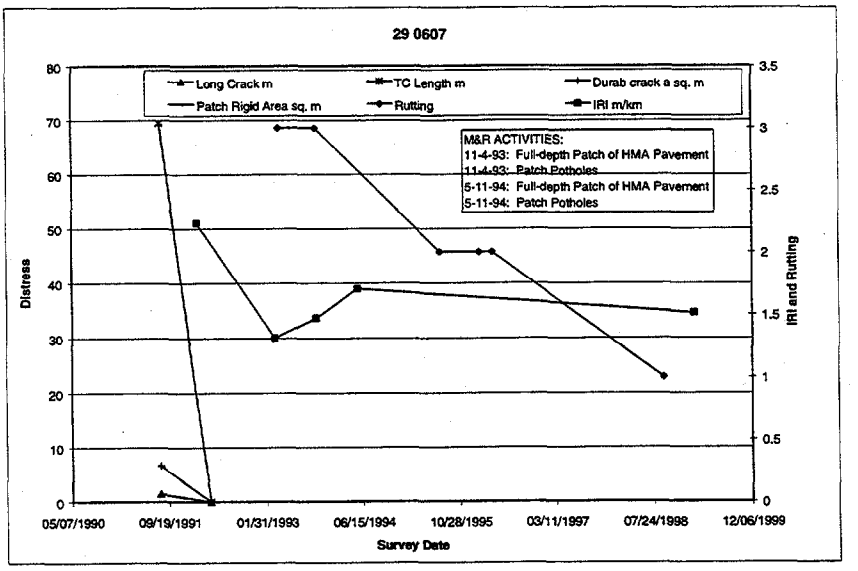
Figure 11 is an example of multi-discrepancies in the same section (test section 290607-JCP). This JCP test section has no HMA overlay recorded in the database. However, it is obvious that an HMA overlay was placed around October 1991 because the survey prior to that date was for a JCP. After October 1991 all data recorded for this section pertains to an HMA-surfaced pavement. M&R activities for this section were recorded in November of 1993 and in May 1994, as noted in figure 11.

Figure 11. Time-series data for various performance indicators for PCC-surfaced (JCP) test section 290607 that has no M&R activities recorded in the LTPP database.

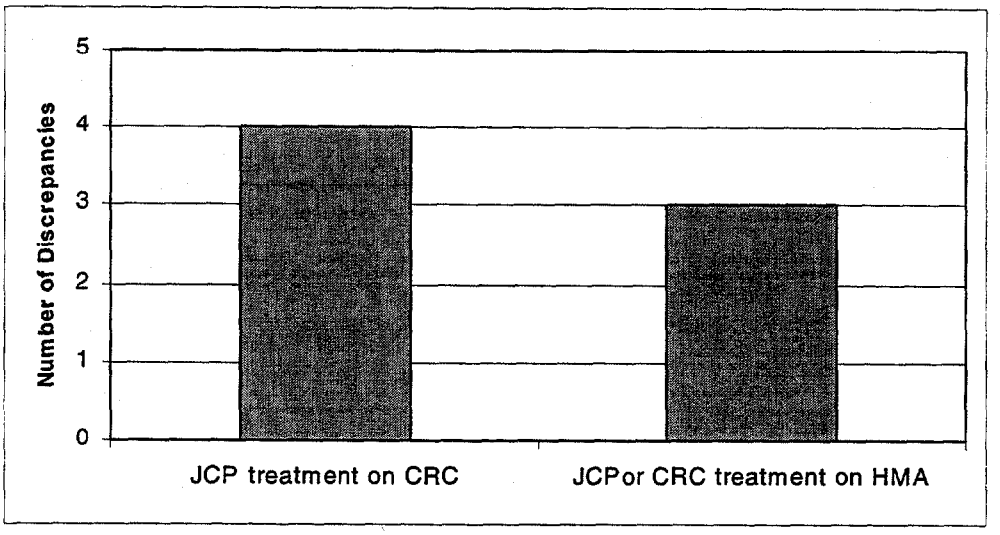
During the review of the M&R data, it was noticed that there were seven instances in which PCC treatments were reportedly applied to HMA surfaces and vice versa. These sections are listed in appendix E. These discrepancies were forwarded to the FHWA. Figure 25 shows a distribution of these anomalies. These sections need to be reviewed to ensure that the sections' surfaces are correctly recorded.

Figure 25. Maintenance treatments reported on wrong surfaces.

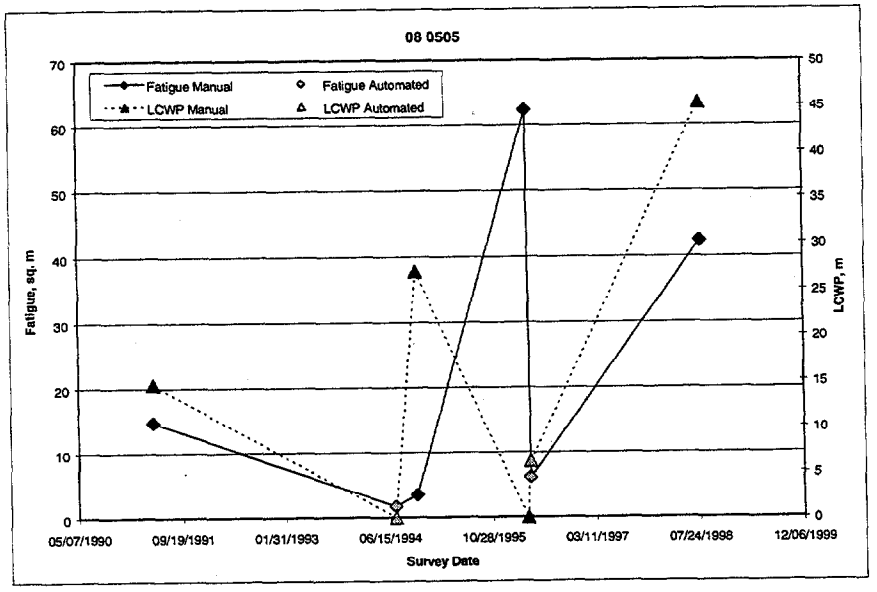
Figure 26. Examples of the difference between the automated and manual distress surveys for test section 080505.

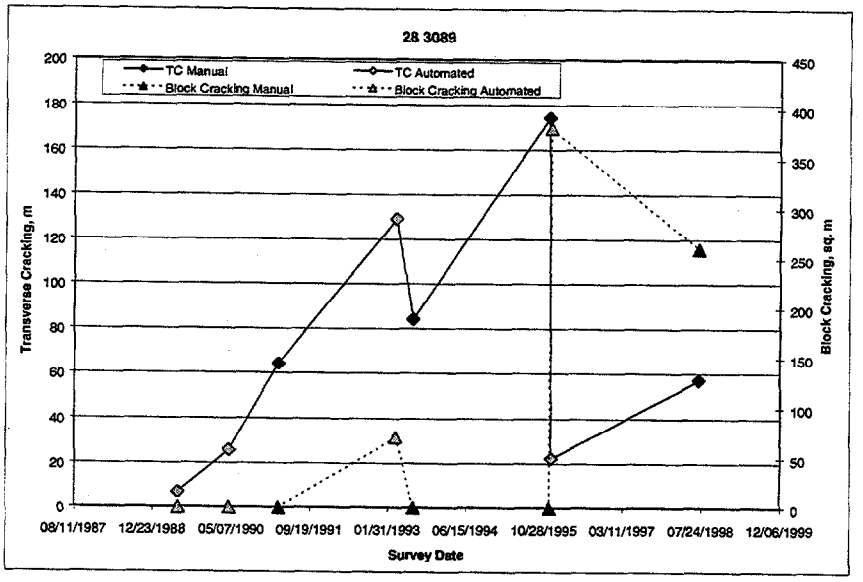
Figure 27. Examples of the difference between the automated and manual surveys for test section 283089.
