AC NO: AC 20-52

MAINTENANCE INSPECTION NOTES FOR
DOUGLAS DC-6/7 SERIES AIRCRAFT

AUGUST 24, 1967

DEPARTMENT OF TRANSPORTATION
Federal Aviation Administration

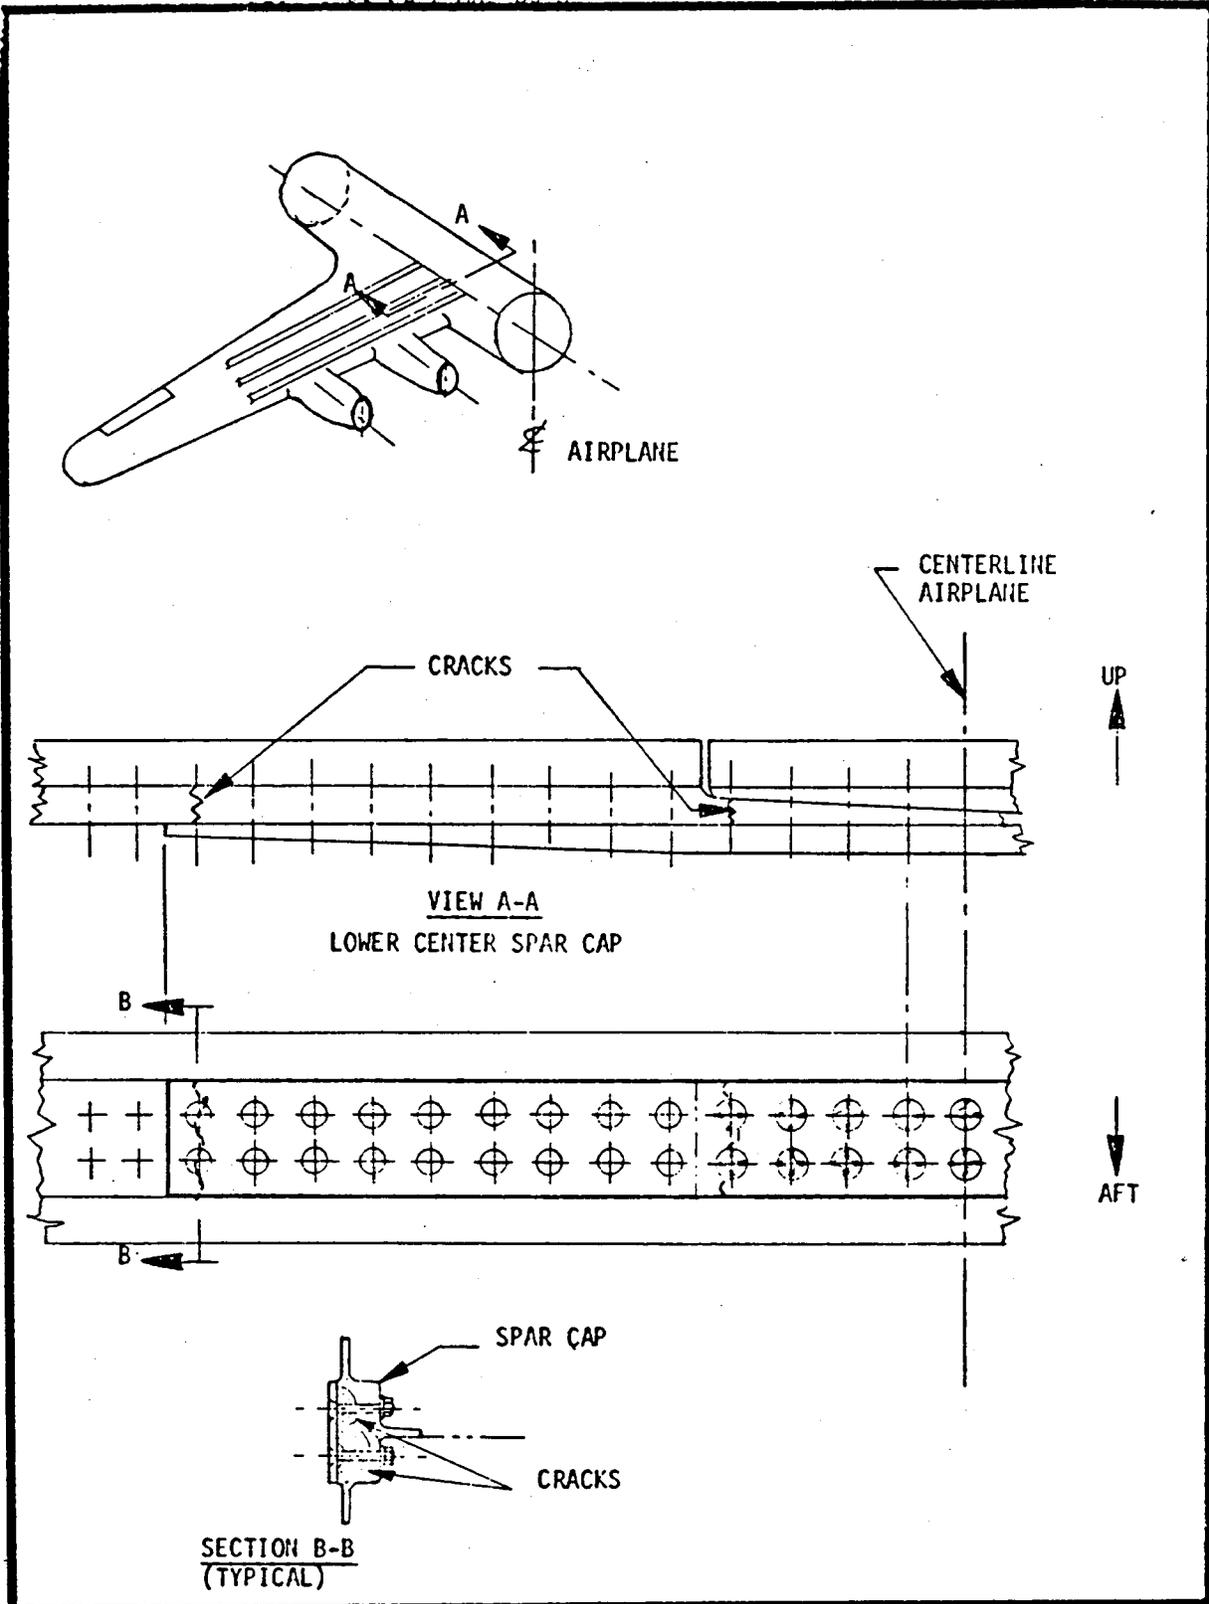
FIGURE G-13. LOWER CENTER SPAR CAP SPLICE AT STATION 0

- (3) Other Reference Documents.
 - (a) DC-6/-7 Advisory Circular 20-52, Appendix 5, Page 1.
 - (b) DC-6 Service Bulletin 854.
- (4) Probable Consequences. Continued cracking of center spar lower cap could result in more extensive structural damage to the wing lower panel.
- (5) Recommendations. Periodic inspections to assure continued structural integrity.
