Report No. FHWA/RD-80/158

# STABILITY OF RELOCATED STREAM CHANNELS

March 1981  
Final Report

1. Report No. FHWA/RD-80/158		2. Government Accession No.		3. Recipient's Catalog No.	
4. Title and Subtitle  Stability of Relocated Stream Channels				5. Report Date March 1981

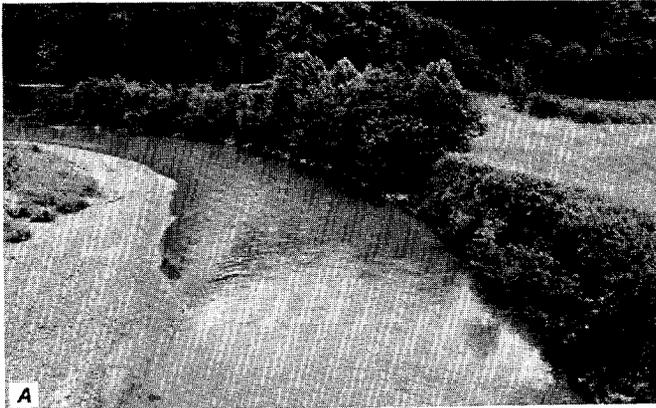
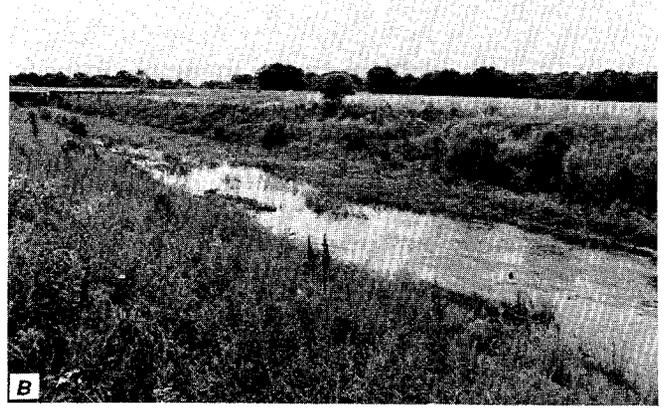
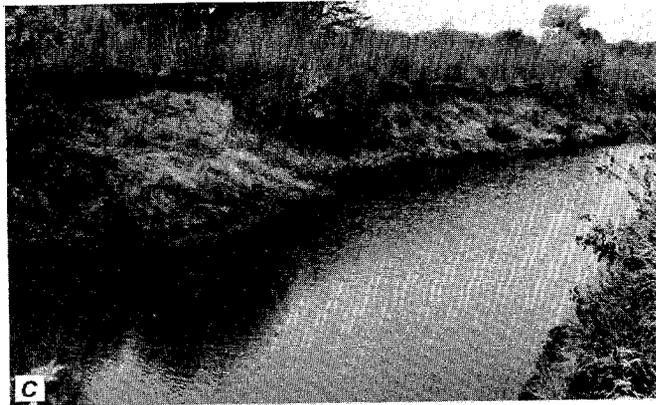
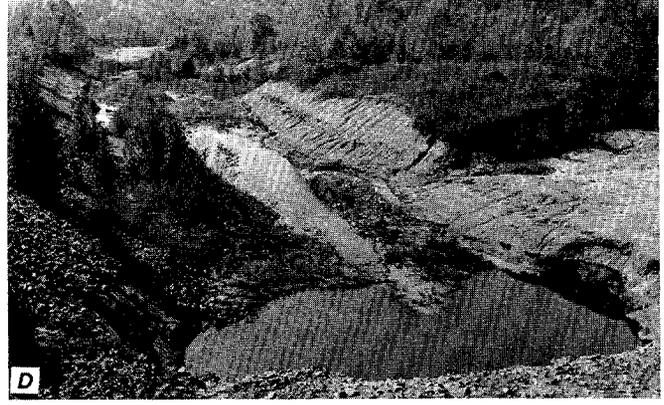
Figure 3. Photographs illustrating bank stability classes. Class A, cut banks rare or absent, Hocking River, Ohio. Class B, cut banks local and not severely cut, Poteau River, Ark. Class C, cut banks local but severely cut or slumped, Big Blue River, Nebr. Class D, banks generally cut or slumped, Crow Creek, Ark.

Typical changes with time in the cross section of a trapezoidal relocated channel, having 2:1 side slopes, are shown in figure 11. In addition, the steepening of side slopes by erosion at the toe is well shown by a photograph of the Poteau River in Arkansas (fig. 3B), where the slopes steepened during a period of 9 yr from an original value of 26.5° to values in the range of 30°-40°. Observed values for the side slopes of relocated channels are within the range of values observed for natural creeks and small rivers, and it is therefore unlikely that the angles will recline as the performance periods are lengthened. Nevertheless, construction of initial side slopes not steeper than 2:1 is a good practice. The steeper the slope, the greater the difficulty in establishing vegetation on it and the more subject it is to failure by slumping. If the growth of vegetation were encouraged by a suitable mulching technique (Normann, 1975), and if no major floods occurred soon after construction, 2:1 slopes could probably be stabilized without much erosion at the toe.

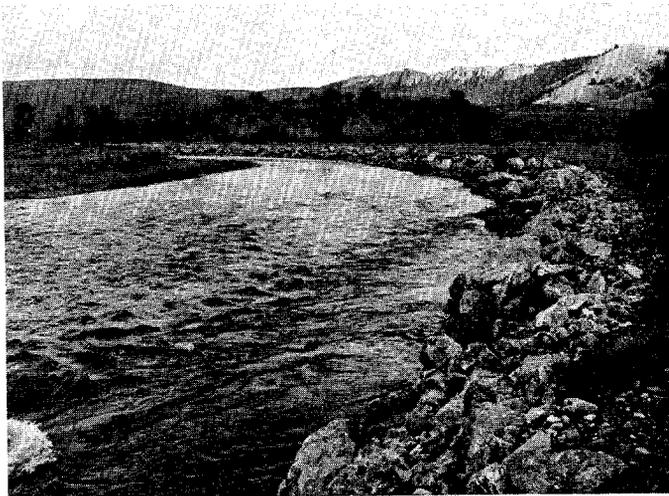
Figure 14. Relocated channel of Clark Fork at artificial meander near Drummond, Mont.

observation in 1979 showed that the meanders were stable, but the appearance was not natural because of the large riprap placed continuously along both banks. The designer of artificial meanders is faced with a dilemma: In order to avoid deterioration of the channel while woody vegetation is becoming established, bank protection measures must be applied and these are likely to look unnatural. In addition, equalling or even exceeding the length of prior channel does not necessarily prevent degradation.

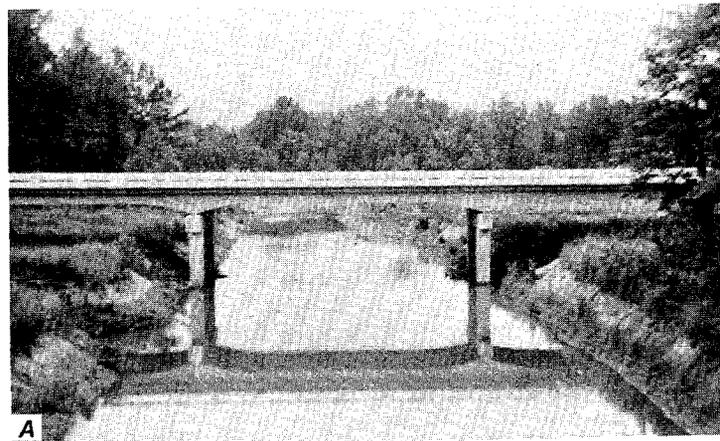
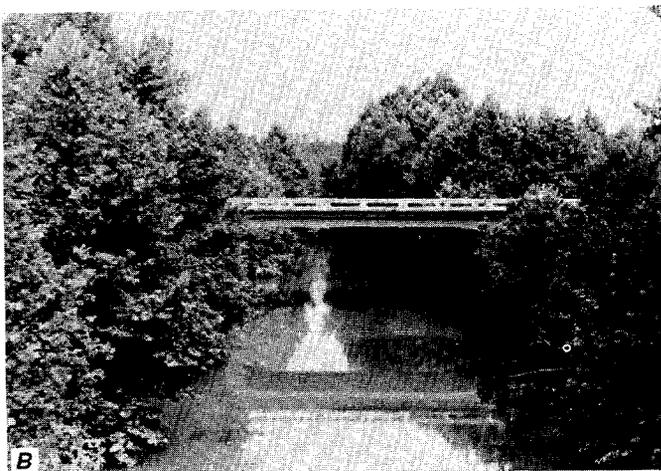
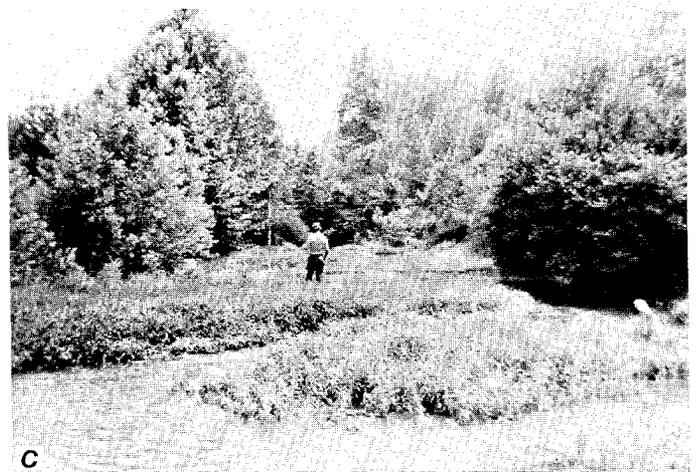
SYNOPSIS--Channel segment was relocated and thereby shortened from a length of 605 m to 400 m, for purpose of improving channel alinement at bridge (fig. 16 ). Performance period, 17 yr (1961-78) during which the largest flood (in March of 1970) had a recurrence interval of about 10 yr. As built, the relocated channel was trapezoidal in cross section, with a bottom width of 15 m, 1½:1 side slopes, and a longitudinal slope of 3.5 m/km. No bank protection measures were applied. This site was reported on by Jefferson (1965), who observed minor bank erosion near the bend in the relocated channel but saw no evidence of instability elsewhere. Channel cross sections were surveyed by the U.S. Geological Survey in 1965, and these same sections were resurveyed in 1978 (fig. 17 ). The right bank at section 1 receded about 6 m during the period 1965-78, a lesser amount of bank erosion occurred in section 2, and none at section 4. The surveys also indicate about 0.6 m of degradation at sections 1 and 2, but aggradation at section 4. By 1978, the bankline had become densely vegetated (figs. 18A and 18B ) and the cut banks, although present, seemed not to be receding. Grass had become established on alternate gravel bars in the channel (fig. 18C ), and these may lead to development of sinuosity.

Figure 18. Big Canoe Creek at site 1. A, View upstream along relocated channel from downstream bridge, in 1965. B, View from same point as in A, in 1978. C, View upstream along relocated channel from section 1, in 1978.

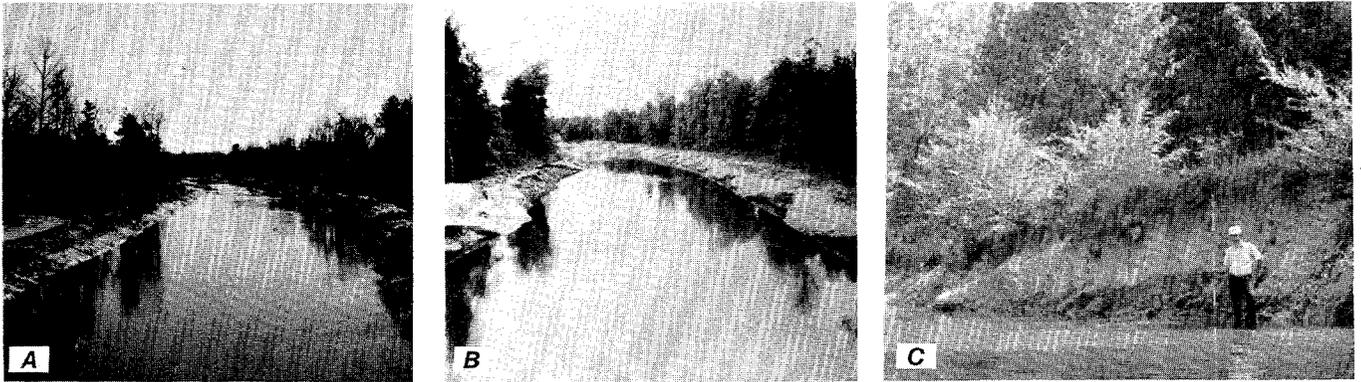
DISCUSSION--The timing of floods in relation to channel relocation is a definite factor in channel stability, and the flood at this site occurred at an unfortunate time. Even if an attempt had been made to plant vegetation along the banks, it could scarcely have become well enough established to inhibit bank slumping. If further bank erosion is to be controlled under such circumstances, it would be necessary to regrade the banks after the flood and apply a vegetal lining or some other bank protection measure.

Figure 20. Calebee Creek at site 2. A, Relocated channel as viewed upstream from interstate bridge, on January 19, 1964. B, View from same point as in A, on April 22, 1964. C, Bank erosion at section 2, on August 28, 1978.

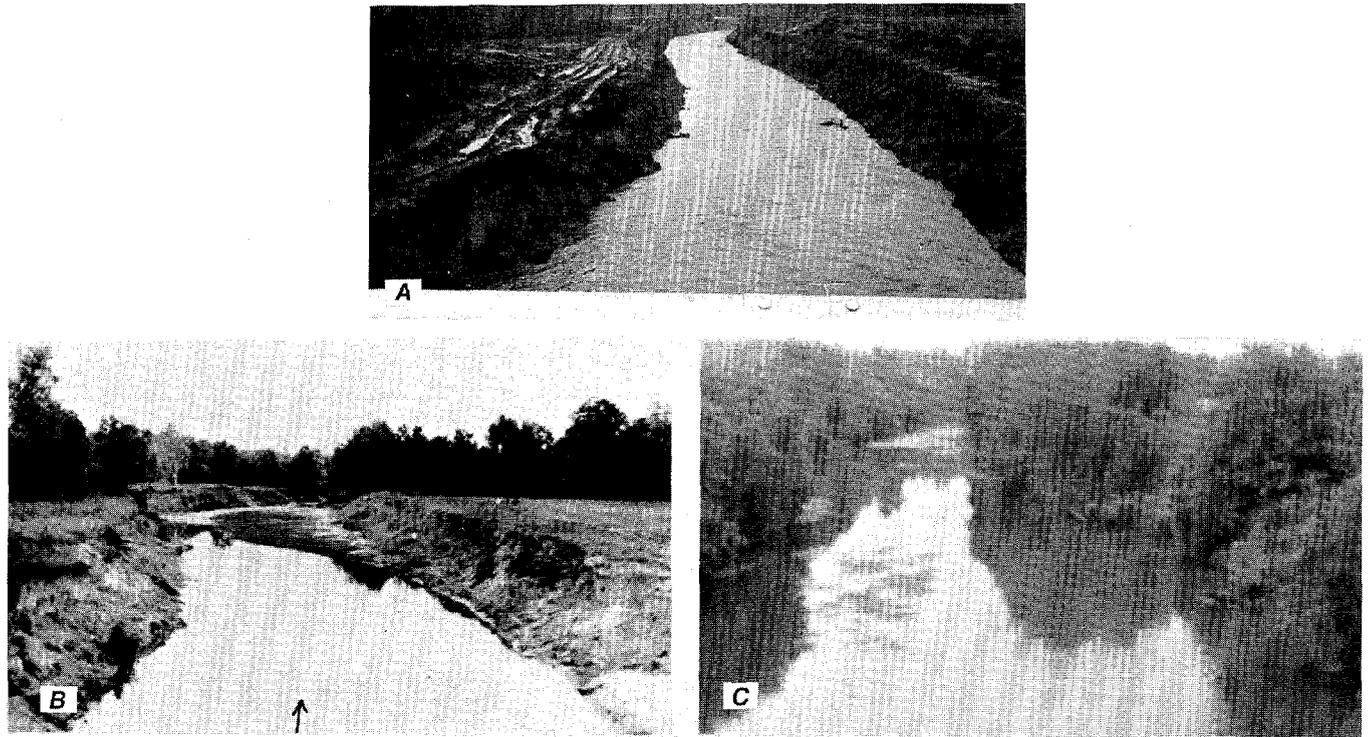
cantly during the period 1965-78, and in 1978 trees were well established along the bankline (fig. 23C ). As observed on a 1955 airphoto, meandering reaches of the natural channel were decidedly unstable, as indicated by almost continuous cut banks and wide point bars. On a 1974 airphoto, the pattern of the natural channel is much changed because of many meander cutoffs, but the degree of instability is about the same as in 1955.

Stability class B4 for relocated channel and class C4 for adjacent segments of natural channel. Lateral instability of the relocated channel is attributed to its narrow width, to erodibility of the bank materials, and to the occurrence of a major flood almost immediately after construction.

DISCUSSION--Although the relocated channel widened greatly as a consequence of the flood that occurred shortly after construction, its width in 1978 was no greater than that of the adjacent meandering reach downstream from the bridge and it had greater lateral stability than this reach. Furthermore, it was not much affected by the flood of 1975, for which a peak dis-

Figure 23. Cedar Creek at site 3. A, Relocated channel as viewed downstream from bridge, in January 1961. B, Same view as A, in June 1962. C, Same view as A, in August 1978.

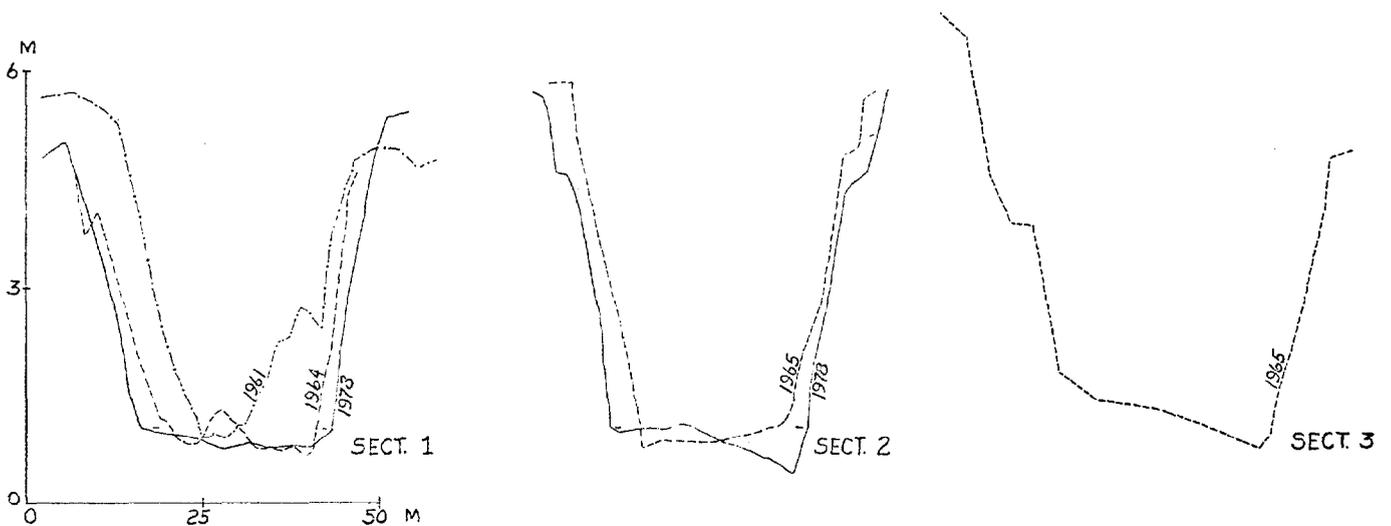
SYNOPSIS--Channel was relocated and thereby shortened from a length of 1,040 m to a length of 655 m, for apparent purpose of preventing encroachment of meander loop on roadway and possibly for convenience in construction of the new bridge (fig. 22 ). Performance period, 17 yr (1961-78), during which a large flood occurred in 1961, soon after construction, and an extreme flood occurred in 1975. The relocated channel (fig. 23A ) was trapezoidal in cross section, with a bottom width of 12 m, 1:1 side slopes, and a longitudinal slope of about 1.2 m/km. The bridge abutment fill-slopes were revetted with concrete pavement, but no bank protection measures were applied to the relocated channel. From observations made in January 1964, Jefferson (1965) reported that local indentations in the bankline had formed by lateral erosion; and that the channel had generally widened, particularly at a section 150 m downstream from the bridge, where an outcrop of resistant marl in the streambed dips gently toward the left bank (fig. 23B ). In addition, a shift in the stage-discharge relation for the stream gage indicated about 0.15 m of channel degradation. Most of this erosion probably occurred during the 1961 flood. According to a cross section surveyed in 1965, the bottom width of the channel had increased to 30 m at the widest section (fig. 24 , section 3). Although this section was not resurveyed in 1978, channel width at other sections did not increase signifi-

Figure 24. Surveyed cross sections of relocated channel, Cedar Creek.

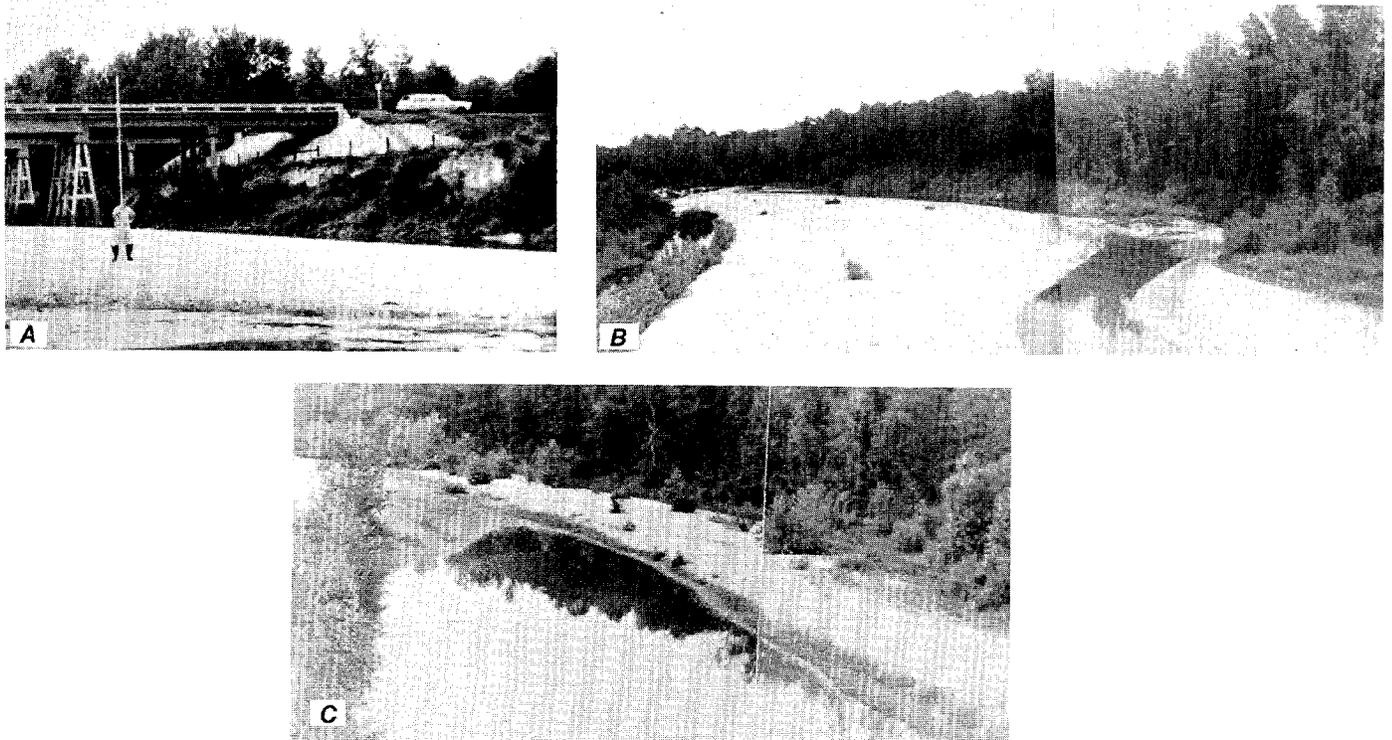
upstream from the bridge in 1964-65, riprap was placed at the abutments and the eroded bank indentation was filled and revetted with riprap. Bank erosion at the surveyed cross sections has progressed little since 1965 (fig. 27), and trees have become well established along the bankline (fig. 26C).

DISCUSSION--Widening of the relocated channel, although severe, was predictable in view of the prior instability of the natural channel and the lack of countermeasures. The channel is not likely to increase much in width, but lateral erosion is probable as the thalweg shifts from side to side within the wide channel.

Figure 26. Line Creek at site 4. A, Lateral erosion at right abutment of interstate bridge, as photographed in 1965. Pile bent behind man was originally at toe of abutment fill slope. B, Relocated channel as seen downstream from interstate bridge, in 1966. C, Same view as B, as photographed in 1978. Channel has shifted to left.

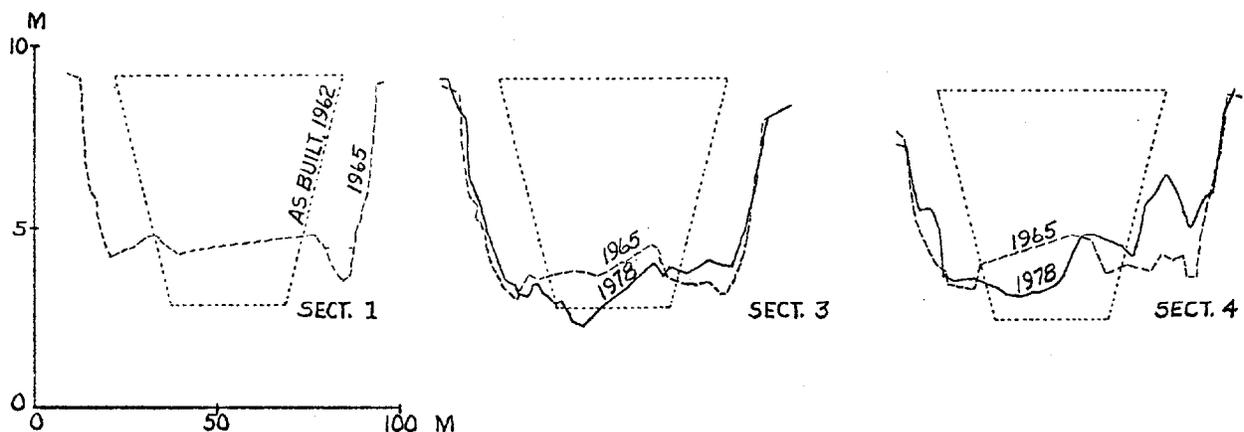
Figure 27. Surveyed cross sections of relocated channel of Line Creek, in comparison with channel dimensions as specified on plans.

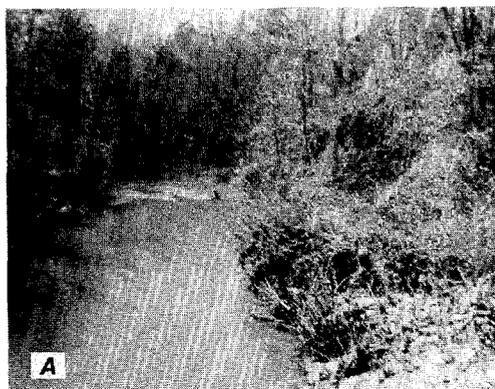
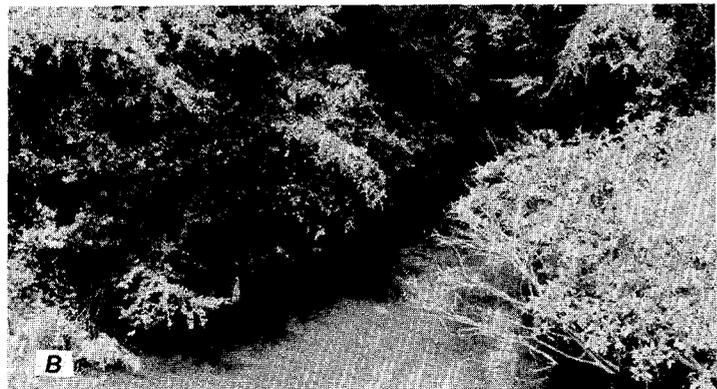
SYNOPSIS--Channel of stream flowing through swampy and densely forested flood plain was relocated to improve channel alignment and flow conveyance through bridge opening; a channel segment 145 m in length was straightened and shortened to 100 m (fig. 28 ). Performance period, 24 yr (1954-78), during which a 25-yr flood occurred in February 1961. Relocated channel was trapezoidal in cross section, with a bottom width of 6 m, 1.5:1 side slopes, and a channel slope of 1.5 m/km. No countermeasures were applied. In January 1964, the site was observed by Jefferson (1965), who reported no evidence of instability (fig. 29A ) and noted that the natural low-water channel was inefficient at high water stages. However, minor bank erosion near the bridge, perhaps caused by drainage along the roadway embankment, was photographed in April 1964 by members of the U.S. Geological Survey. In June 1978, the site was revisited by the Geological Survey. Although cut banks in moderately coherent clayey sand were observed, the banks were vegetated (fig. 29B ) and the channel had not enlarged. Water in the relocated channel was ponded by a beaver dam downstream.

Figure 29. Little Lubbub Creek at site 5. A, View upstream from bridge along relocated channel in January 1964. B, Same view as in A, June 1978.

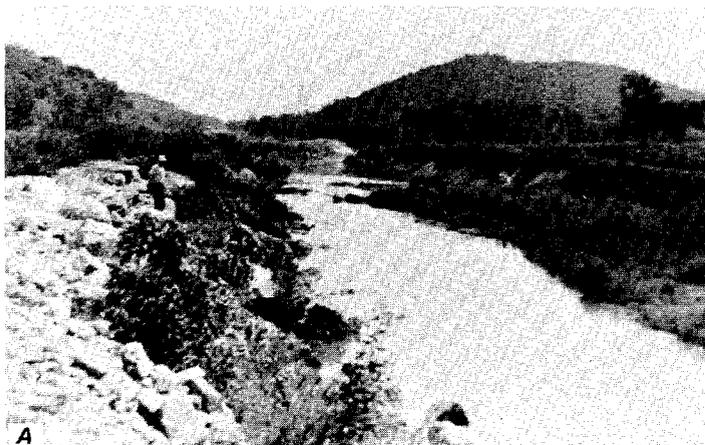
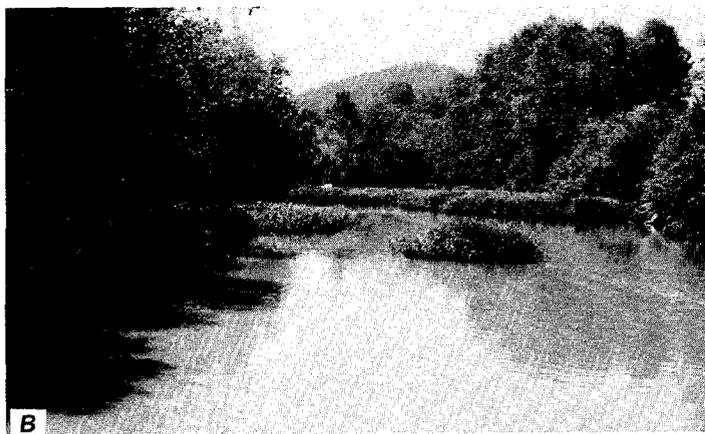
DISCUSSION--The bottom width of the relocated channel was about 1.5 times that of the natural channel; consequently, bars have formed in the relocated channel and these may eventually induce sinuosity. The angular junctions of the relocated channel with the natural channel (fig. 30 ) might have been expected to induce bank erosion; but this has not occurred, evidently because of the resistance of the bank materials. However, a scour hole about 2.5 m deep has formed in the channel bed at the downstream junction.

Figure 33. Ohatchee Creek at site 6. A, View downstream along relocated channel near station 3, in 1967. B, View downstream along relocated channel near station 3, in 1978.

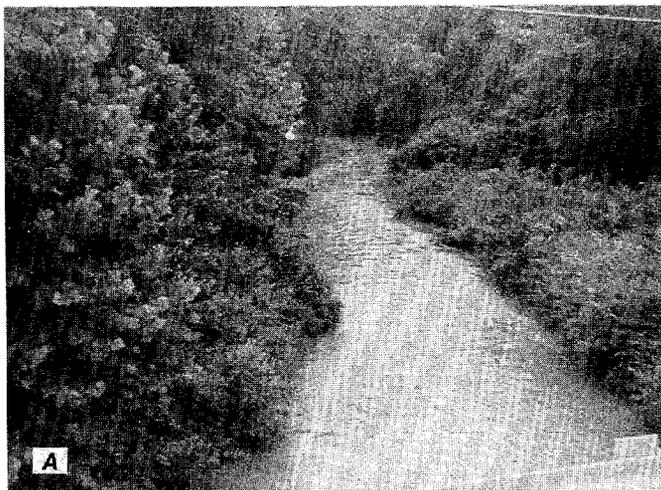
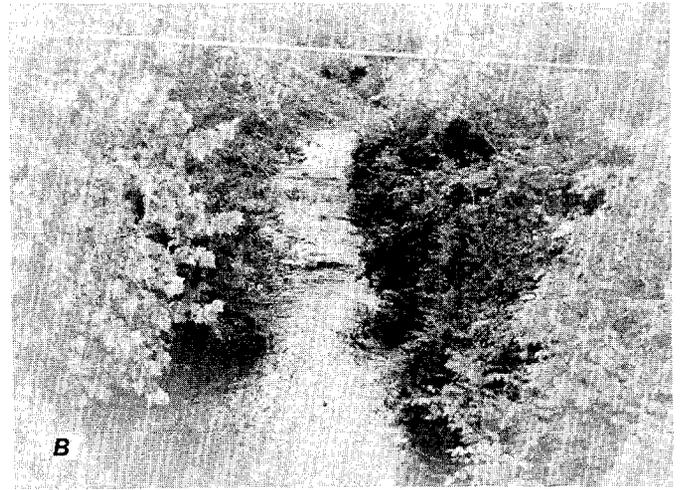
DISCUSSION--The dredged bypass channel has served the intended purpose of diverting flood flow through a relief bridge that would, in the absence of the channel, have been built longer to span both arms of the oxbow depression. The risk that the stream would be entirely diverted through the dredged channel seems not to have been considered in design, but such diversion has not occurred and seems unlikely now. Banks of the dredged channel have been stabilized by vegetation, and the natural channel remains stable.

Figure 36. West Fork Choctawatchee River at site 7. A, View downstream along bypass from bridge, in 1965. B, View downstream along bypass channel from bridge, in 1978.

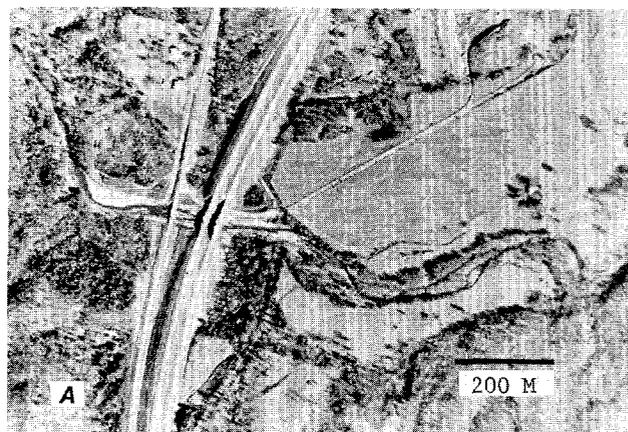
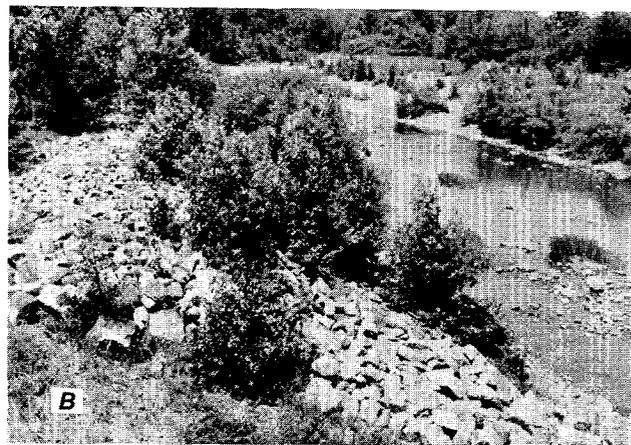
POST-ALTERATION FACTORS--Upstream from the SR-84 bridge, near the junction of natural and relocated channel, the relocated channel has widened from an as-built width of 25 m to a width of 36 m in 1979. Channel degradation has been precluded by an outcrop of resistant bedrock in the channel upstream from the SR-84 bridge. No further floods have occurred since 1968, but the existing bank protection appears to be competent to resist further bank erosion.

DISCUSSION--The upstream junction of natural and relocated channel was sufficiently angular to require the use of bank protection measures, in view of the erodibility of the banks and the magnitude of the flood.

Figure 38. Blakley Creek at site 8. A, Airphoto of channel relocation, in 1976. (From Arkansas Dept. of Transportation) B, Upstream view of relocated channel in 1979, showing rock dike at right bank near SR-84 bridge.

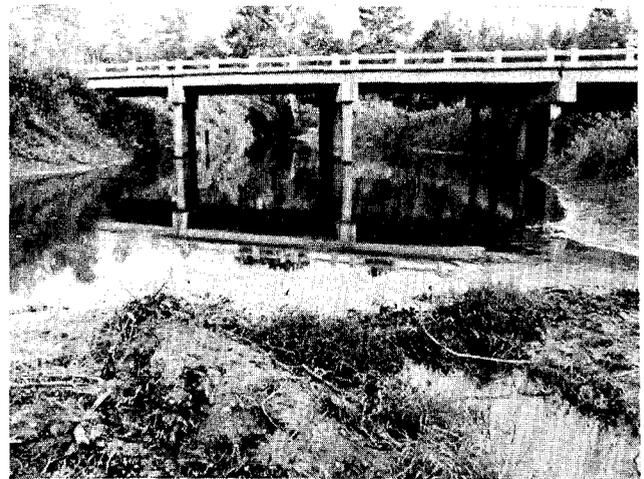
POST-ALTERATION FACTORS--In 1973, shortly after construction was completed, a flood estimated at 50-yr or greater recurrence interval caused erosion of the bridge abutment fill slopes and roadway embankment, and general scour at the bridge opening; similar erosion, to a lesser degree, occurred in 1975. The eroded areas were filled in, but no riprap or other bank protection measures were applied. Establishment of vegetation along the channel was delayed by these floods, but by 1979 young trees were beginning to grow along the banks.

DISCUSSION--The relocated channel was widened and deepened by erosion at the bridge because of constriction of flood plain flow. Elsewhere, the relocated channel has not increased in top width, but its original configuration has been much changed by fill and scour. The erosion that occurred is attributed to the fact that the recently constructed channel was unvegetated and unprotected by countermeasures. No effect of the relocation on the natural channel, which is bordered by dense forest, could be discerned. The relocated channel seems well designed, and its width, greater by a factor of 2 than the natural channel, is probably justified by the severe floods to which this area is subject. The pool at the bridge is analogous to scour pools that commonly form at relief bridges. This pool will probably remain and become stabilized by vegetal growth along the banks and the rest of the relocated channel will probably be stabilized and constricted by vegetation.

Figure 40. Sandy Creek at site 9. Upstream view toward bridge in 1979, showing area scoured during flood in 1975.

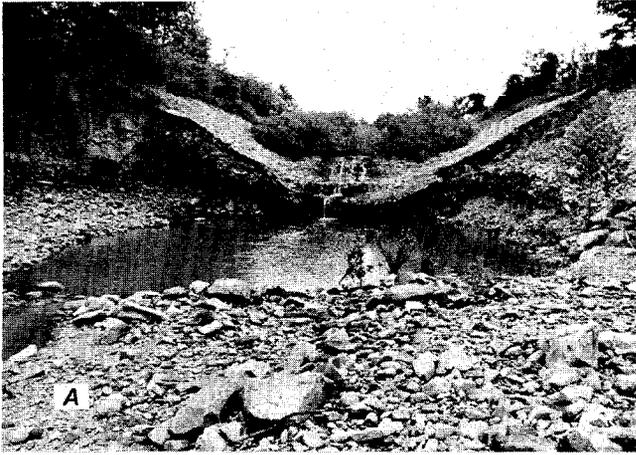
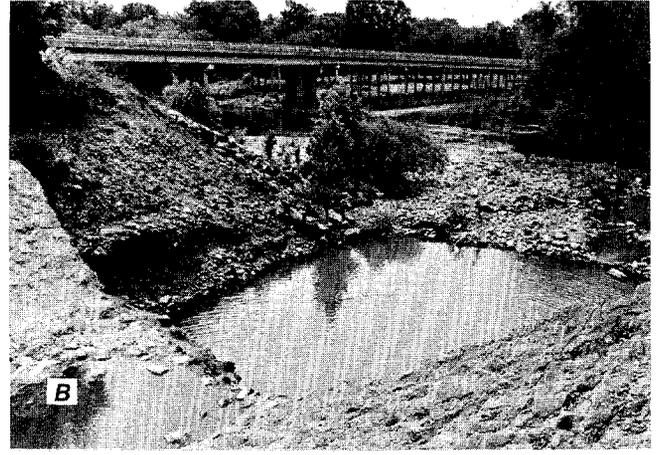
In 1979, a large scour hole having a depth of 1-2 m was observed below the check dam (figs. 43A and 43B), and the downstream end of the check dam was undermined. The top width of the relocated channel had not increased along most of its length but degradation estimated at 1-2 m had occurred prior to construction of the check dam and bank erosion had occurred at the upstream and downstream ends of the relocation (figs. 43A and 43C). About 1 m of degradation was observed on the natural channel upstream from the relocation (fig. 43D).

POST-ALTERATION FACTORS--Channel degradation was apparently a major reason for construction of the check dam, but there is no record of the actual amount of degradation at the time the dam was built. However, the gravel bar at the tributary entrance was mostly derived from bank erosion at the entrance and from bed scour at the check dam overfall. Rock riprap placed along the banks downstream from the check dam has been most removed by erosion (fig. 43B).

DISCUSSION--In 1979, the lip of the check dam stood 2.5 m above the surface of the plunge pool at its base. If the check dam fails, degradation will proceed upstream along the tributary, but it will be detained by the resistant cemented gravel in the streambed. The most serious erosion has been induced by overfall at the check dam. Overfall of this magnitude could probably have been prevented by a series of low, flexible check dams of rock riprap, rather than a single check dam.

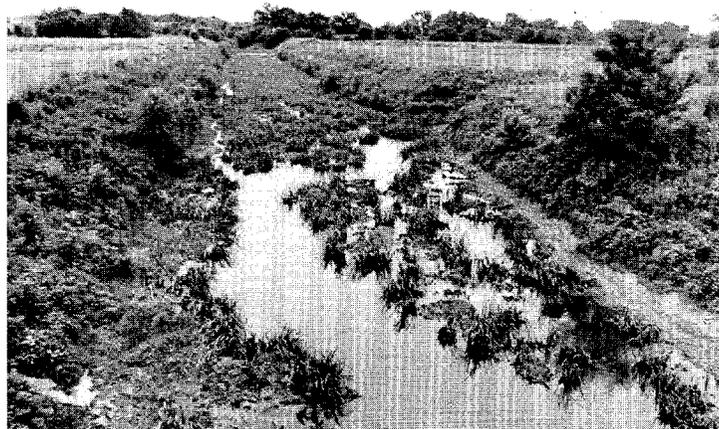
POST-ALTERATION FACTORS--Although the site is ungaged for streamflow, lines of debris indicate that overbank flow has occurred at least once since channel relocation. There is no evidence of post-construction maintenance at the site. Young trees have become established at the toe of banks along the relocated channel (fig. 45 ).

DISCUSSION--Bank stability has probably been enhanced along the relocated channel by its greater bottom width (18 m as compared with 12 m for the natural channel), but this has led to a growth of vegetation in the channel bottom.

Figure 45. Relocated channel of Poteau River, upstream from US-71 bridge, in 1979.

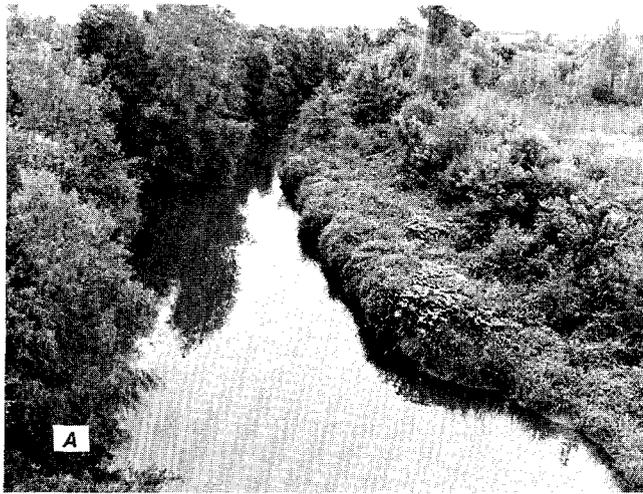
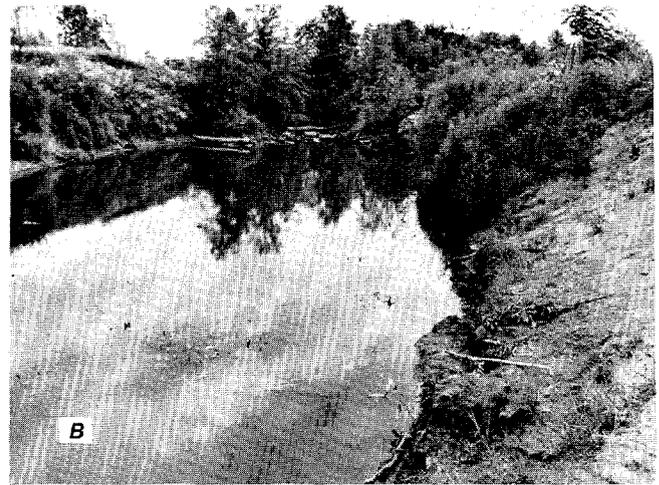
ALTERATION AND POST-ALTERATION FACTORS--Channel length was reduced by a factor of 0.45, with a consequent substantial increase in slope. At the upstream end of the relocation, the natural channel is crossed by a length of iron pipe and a low dam of siltstone riprap (fig. 47B) that evidently represents a check dam, although none is specified on the plans. Bank erosion has occurred downstream from this dam and is attributed to overfall at the dam. Elsewhere, the banks of the relocated channel were stable and well vegetated, and channel width has decreased upstream from the bridge.

DISCUSSION--A relocation involving rather drastic shortening, over a length of channel that is large in relation to stream size, would be expected to cause degradation; but little or none is evident. Degradation has probably been prevented by the check dam (whatever its origin) or by outcrops of bedrock in the channel.

Figure 47. Flat Rock Creek at site 13. A, View upstream from I-405 bridge, in 1979. B, Upstream end of relocated channel, in 1979.

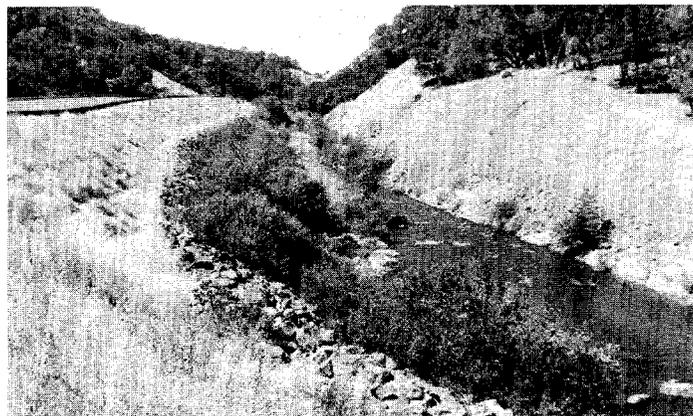
POST-ALTERATION FACTORS--There is no record of maintenance or installation of additional countermeasures at the site, and no slumping or bank erosion was evident when the site was inspected in September, 1978. Shrubs and small trees had become well established in the riprap along the left bank.

DISCUSSION--Slumping of the alluvium (or colluvium) in the upper part of the right bank may occur at some future time, and this could result in blockage of the relocated channel.

Figure 49. View downstream along channel relocation, East Fork Russian River, in 1978.

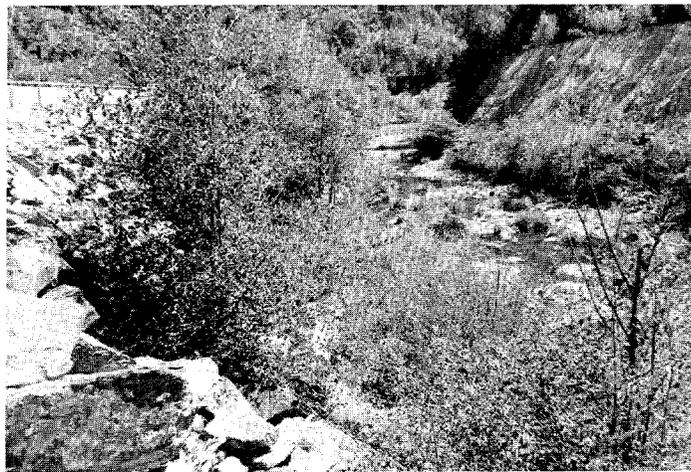
POST-ALTERATION FACTORS--No maintenance work, following the extreme flood of 1964, is apparent. Small trees have become established on the riprapped highway embankment and along the base of the cut slope (fig. 51 ).

DISCUSSION--Landsliding, the major potential for instability along the relocated channel, is very common in some California terrains, but is not evident here along the valley of Outlet Creek. The lack of naturally occurring landslides, which is attributed to the resistance of the underlying bedrock, was an indication that the cut slope would not be particularly susceptible to failure by mass movement. Except for the bare upper part of the cut slope, the appearance of the relocated channel is not unnatural for a mountain stream in a narrow valley.

Figure 51. View upstream along relocated channel of Outlet Creek, in 1978.

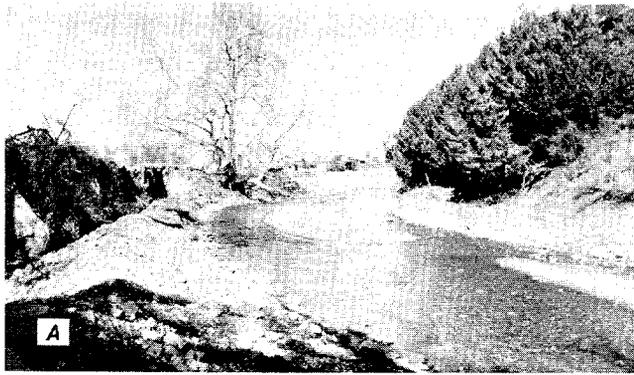
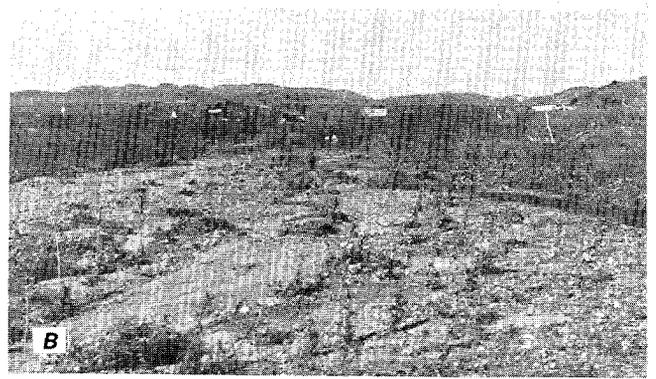
POST-ALTERATION FACTORS--Floods having an estimated recurrence interval of greater than 25 yrs occurred in 1969 and 1978. The banks of the natural channel at a bend upstream from the re-location were severely eroded in 1978 (fig. 53A), and the channel was subsequently realigned by the bulldozing of bed material against the banks. The flood apparently disrupted the riprap facing of dikes along the relocated channel, but there is no evidence that the dikes were broken. Young willows and other vegetation have become established along the dikes and, locally, in the channel bottom.

DISCUSSION--Because the bottom width of the relocated channel is more than twice that of the natural channel, a sinuous low-water channel has developed (fig. 53B ), which may eventually erode laterally against the bounding dikes. In addition, the wide bottom may become overgrown with willows, which will impair its transmission of floods. As depicted on 1957 airphotos, the reach of natural channel subsequently to be re-located was nondescript in appearance, already disturbed by road construction, and not much more attractive in appearance than the present relocated channel.

Figure 53. Nojoqui Creek at site 16. A, Bank erosion, extreme left, upstream from relocated channel, in 1979. B, Downstream view along relocated channel, in 1979.

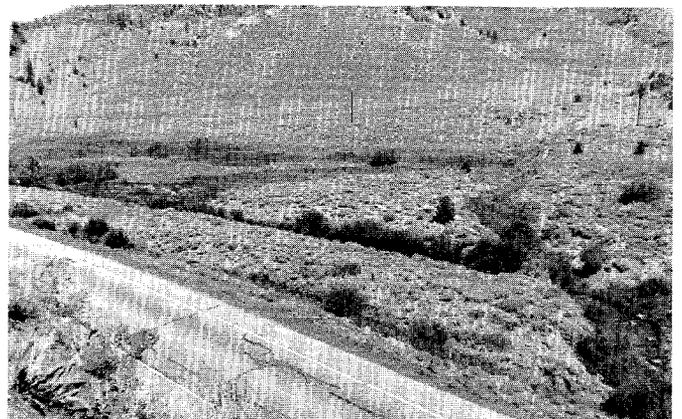
POST-ALTERATION FACTORS--There is no evidence of serious flooding or of maintenance at the site during the performance period, and drainage at the upper end of the relocated channel has been ponded by a beaver dam. Vegetation has become established along part of the channel (fig. 55).

DISCUSSION--At the site of the relocation, the natural channel has been crowded to the south side of the valley by the alluvial fan of a side tributary, and its trend is nearly straight. Recovery of natural vegetation is slow at this altitude (about 2,200 m) and in the arid climate. The relocated channel is not particularly attractive in appearance, but is not very different from the natural channel.

Figure 55. View of relocated channel of Swauger Creek in 1978. Flow is to right.

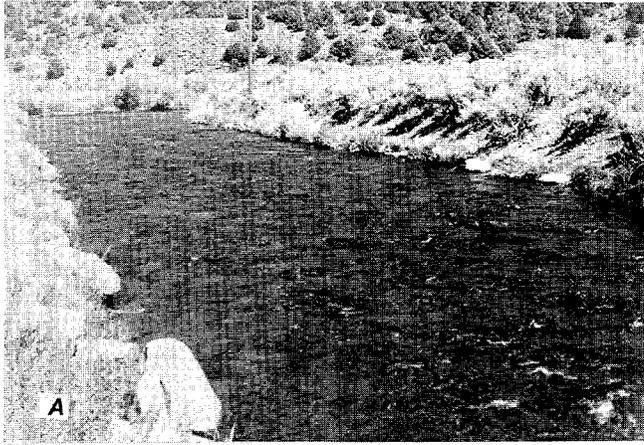
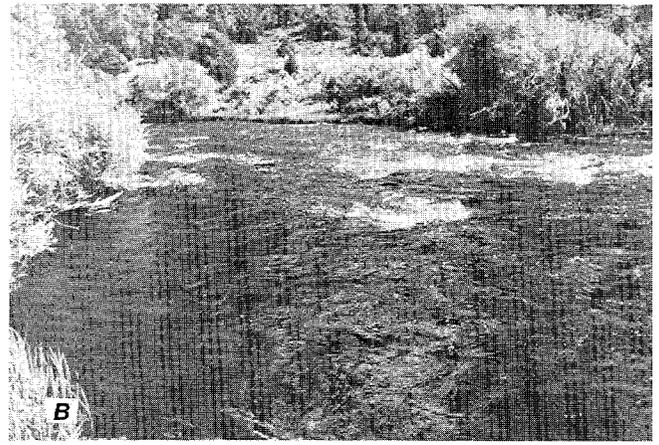
SYNOPSIS--Channel relocation, reach 370 m in length shortened and moved laterally by 70 m to avoid sharp curve in new roadway (fig. 56 ). Performance period 25 yr, 1954-1978. Streamflow is regulated by upstream reservoir, and no major floods occurred during performance period; although a peak flow of  $39 \text{ m}^3/\text{s}$  (ten times average discharge) occurred in 1963. Left bank of relocated channel is riprapped roadway embankment, right bank is in alluvium. Regeneration of vegetation, mainly willows, has occurred for about half the length of the right bank; the rest, although partially bare, is not actively eroding (fig. 57A ). No effect of relocation on the natural channel could be discerned (fig. 57B).

DISCUSSION--An abrupt intersection of a stream channel with a roadway embankment is a potential cause for erosion, but no problems have occurred here during the 25-yr performance period. The heavy riprap along the roadway embankment has contributed to stability, as has regulation by the reservoir. An additional factor is the natural stability, except in extreme floods, of shallow mountain streams having coarse bedloads.

Figure 57. East Walker River at site 18. A, View downstream, about midway along re-located channel, in 1978. B, Natural channel about 30 m downstream from relocation.

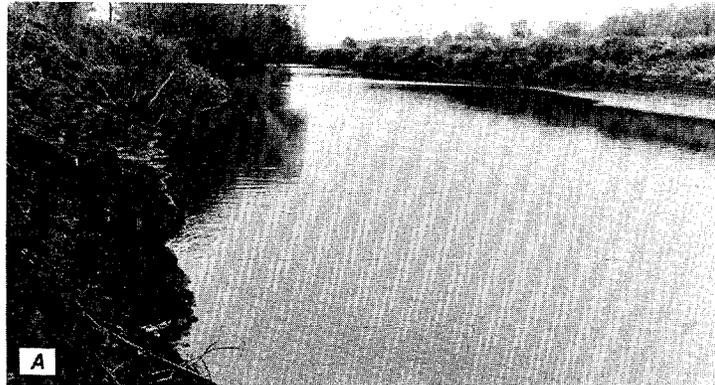
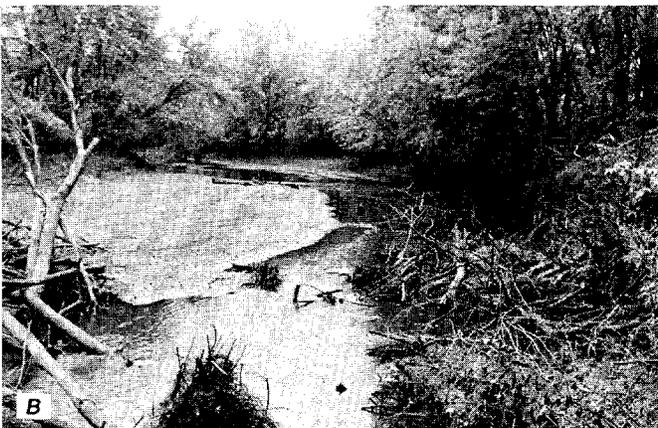
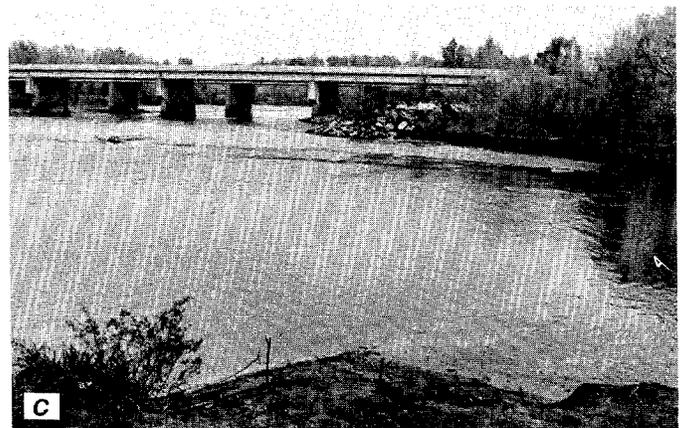
SYNOPSIS--A channel segment of Beaver Creek extending 2,200 m above its junction with Des Moines River was relocated and thereby shortened to 1,950 m; and the junction was moved upstream on the Des Moines River (fig 58 ). The purpose of the relocation was evidently to avoid a crossing of Beaver Creek. Performance period, 18 yr (1961-79), during which the highest flow in an 18-yr period of record occurred in 1974. Relocation was effected by diverting flow along a pilot channel having a bottom width of 12 m and a slope of 1.17 m/km. In 1979, bottom width of the relocated channel ranged from 30 to 40 m. About half of the bankline was bordered by trees, and the rest was bordered by grass. The streamward face of the banks was mostly unvegetated and small scale slumping was common (fig. 59A), but bank recession was judged to be slow. Upstream from the relocation, the natural channel was eroding rapidly at bends (fig. 59B).

In connection with the relocation of Beaver Creek, a meander of the Des Moines River was cut off, with little change in channel length, to improve channel alinement at the interstate bridge (fig. 58 ). Subsequently, an island has formed in the channel upstream from the bridge (opposite the relocated mouth of Beaver Creek), and flow has been diverted toward the west bridge abutment (fig. 59C ). Riprap has been placed

DISCUSSION--Bottom width of the relocated channel of Beaver Creek has increased from 12 m (pilot channel) in 1961 to 30-40 m in 1979. By comparison, the bottom width of the natural channel was in the range of 15-20 m in 1955. No sinuosity of the thalweg within the wide relocated channel was observed in 1979, but such sinuosity is likely to develop. The relocated channel is unattractive in aspect, although the area has potential for recreation.

Figure 59. Beaver Creek at site 19. A, Downstream view of relocated channel, about midway of its length, in 1979. Note small scale slumping of cohesive clay in foreground. B, Natural channel of Beaver Creek, upstream from relocation, in 1979. C, Junction of Beaver Creek, right, and Des Moines River; interstate bridge across Des Moines River in background.

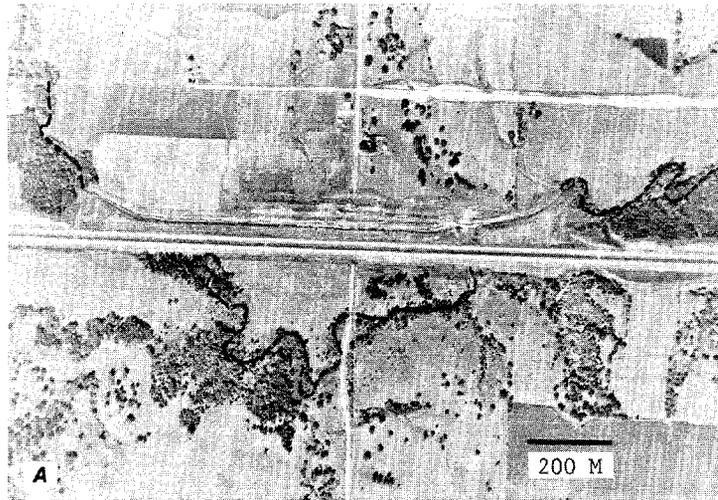
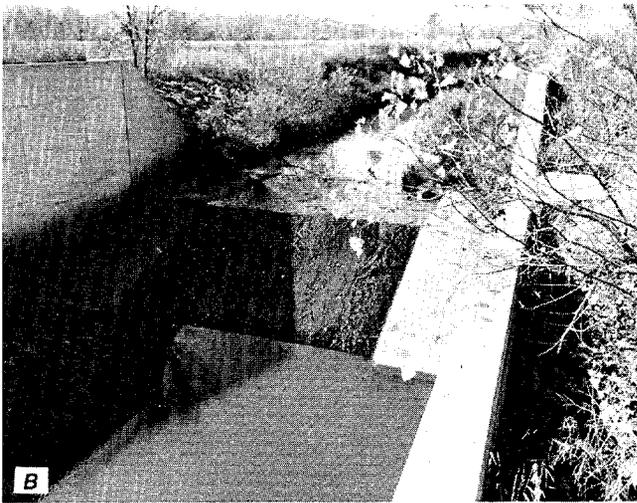
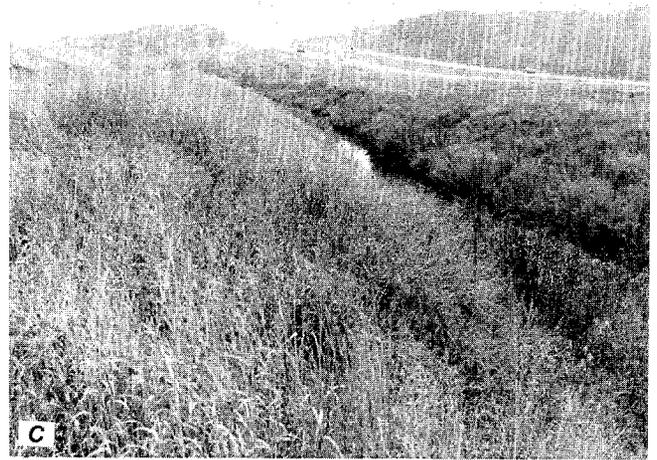
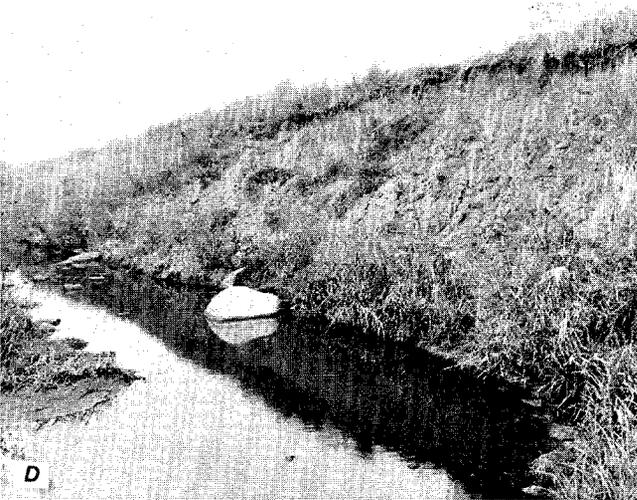
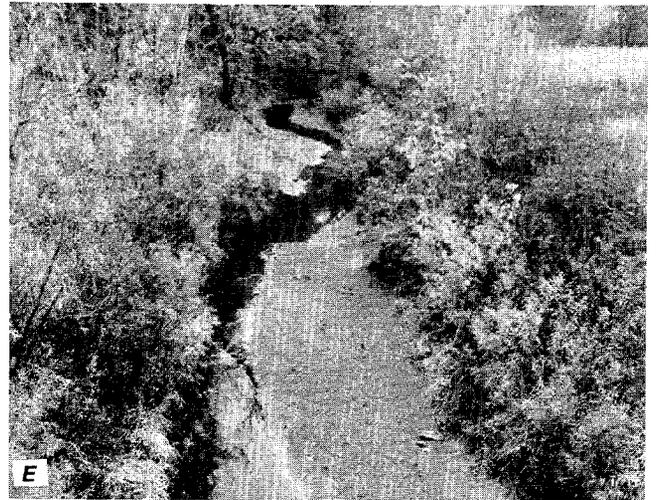
SYNOPSIS--A channel segment 2,050 m in length was relocated and thereby shortened to 1,200 m, in order to avoid two stream crossings (figs. 60 and 61A). Performance period, 13 yr (1966-79). Bear Creek is ungaged, but a general storm occurred in the area in July 1973, which caused a major flood on adjacent gaged streams. As built, the relocated channel was trapezoidal in cross section (fig. 60, inset), with a bottom width of 6 m, 2:1 side slopes, and a longitudinal slope that was reduced to 2 m/km by addition of a concrete drop structure (fig. 61B) having a fall of 2 m. No other counter measures were used, except for local application of jute mesh and sod on the cut (fig. 61C) north of the relocated channel. This cut was terraced (fig. 60, inset), and the terrace treads slope at 2 percent away from the risers. In 1979, the cut was heavily grassed, but the banks along the relocated channel had slumped in a few places (fig. 61D), and several gullies 2-3 m in depth had developed from side drainage. In addition, several large slumps were observed on the opposite (south) bank of the channel downstream from the culvert entrance. The banks of the relocated channel were otherwise generally stable, and the channel bottom width was within 1 or 2 m of the width as built. Two beaver dams were observed in the relocated channel, one about midway of its length and the other near the downstream end. Downstream from the relocation, the natural channel was generally stable (fig. 61E) except for cut banks at bends, and its condition was similar to that observed on a 1955 airphoto.

Stability class C2 for relocated channel and class B1 for adjacent segments of natural channel. Slumping along the relocated channel is attributed to the height and steepness of the channel side slopes and the lack of coherence of the slope materials. Gullying is attributed to the same factors. Degradation has probably been prevented by the concrete drop structure, although there is some evidence for 0.5-1 m of degradation along the relocated channel upstream from the structure.

DISCUSSION--The length of the relocated segment was large in relation to stream size, and original channel length was reduced by a factor of 0.6. Serious channel degradation would probably have occurred without the drop structure. Terracing of the high cut has probably prevented more serious slumping and gullying.

Figure 61. Bear Creek at site 20. A, Airphoto of channel relocation in 1967. B, Concrete drop structure on relocated channel. C, Downstream view along relocated channel, in 1979. D, Bank slumping along relocated channel, about midway of its length. E, Natural channel in 1979, at bridge 700 m downstream from relocation.
