Report No. FHWA/RD-80/158

# STABILITY OF RELOCATED STREAM CHANNELS

March 1981  
Final Report

1. Report No. FHWA/RD-80/158		2. Government Accession No.		3. Recipient's Catalog No.	
4. Title and Subtitle  Stability of Relocated Stream Channels				5. Report Date March 1981

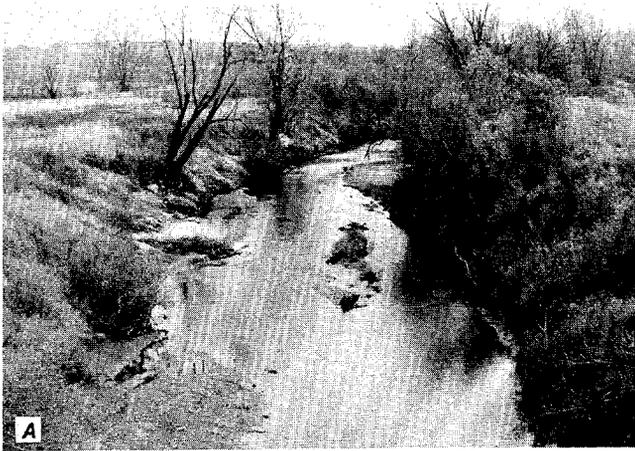
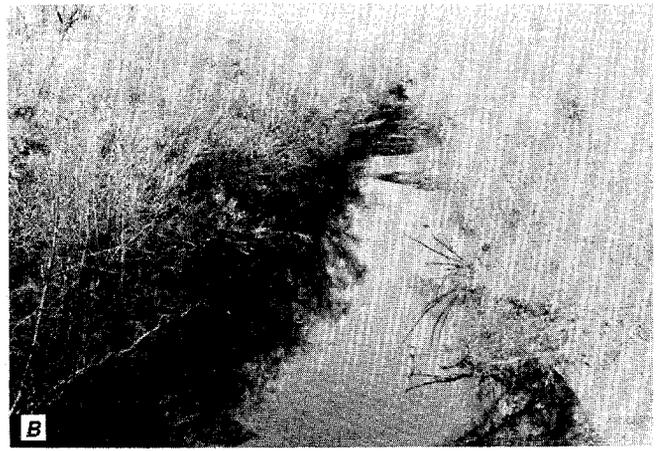
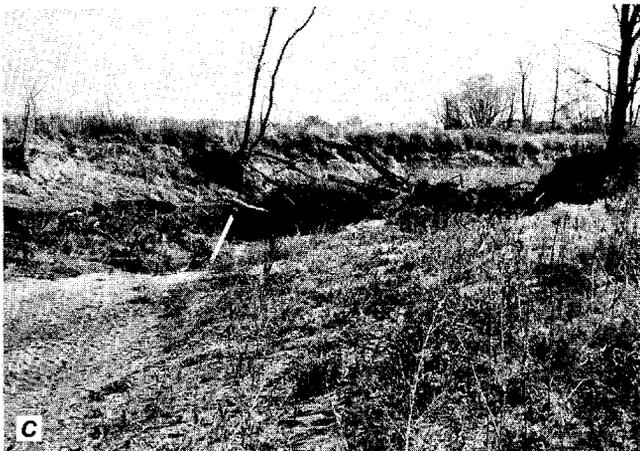
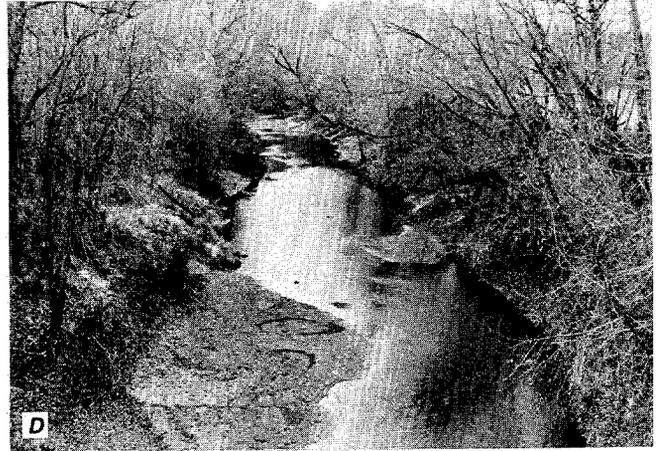
SYNOPSIS--Channel segment was relocated and thereby shortened from a length of 975 m to 580 m, for purpose of improving channel alignment at bridge and to accommodate planned roadway alignment (fig. 63 ). Performance period, 16 yr ✓ (1963-79). No flow records for Soap Creek or adjacent comparable streams are available; however, at least one flow above bankfull stage is indicated by overbank deposits observed in 1979. Relocated channel, as built, was trapezoidal in cross section, with a bottom width of 18.5 m, 2:1 side slopes, and a channel slope of about 0.5 m/km. No bank protection measures were specified on the plans or observed in the field; and vegetation along the relocated channel was cleared and not replanted. In 1979, the relocated channel was stable, with vegetated banks, both downstream (fig. 64A ) and upstream (fig. 64B ) from the bridge, and the bottom width was within 1-2 m of as-built bottom width. Upstream from the relocation, the natural channel of Soap Creek had cut banks at some bends, and about the same degree of stability as observed on a 1957 airphoto. At the first bend downstream from the relocation, bank erosion was severe (fig. 64C ) and bottom width had reached 40 m; severe bank erosion was also observed at the second bend. However, at the old US-63 bridge, 1.8 km downstream, the natural channel was generally stable (fig. 64D ) except for some inactive bank slumping.

DISCUSSION--Consequences of the relocation are similar to those of a natural meander cutoff, which commonly is followed by a period of rapid growth of adjacent meanders. It is noteworthy that the straight relocated channel is more stable than adjacent meandering reaches of the natural channel.

Figure 64. Soap Creek at site 22. A, Junction of natural and relocated channels (middle ground), as viewed downstream from US-63 bridge, in 1979. B, Relocated channel as viewed upstream from US-63 bridge. C, Bank erosion at first bend downstream from channel relocation. D, Natural channel upstream from old US-63 bridge.

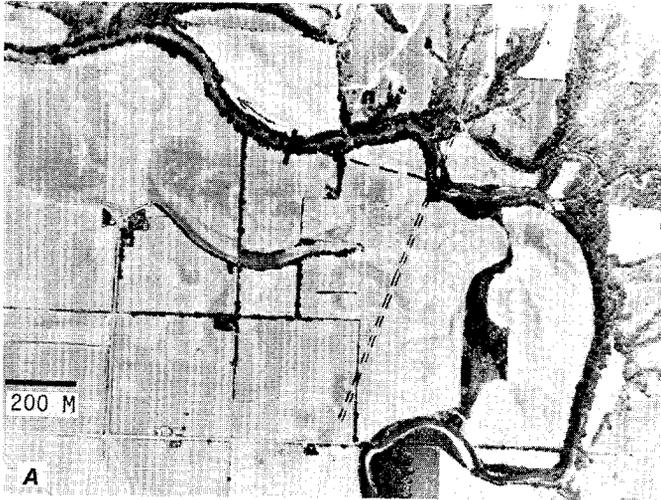
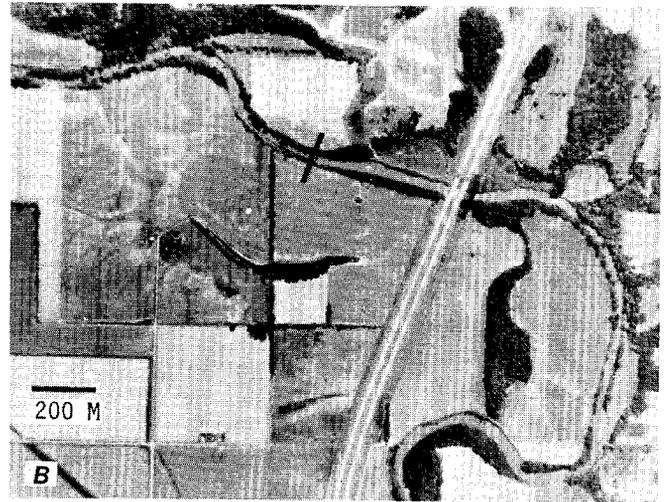
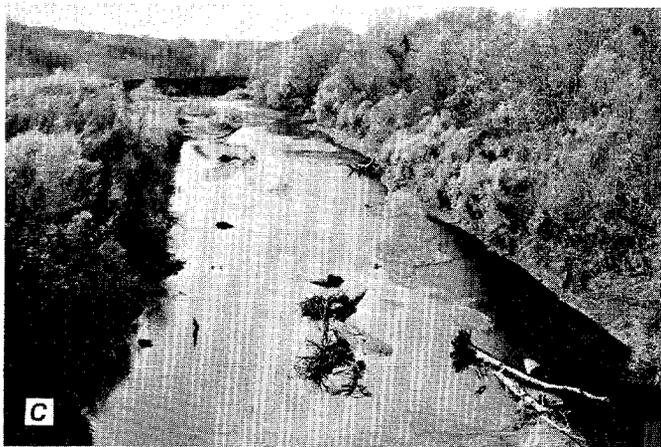
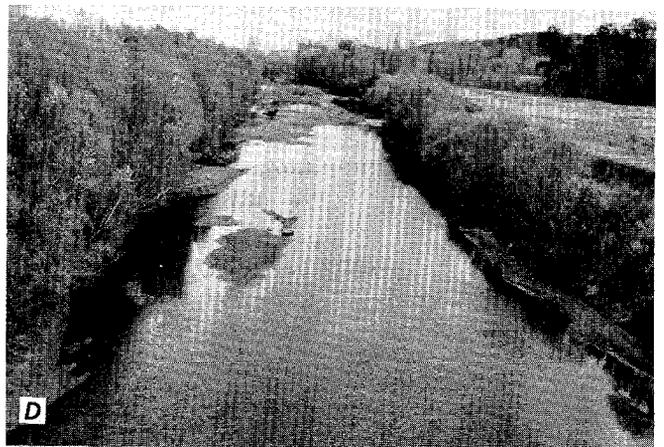
DISCUSSION--Although the relocated channel has widened since construction by a factor of 2-2.5, the stabilized bottom width attained in 1979 is within the range of bottom-width values for the natural channel.

Figure 65. Thompson River at site 23. A, Airphoto of relocation site in 1967. Planned course of relocated channel is shown in single dashed line; of roadway, in double dashed line. (From U.S. Dept. of Agriculture). B, Airphoto of relocation site in 1977. Ends of relocation, which is 460 m in length, are shown by heavy bars across river. (From U.S. Dept. of Agriculture). C, View upstream from I-35 bridge along relocated channel, in 1979. D, View downstream from I-35 bridge along relocated channel, in 1979.

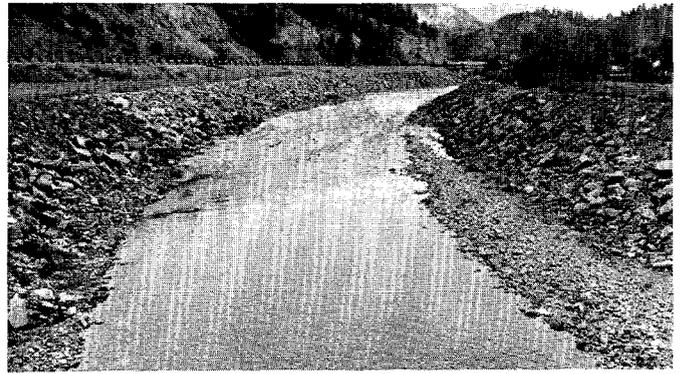
DISCUSSION--Inasmuch as the banks of the relocated channel were riprapped, the curves in the relocated channel would probably have caused no problems during floods of moderate intensity. During the 85-yr flood of 1974, in which the average water velocity in the relocated channel reached about 3 m/s, the curves proved to be too sharp. Substantial expense was involved in modifying the channel and in replacing the Ramp AB bridge, whose waterway opening proved to be inadequate. Some channel degradation, perhaps amounting to 0.6 m, has apparently occurred, as indicated by exposure of piers and a pipeline at the Main Street bridge; but this may not be caused by the channel relocation.

Figure 67. View downstream, from Main Street bridge, along relocated channel of Pine Creek. Erosion during 1974 flood occurred along bank in left background.

In 1977, the relocated channel was modified to prevent a recurrence of flood erosion damage. The radius of the bend at the Main Street bridge was increased from 84 m to 349 m, and the radius of the bend above the Ramp AB bridge was increased from 81 m to 218 m. Riprap on the banks of the modified channel was placed to a depth of 1 m, and the toe of the riprap blanket was extended to 1.5 m below the channel bottom. Riprap on the outside of the curve above the Ramp AB bridge was concrete grouted. There has been little growth of vegetation along the channel since 1977.

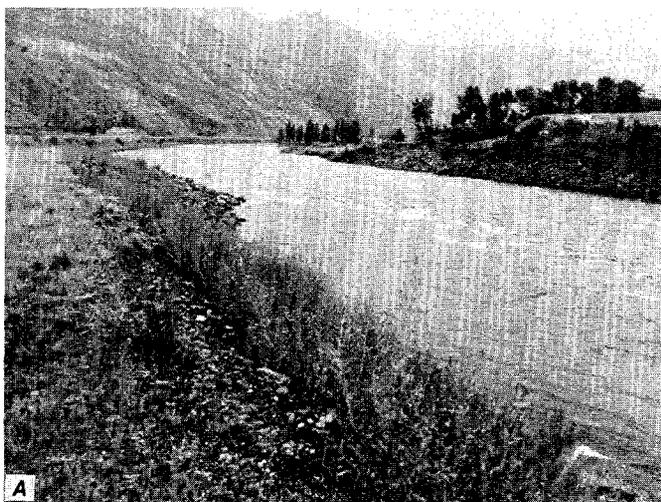
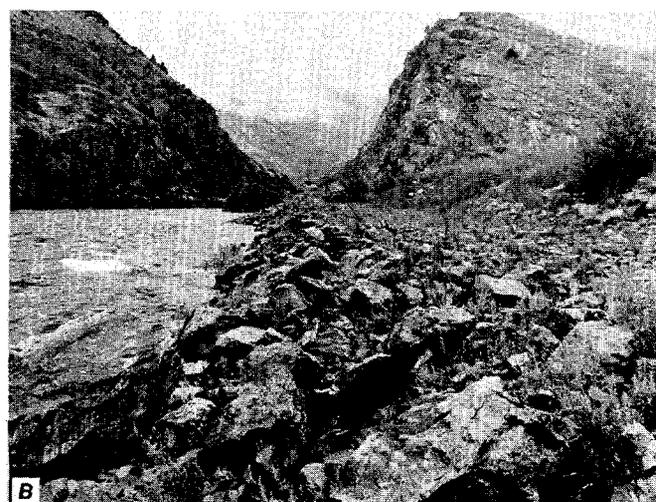
DISCUSSION--The channel cannot migrate very far laterally because the narrow alluvial valley bottom is bounded by bedrock. The main potential for instability is along the roadway embankment, which is at the outside of a broad curve. Here, the heavy riprap revetment maintained stability even during an extreme flood. No aerial photographs taken prior to relocation are available, so the natural channel cannot be assessed. However, in 1979 no cut banks were observed in the alluvial reach upstream from the relocation, and downstream the channel is in a rocky gorge.

Figure 69. Salmon River at site 25. A, Upstream view along relocated channel in 1979. Wide riprap berm along roadway embankment is at left. B, Downstream view of rocky gorge downstream from relocation. Heavy riprap along right bank of relocated channel is in foreground.

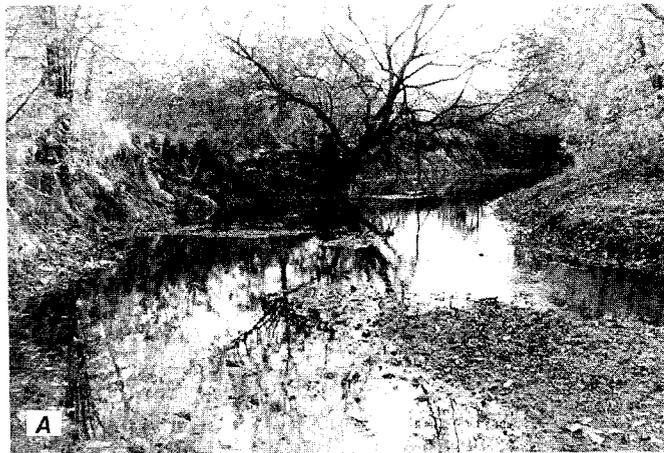
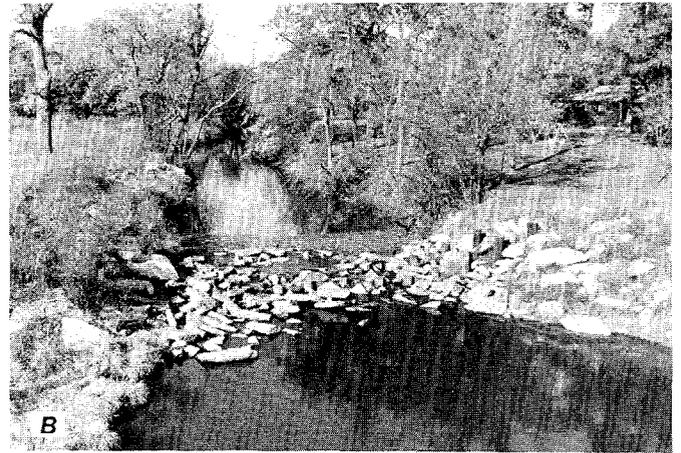
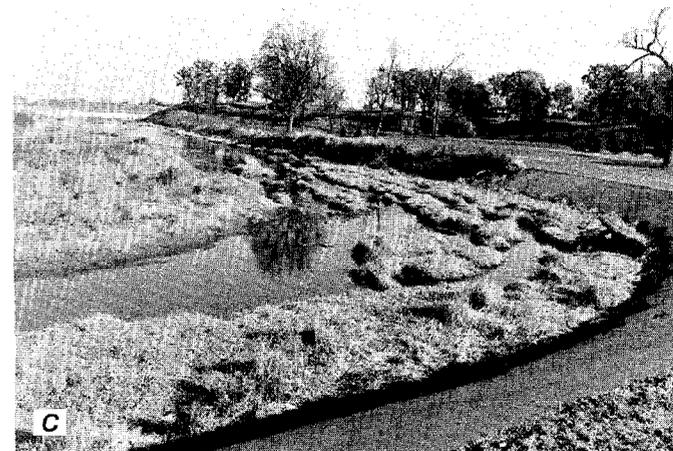
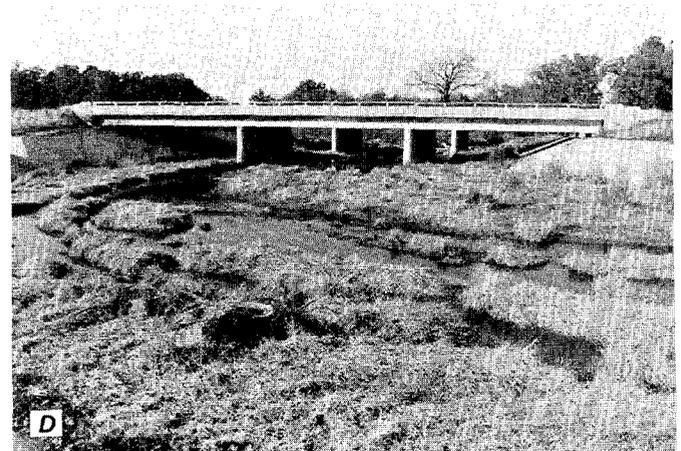
tion, amounting to about 0.6 m, extended upstream along the natural channel and downstream along the relocated channel as far as a concrete check dam. Lateral erosion also occurred at the toe of the concrete slope pavement just downstream from the bridge. Downstream from the relocation, the natural channel was apparently not much affected, as the extent of cut banks as observed in 1978 (fig. 71A ) is not significantly different from that shown on a 1965 airphoto.

Figure 71. Stevens Creek at site 26. A, Natural channel in 1978, about 125 m downstream from relocated channel. B, Check dam, built after 1974 flood, upstream from I-72 bridge. Natural channel in background. C, View of relocated channel looking downstream from I-72 bridge, in 1978. D, View of relocated channel looking upstream toward I-72 bridge, in 1978.

DISCUSSION--Although the relocated channel is overly wide, and a braided low-flow channel has developed within it (fig. 71D ), the erosion that occurred between stations 30.5 and 32 is attributed to the increase in slope, which resulted from drastic channel shortening. At the transition between the natural and the relocated channel, the increase in slope (and consequent increase in water velocity) caused channel degradation and undercutting of banks, which contributed to the lateral erosion. Action of eddies at the expansion may also have been involved in the lateral erosion. Downstream from the bridge, the bottom of the overly-wide relocated channel is now largely overgrown with coarse grass (fig. 71D ), which is likely to trap sediment. Infilling and consequent reduction of channel capacity will probably occur. In addition, a meandering low-flow channel can be expected, which may cut laterally against the banklines. Scour downstream from check dams is a common occurrence, and they must be regarded as risky countermeasures. Placement of riprap on the bed and banks through the eroded reach upstream from the bridge would probably have been a better remedy for degradation.

POST-ALTERATION FACTORS--In 1974, the year after completion of the relocated channel, a flood occurred that exceeded in stage by about 0.3 m the previous flood of record. To remedy the erosion damage between stations 30.5 and 32, and to prevent recurrence, the bank was filled in to its former position and riprapped. The transition section was eliminated and a check dam, consisting of a double row of timber pile faced with chain-link fence fabric and filled in with broken concrete riprap, was built just upstream from the I-72 bridge (fig. 71B ). Riprap was also placed at local problem areas on the relocated channel downstream from the bridge (fig. 71C ). During a second flood in April of 1979, an undulating hydraulic jump was observed at the check dam, a hole 3.5 m deep was scoured at the east pier of the bridge, and much of the riprap at the check dam was removed by erosion.

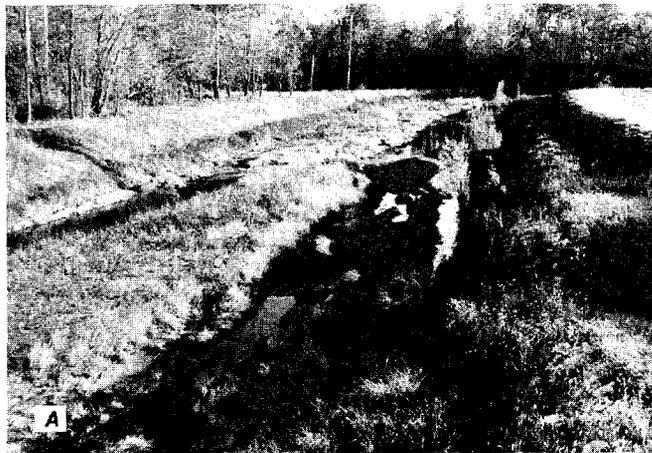
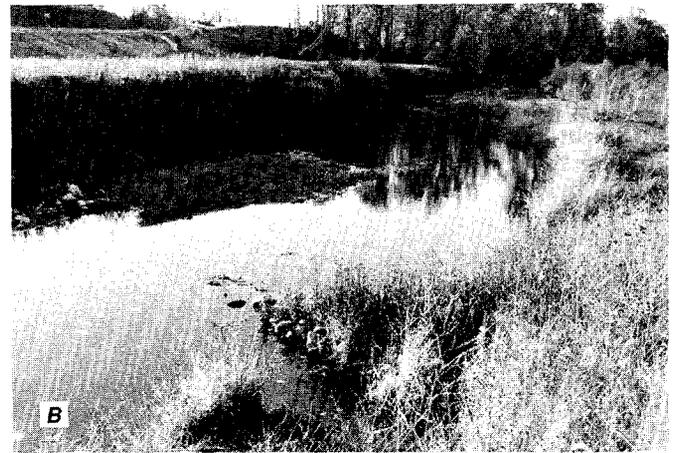
SYNOPSIS--Channel was relocated by cutting across a broad bend, thereby reducing the length of the channel segment from 418 m to 366 m, for the apparent purpose of improving channel alinement at the new US-36 bridge (fig. 72 ). Relocation may also have facilitated construction of the new bridge. Performance period, 2 yr (1976-78), during which no major floods occurred. The site nevertheless provides an example of the performance of fish habitat structures described as "fish and sediment ponds" on the plans, and it also demonstrates an early consequence of an overly wide relocated channel. The relocated channel was trapezoidal in cross section, with a bottom width of 21.5 m, 2:1 side slopes, and a channel slope that ranged from 2 m/km to 6 m/km. Riprap bank protection was placed at the bridge and at the downstream curve in the relocated channel. A "fish and sediment pond" consisted mainly of a riprap check dam extending across the stream, rising about 0.6 m above the streambed, but not keyed into the streambed or streambanks. Such a structure would not be expected to be permanent, and the structures at this site were mostly gone by 1979 (fig. 73A ). Upstream from the bridge, alternate bars have formed along the sides of the channel, and these are inducing bank erosion and sinuosity. Downstream from the bridge, flow is divided by grassed bars (fig. 73B ) on which willows are likely to become established. The relocation

Figure 73. Leatherwood Creek at site 27. A, View upstream along relocated channel from US-36 bridge, in 1978. "Fish and sediment pond A" at left center. B, View downstream along relocated channel in 1978.

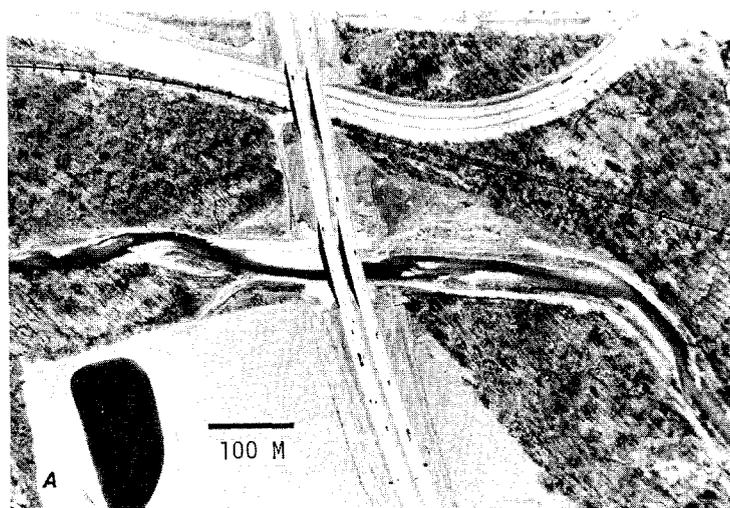
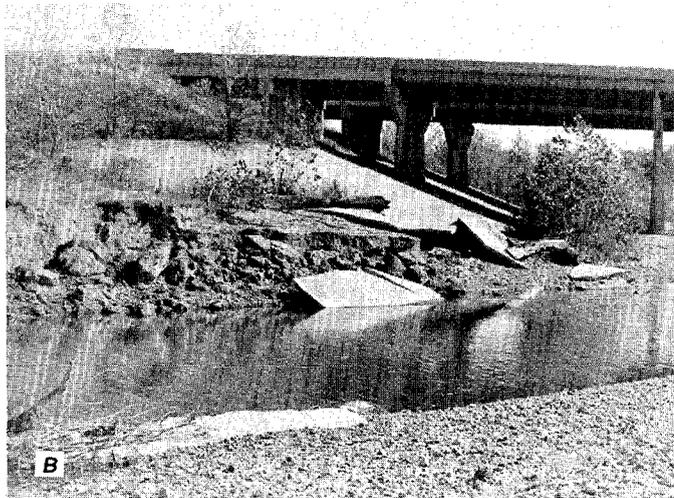
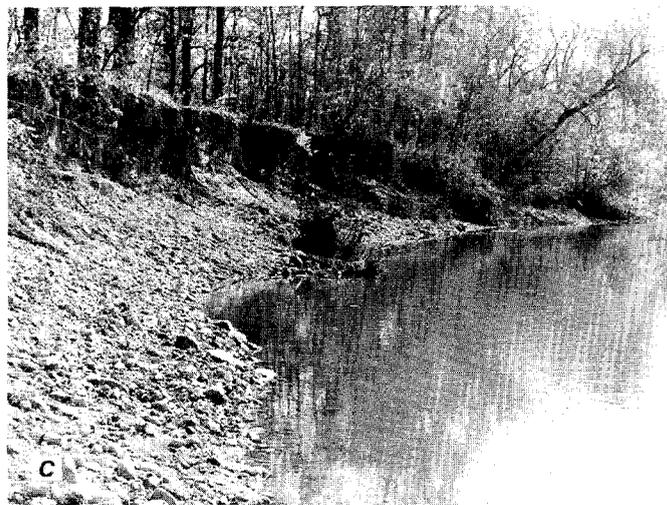
POST-ALTERATION FACTORS--Most of the bank erosion in the relocated reach, as observed in 1978, has occurred since 1972, and the concrete slope pavement was almost intact in that year. No countermeasures to replace the damaged left-bank pavement are evident, but riprap and a sheet-pile cutoff wall have been placed at the upstream end of the right-bank pavement. The straight reach of relocated channel downstream from the bridge has not increased in width and appears stable, with a good growth of young willow, sycamore, and cottonwood along the bank-line.

DISCUSSION--The instability of the left bank of the natural channel, prior to relocation, was an indication of potential problems with lateral erosion of the relocated channel. In hindsight, it seems probable that the lateral erosion may

Figure 75. Eagle Creek at site 28. A, Airphoto of channel relocation, in 1972. (From Indiana Dept. of Transportation). B, Eroded concrete slope pavement at left bank upstream from bridge, in 1978. C, Eroded left bank at downstream bend in relocated channel, in 1978.

have been prevented by the placement of flexible revetment, such as riprap, along the left bank at the junction of natural and relocated channel. Rigid revetment, such as concrete slope pavement, is particularly susceptible to destruction by outflanking. Upstream from the relocation, the right bank is composed of resistant glacial till, which apparently deflects flow toward the less resistant left bank. The present situation is difficult, because the meander may continue to grow and migrate to the left, worsening the alinement of flow approaching the bridge. As a countermeasure, the left bank could be straightened and protected with flexible revetment for a distance of about 75 m upstream from the bridge. Special care would have to be taken to prevent outflanking of the upstream end of this revetment.

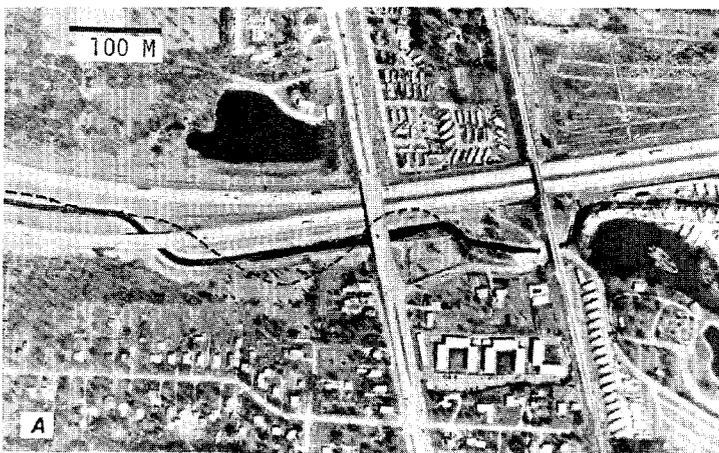
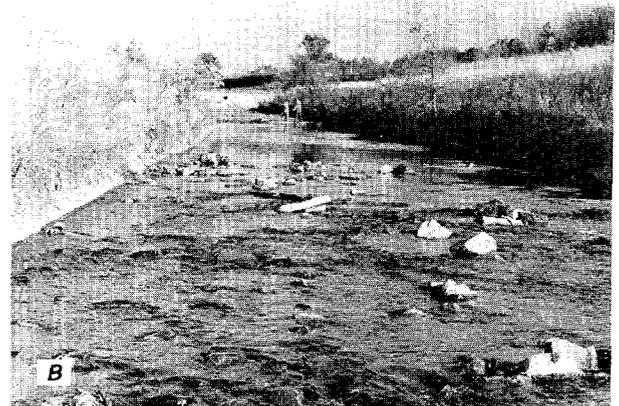
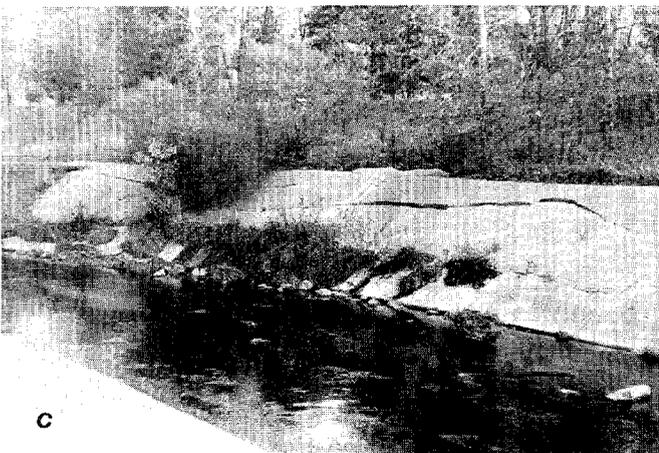
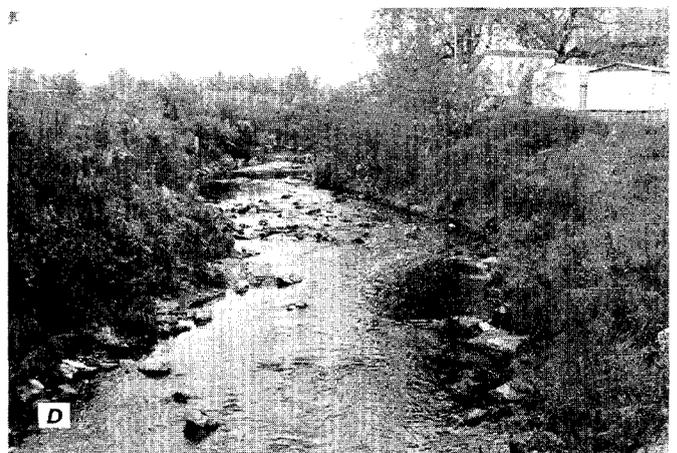
SYNOPSIS--In the construction of I-465, Lick creek was relocated for a channel length of about 1 km, of which only the upstream 600 m were studied for this report (fig. 76A ). As with most streams in urban areas, the natural channel has been disturbed over a long period of time by various kinds of construction; therefore, only the performance of the re-located channel will be considered. Performance period 16 yr (1962-78) during which a severe flood occurred in 1974, and the maximum flood for the period of record, in June 1978. As built, the relocated channel was trapezoidal in cross section, with a bottom width of 9 m, 2:1 side slopes, and a channel slope of about 3 m/km. The channel bottom is crossed at intervals by low concrete check dams, for which no design specifications were obtained. Banks were revetted with concrete slope pavement at curves, and elsewhere with articulated concrete blocks set above a concrete toe wall. In 1979, vegetation had become well established in the concrete blocks (fig. 76B ) which were intact except at two places, one at a culvert and the other at a side

drain. Partial failure of the concrete slope pavement, over a much greater lateral distance, was also observed at a side drain (fig. 76C). Upstream from the relocation, the natural channel (fig. 76D) is closely bordered by houses, and the steep banks are cut from place to place.

Figure 76. Lick Creek at site 29. A, Airphoto of relocated channel in 1972. Approximate course of prior channel is shown in dotted line. (From Indiana Dept. of Transportation). B, Upstream view, toward bridge, of relocated channel in 1978. C, Partial failure of concrete slope pavement at side drain upstream from bridge, as photographed in 1978. D, "Natural" channel upstream from relocation, in 1978.

DISCUSSION--The failure of bank revetment by undermining at side drains and culverts is noteworthy. The articulated concrete blocks seem superior to the concrete slope pavement, because their failure is more localized and because vegetation, including trees, has become estab-

lished on them. The relocated channel is assigned to stability class A because of the generally good performance of the revetment, whose local failure is tentatively attributed to lack of a suitable filter blanket.

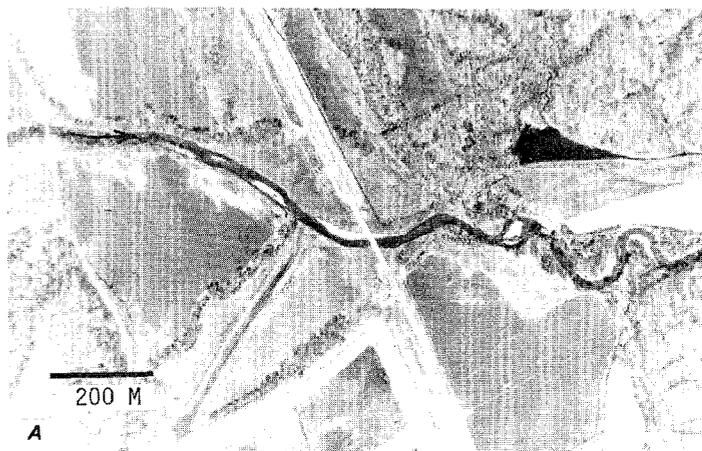
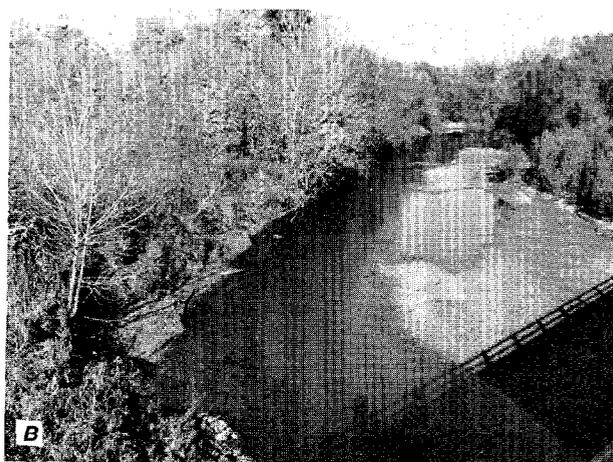
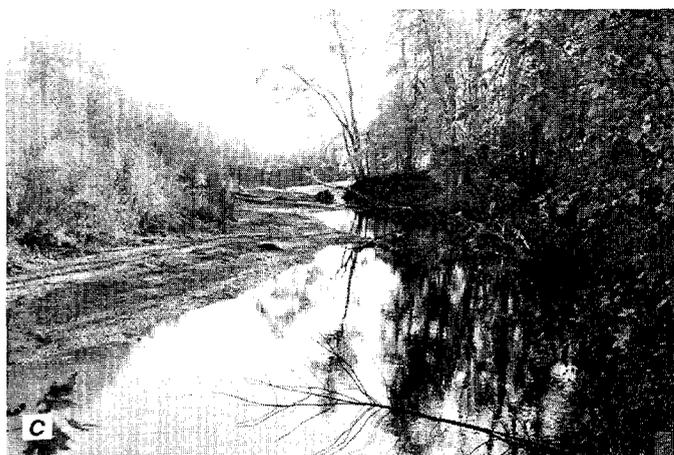
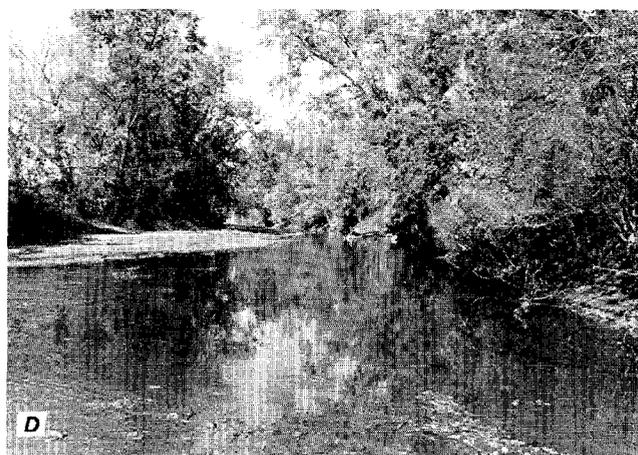
POST-ALTERATION FACTORS--No maintenance or installation of countermeasures since relocation, is evident. Vegetation along the relocated channel was slow in becoming established, as little is evident on 1972 airphotos; but a good vegetal cover was present, except for a few places, in 1978 (fig. 78B).

DISCUSSION--Although the relocated channel has performed satisfactorily during the 16-yr period since relocation, the development of point (or alternate) bars in the channel (fig. 78A) is an indication that meander development has begun. However, this development is progressing slowly, and is not likely to be a problem during the normal life span of the bridge. Now that vegetation has become established, the relocated channel (fig. 78B) looks much like the natural channel (fig. 78C and D).

Figure 78. Brouillets Creek at site 30. A, Airphoto of relocated channel in 1972. B, View of relocated channel looking upstream from bridge, in 1978. C, Natural channel downstream from bridge, in 1978. D, Natural channel upstream from bridge, in 1978.

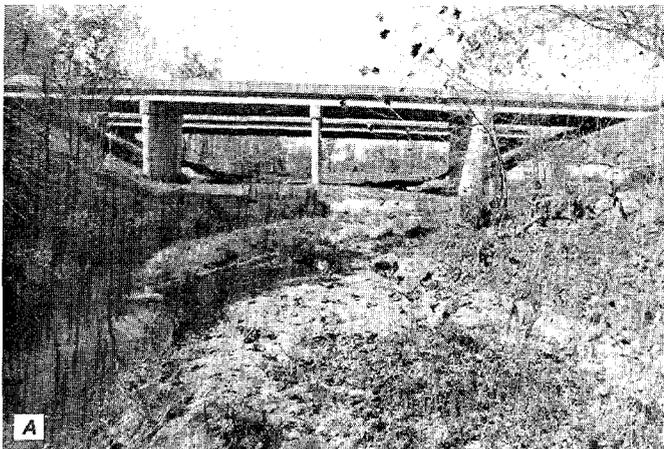
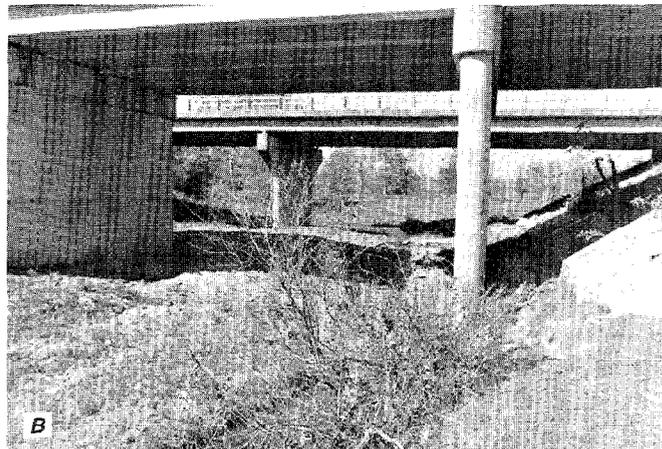
POST-ALTERATION FACTORS--Although the low-water flow line was placed in the center of the widened channel at the time of construction, it has subsequently migrated against the toe of the left-bank abutment fill-slope. Except for scattered shrubs and annuals, little vegetation had become established along the widened channel by 1978.

DISCUSSION--The reasons for widening the natural channel by such a large factor are not apparent, but the designer may have operated on the premise that overwidening could do no harm. The consequent lateral migration of the low-water channel is probably not serious in view of the small size of the stream and the very large area of the bridge waterway, but it may lead to maintenance expense.

Figure 80. Feather Creek at site 31. A, View upstream in 1978, showing width of bridge waterway in relation to that of natural channel, in left foreground. B, View in 1978, showing location of low-water channel against abutment, at right, and, at left, infilling of wide channel.

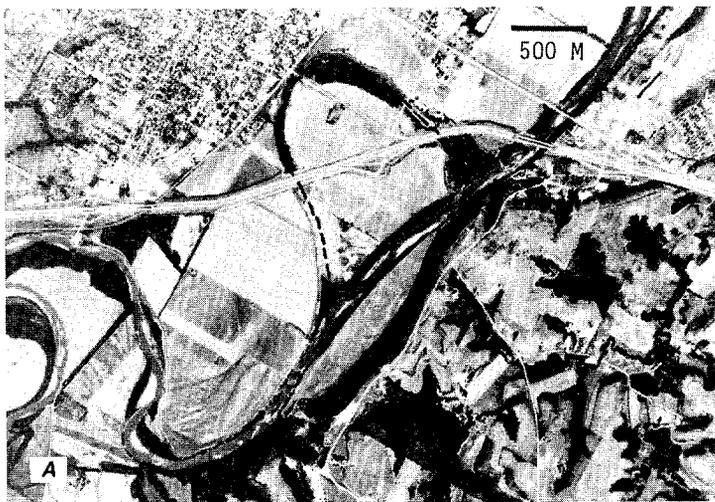
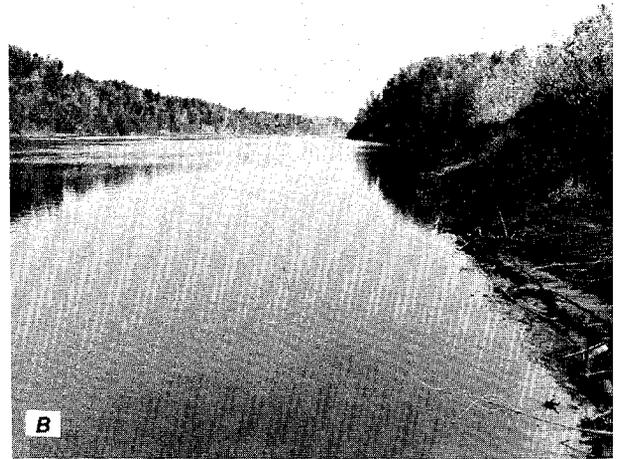
SYNOPSIS--Channel was relocated by cutting off a meander loop, thereby reducing the length of the segment from 3,475 m to a value of 1,675 m; for the purpose of avoiding an additional crossing along the planned roadway location and to obtain embankment fill from the excavated channel (figs. 81 and 82A). Performance period, 16 yr (1963-79), during which no major floods occurred. According to the plans, the relocated channel was trapezoidal in cross section, with a bottom width of 134 m, 2:1 side slopes, and a longitudinal slope of 0.3 m/km. No bank protection along the relocated channel was specified in the plans or observed in the field. The ends of the prior channel were closed, but the channel was not filled for most of its length. In 1979, bottom width was 84 m, trees grew densely along the bankline (figs. 82A and 82B), and the streamward faces of banks tended to be steep, rather high (3.3-3.5 m), and unvegetated. Thus, by comparison with the width as planned, the width in 1979 had diminished by about 50 m. No information was obtained as to any departure of as-built width from planned width.

DISCUSSION--The relocation involved a meander cutoff that was long both in absolute measurement and in relation to stream width, but longer cutoffs have occurred naturally both upstream and downstream since 1863 (Dort and others, 1979). The bottom width of the relocated channel (134 m) relative to that of the natural channel (55 m) was apparently more than adequate to offset the increase in channel slope consequent upon relocation. Alternate bars that have formed in the relocated channel (fig. 82A) are the precursors of sinuosity and have already induced bank erosion by diverting flow to the opposite bank. However, sinuosity of a degree detrimental to flow alignment at the bridge will probably not develop during the useful life of the bridge.

Figure 82. Smoky Hill River at site 32. A, Airphoto of channel relocation in 1978. (From U.S. Dept. of Agriculture). B, Downstream view along relocated channel in 1979.

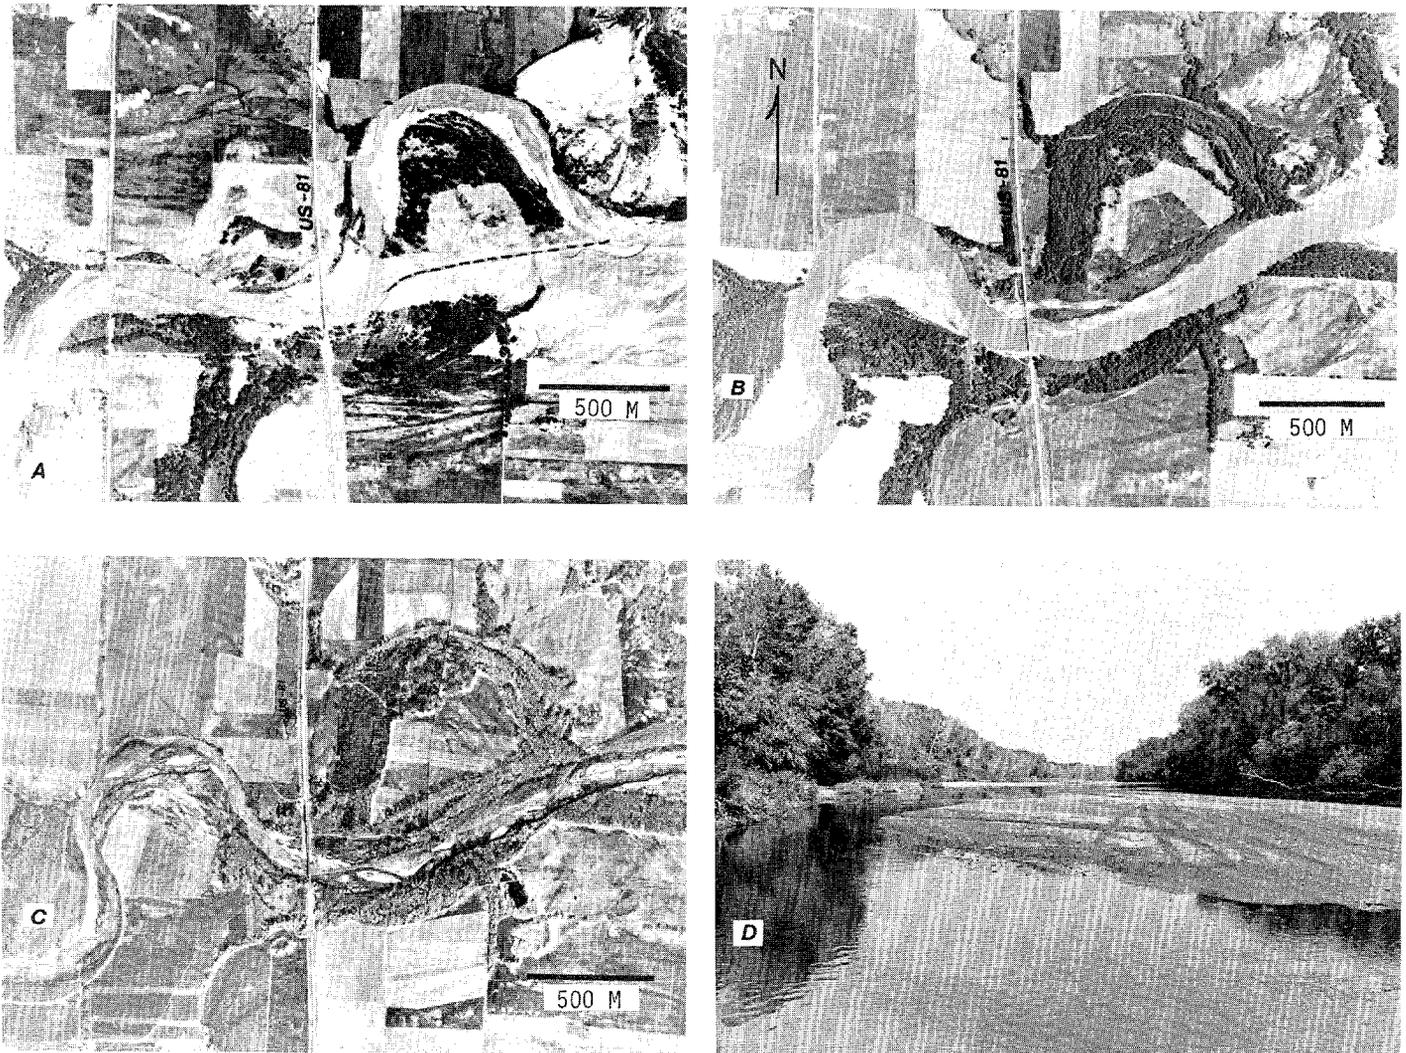
endangering the right-bank bridge abutment. In 1948, a pilot channel was constructed beneath the bridge to divert flow to the left, and a pile retard was constructed at the left bank upstream from the bridge (fig. 83B ). Flow was not diverted by the pilot channel. In 1972, a jack field was constructed at the right bank near the bridge. The countermeasures, together with the general increase in stability of the river, have prevented further lateral migration toward the left bridge abutment.

DISCUSSION--Although the relocated channel has become stabilized and has had little or no detrimental effect on the river, the purpose that it has served in protecting the bridge is questionable. Bank protection or flow-control measures at and downstream from the left bridge abutment would probably have been more effective, at less cost.

Figure 83. Republican River at site 33. A, Airphoto of channel relocation in 1937. (From U.S. Dept. of Agriculture). B, Airphoto of relocated site in 1952. (From U.S. Dept. of Agriculture). C, Airphoto of relocation site in 1975. (From Kansas Dept. of Transportation). D, View downstream about midway along relocated channel, in 1979.

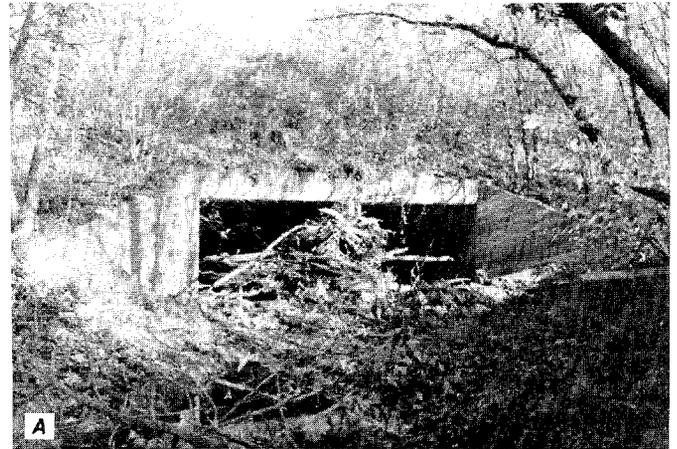
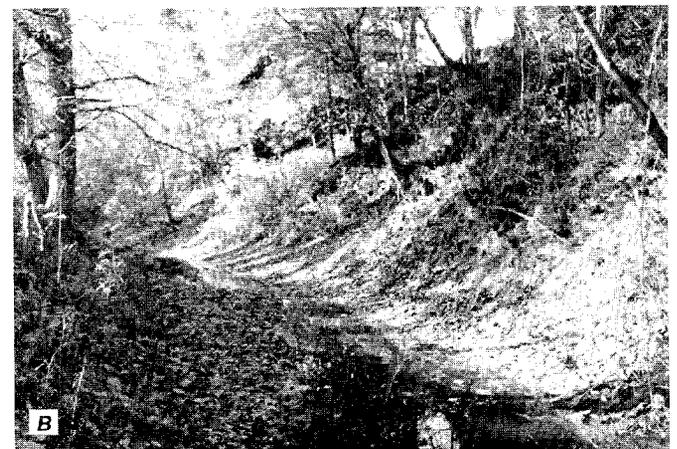
ALTERATION FACTORS--In relocation, the channel was shortened by a factor of 0.7, and the relocated channel was constructed to about the same width as the prior channel. Most of the relocated channel is within a double, 12 by 10 ft (3.66 by 3.05 m) reinforced concrete box culvert (fig. 85A). The wide concrete wing-walls of the culvert have apparently been effective in preventing lateral erosion.

Figure 85. Yellow Creek at site 34. A, Culvert entrance at upstream end of relocated channel, in 1978. B, Natural channel upstream from relocation, in 1978.

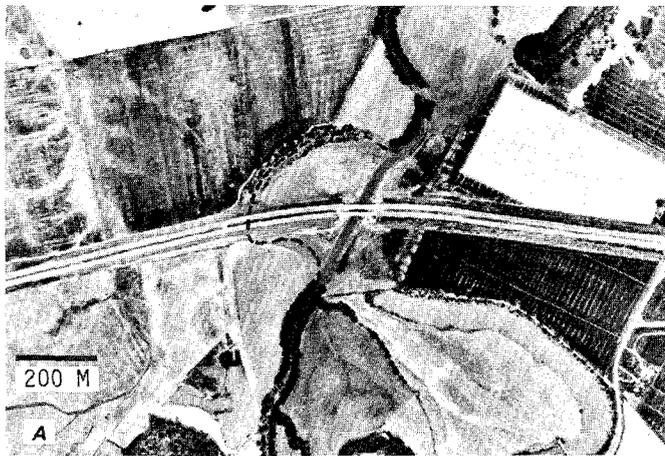
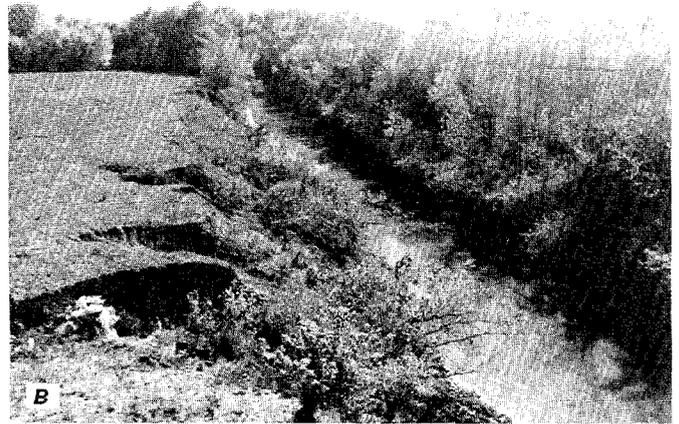
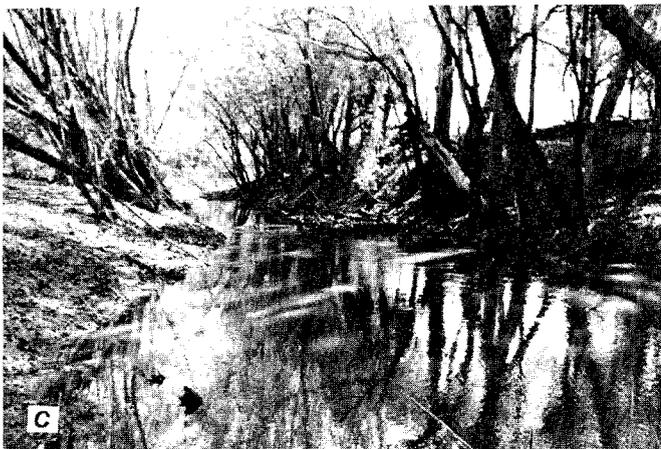
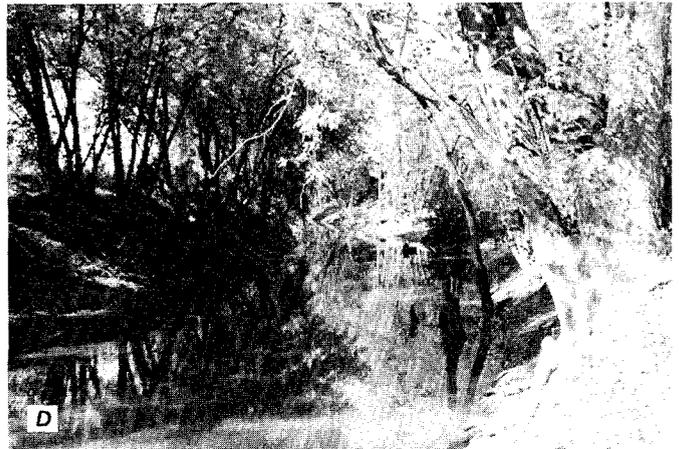
POST ALTERATION FACTORS--A major flood occurred at the site in 1970, four years after the alteration and before natural vegetation could have been well established. Field study of the site in 1978 indicated that no severe erosion occurred, and that the channel bottom was in fact less wide than in 1969. Gully erosion and recession of the upper right bank upstream from the bridge (fig. 87B ) is attributed to the planting of row crops close to the channel, and the failure of natural vegetation to become established on the bank slope. In 1978, trees were well established along the left bank. No maintenance work on the relocated channel is apparent.

DISCUSSION--In view of the site of the stream, the degree of channel shortening, the occurrence of a major flood, and the lack of bank protection, the stability of the relocated channel is surprising. The factors that account for the prior stability of the natural channel--coherence of bank materials and degree of incision--have apparently contributed to the stability of the relocated channel. Recession and gulying of the upper bank upstream from the bridge is troublesome, but it does not constitute a real threat to channel stability.

Figure 87. Rolling Fork at site 35. A, Aerial photograph of channel relocation in 1969. (From U.S. Dept. of Agriculture). B, View of relocated channel, looking upstream from bridge, in 1978. C, Natural channel downstream from relocated channel, in 1978. D, Natural channel upstream from relocated channel, in 1978.

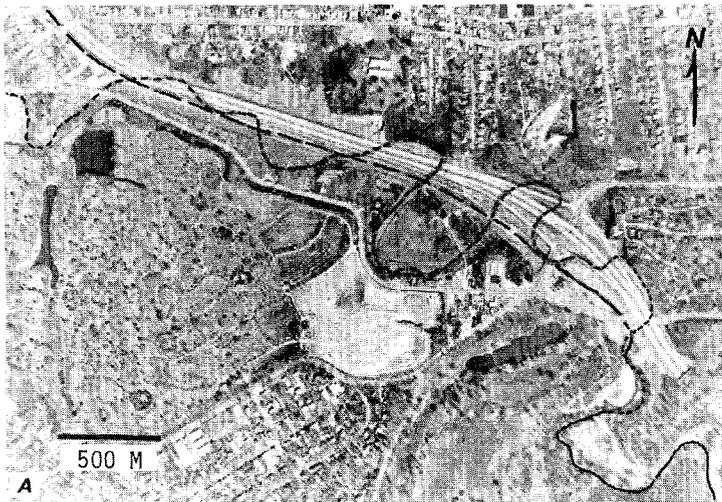
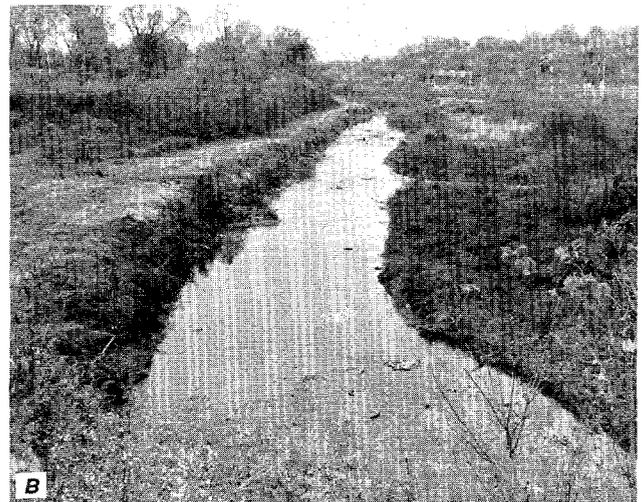
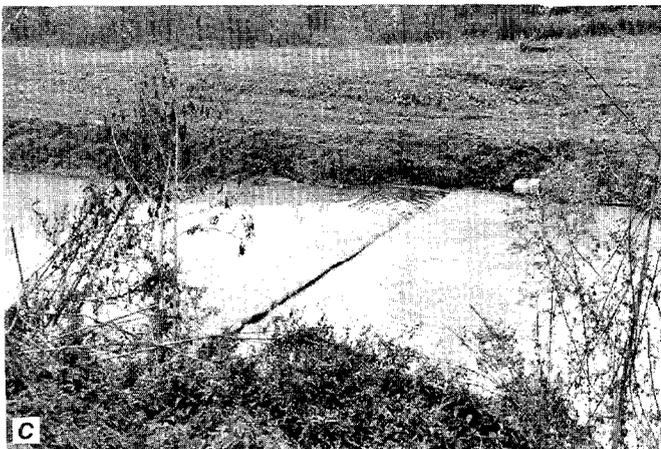
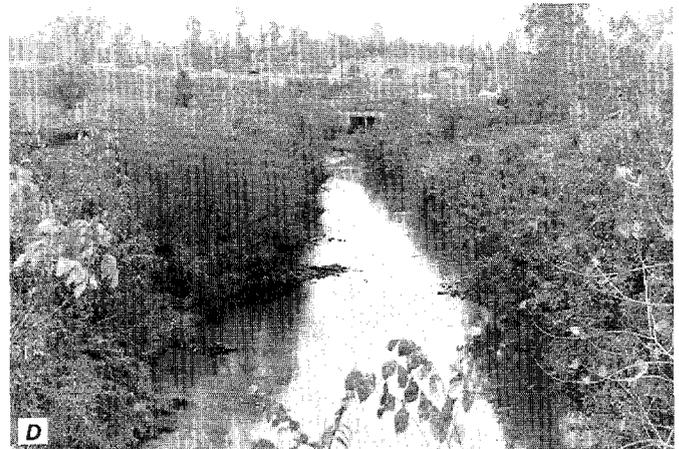
POST-ALTERATION FACTORS--As indicated on an airphoto taken in 1971, bank erosion occurred during the 1970 flood along the relocated channel downstream from Grinstead Drive. However, this erosion was not severe, and by 1978 the banks were vegetated and only minor local erosion was evident (figs. 88B and C).

DISCUSSION--In view of the degree of shortening, the stability of the relocated channel is better than would be expected, and it has been adequately tested by flood. The relocated channel is much less attractive in appearance than is the natural channel upstream in Cherokee Park. However, the appearance of the channel would have been much impaired by several crossings of the interstate highway, even if no relocation had been done.

Figure 88. Beargrass Creek at site 36. A, Aerial photograph, taken in 1971, showing channel relocation. Prior channel is shown in dotted line, relocated channel in dashed line. (From U.S. Geological Survey) B, Relocated channel looking downstream from bridge at Grinstead Drive. C, Relocated channel at concrete check dam. D, Relocated channel, looking upstream from bridge at Grinstead Drive.

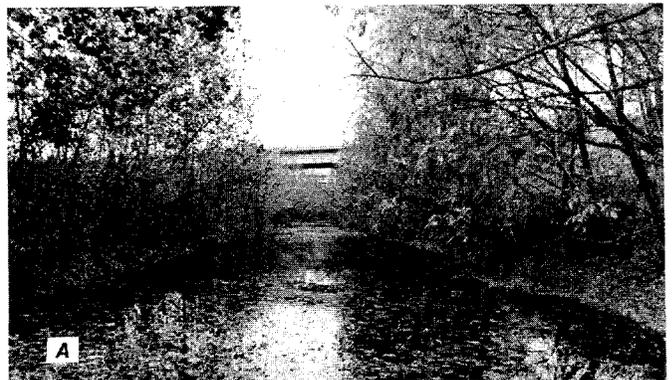
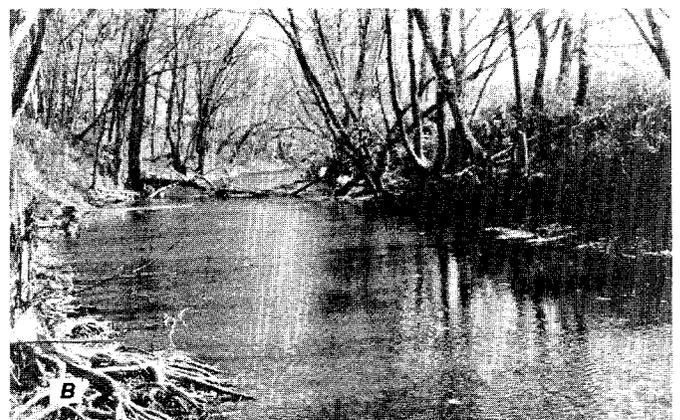
ALTERATION AND POST-ALTERATION FACTORS--Straightening of the channel led to only a slight decrease in length, from 245 m to 240 m, and consequently only a slight change in slope. No information was obtained on the as-built width of the relocated channel, but both the bottom and top width as measured on a 1969 airphoto are very nearly the same as for the natural channel. The banks of the relocated channel were evidently revetted to some degree with limestone riprap, of which only discontinuous remnants were visible in 1978. Sycamore, willow, and box elder have become well established along both banks of the relocated channel (fig. 90A).

DISCUSSION--The factors that account for the stability of the natural channel--low slope, coherent bank materials, and a slight degree of incision--have also contributed to the stability of the relocated channel. In addition, the riprap placed along the relocated channel contributed to stability and probably to the early establishment of vegetation.

Figure 90. Benson Creek at site 37. A, View upstream toward bridges in 1978, from end of relocation. B, Natural channel upstream from relocation, in 1978.

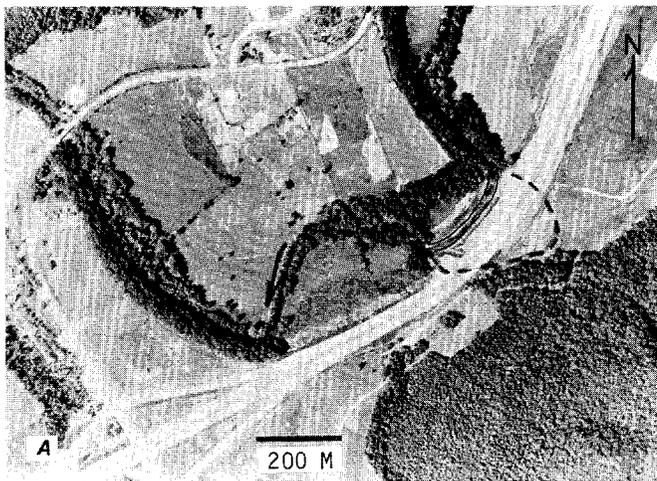
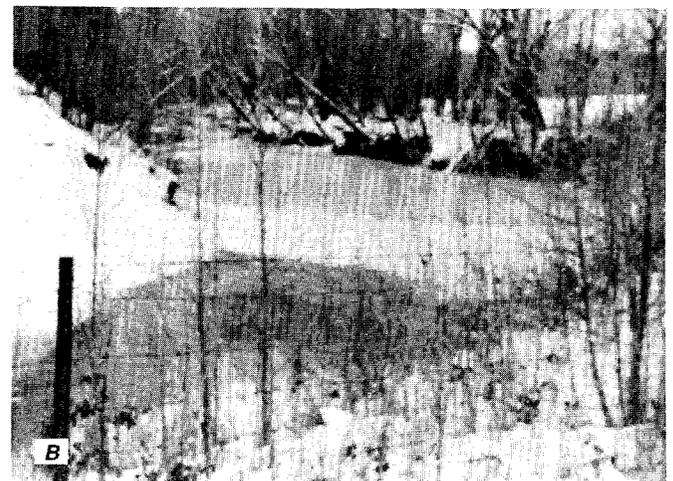
DISCUSSION--The junctions of relocated and natural channel are nearly at 90°, a factor that commonly leads to bank erosion. The lack of bank erosion is tentatively attributed to natural bank coherence, enhanced by vegetation.

Figure 91. North Fork Triplett Creek at site 38. A, Airphoto of channel relocation in 1972. Prior channel shown in dashed line. (From U.S. Dept. of Agriculture). B, Upstream junction, at bend, of relocated and natural channel in 1980.
