Report No. FHWA/RD-80/158

# STABILITY OF RELOCATED STREAM CHANNELS

March 1981  
Final Report

1. Report No. FHWA/RD-80/158		2. Government Accession No.		3. Recipient's Catalog No.	
4. Title and Subtitle  Stability of Relocated Stream Channels				5. Report Date March 1981

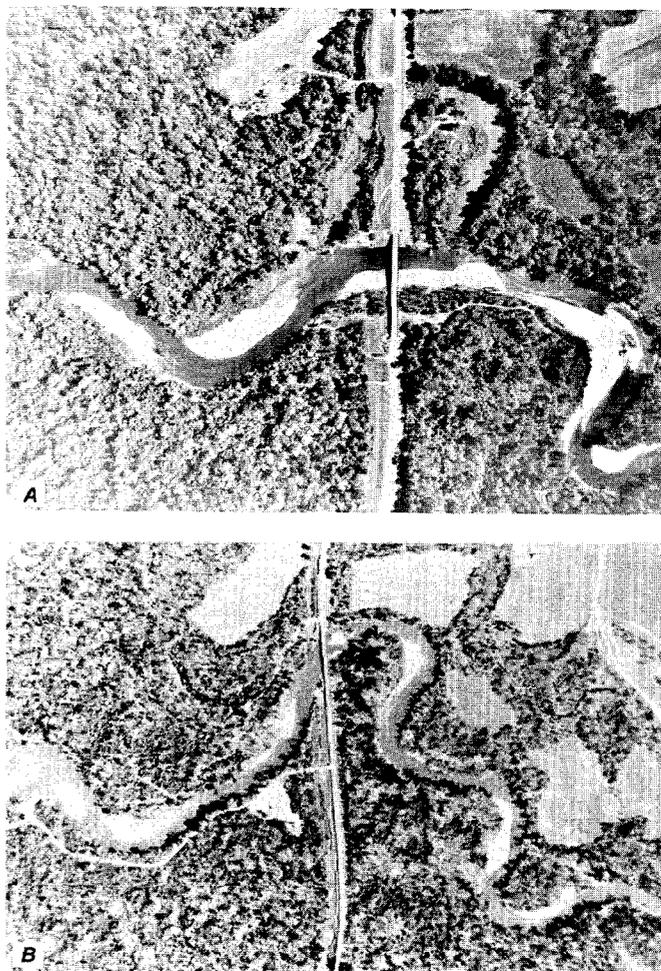
Stability class D4 for relocated channel, and also class D4 for adjoining reaches of the natural channel. As observed on a 1957 airphoto, taken prior to the channel relocation, the natural channel has an unstable aspect because of its wide point bars and cut banks at bends (fig. 93B ). At some time during the period 1957-73, at a point about 2.5 km upstream from the bridge site, a large complex meander loop was cut off naturally. The relocation has probably had little effect on the natural channel upstream from the bridge but has induced, or contributed to, severe bank erosion

at the first bend downstream (fig. 93A ) and imminent cutoff of the bend. The critical factor in instability of the relocated channel is prior instability of the natural channel, which is in turn attributed to erodible banks and, in part, to local clearing of the flood plain forest. Bank erosion of the natural channel downstream from the relocation is attributed to the unfavorable alinement of the transition.

broad meander loop upstream and a more narrow loop downstream (fig. 93A ), such that bank erosion was probable at the downstream loop.

**DISCUSSION**--Inasmuch as the river has rather high sinuosity and an apparently rapid rate of lateral migration at bends, good crossing sites are uncommon. The former crossing site was decidedly unsatisfactory (fig. 93B ), and cutting off the meander loop seems the most logical way of improving it. Protection of the bridge at the present site will require counter-measures both at the left abutment and at the outside of the first meander loop upstream.

Figure 93. Amite River at site 39. A, Airphoto of site in 1975. (From Louisiana Dept. of Transportation) B, Airphoto of site in 1937. (From U.S. Dept. of Agriculture).

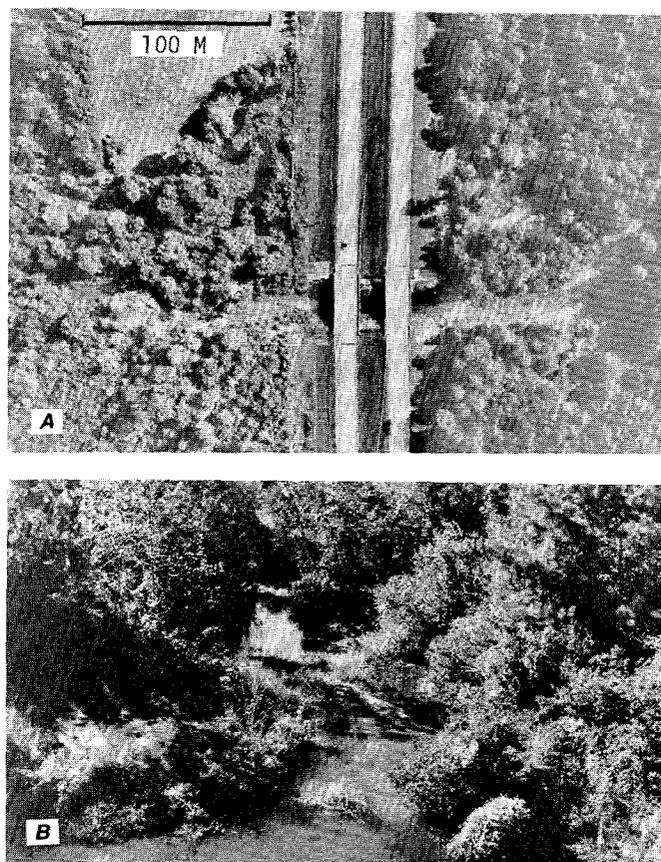
POST-ALTERATION FACTORS--In connection with general scour at the bridges, the bank revetment on the abutment fill-slopes was undermined. The concrete slope pavement subsided and the slabs were displaced downslope. The sacked concrete also failed on the lower slope but remained more intact than did the pavement. In the area of general scour, bottom width of the relocated channel was increased from its original value of 7.5 m to 11 m. The revetment had not been repaired by 1979, and no further erosion was apparent. Vegetation had become re-established along the relocated channel (fig. 95B).

DISCUSSION--In view of the small size and prior stability of the natural channel, and its border of dense forest, it would probably have remained stable if general scour had not been induced at the bridges by contraction of flood flow.

Figure 95. Cool Creek at site 40. A, Airphoto of site in 1975. B, Relocated channel in 1979, as viewed upstream from I-55 bridge.

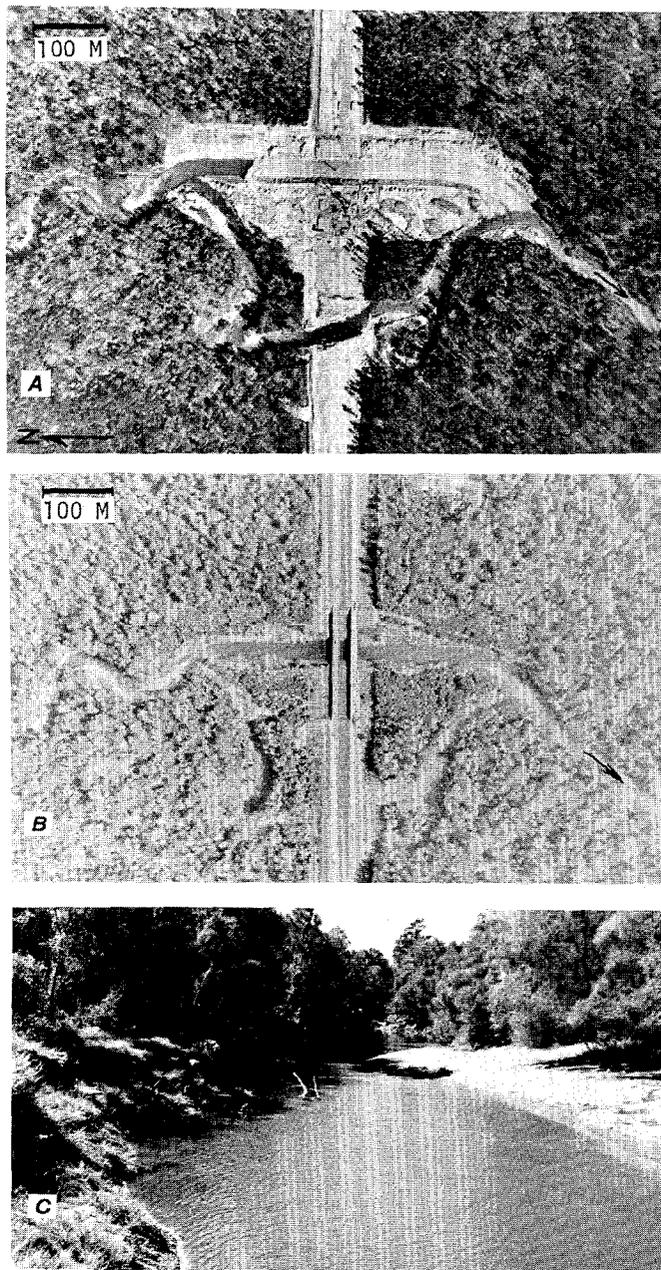
Stability class B3 for relocated channel, class B2 for adjacent reaches of natural channel. Critical factors in widening of the relocated channel are the removal of bank vegetation, which was not replaced, and contraction of flood flows at the bridge.

18 m and a top width of about 24 m, the relocated channel was built with a bottom width of 24.5 m and a top width of 41 m. This increase in width was enough to offset the increase in slope, yet not so much as to induce infilling and the formation of a meandering low-water channel. Widening of the relocated channel in the vicinity of the bridge is attributed to contraction of flood flow, and could probably have been prevented with a suitable revetment.

Figure 96. Tickfaw River at site 41. A, Airphoto of site during relocation in 1967. B, Airphoto of site in 1978. (From Louisiana Dept. of Transportation) C, Downstream end of relocated channel. Left bank is at outside of curve in channel.

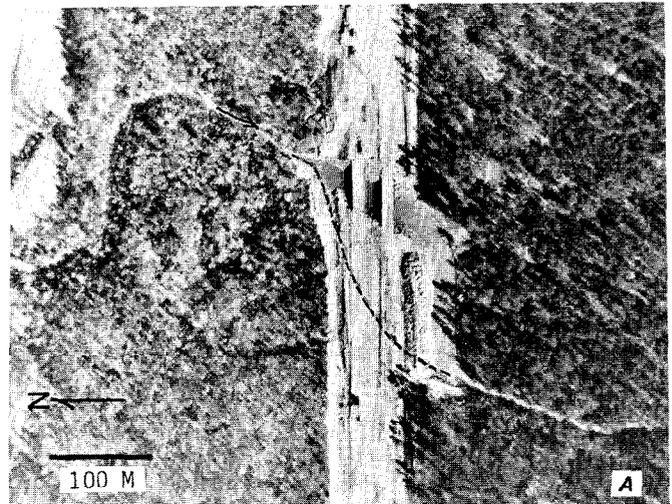
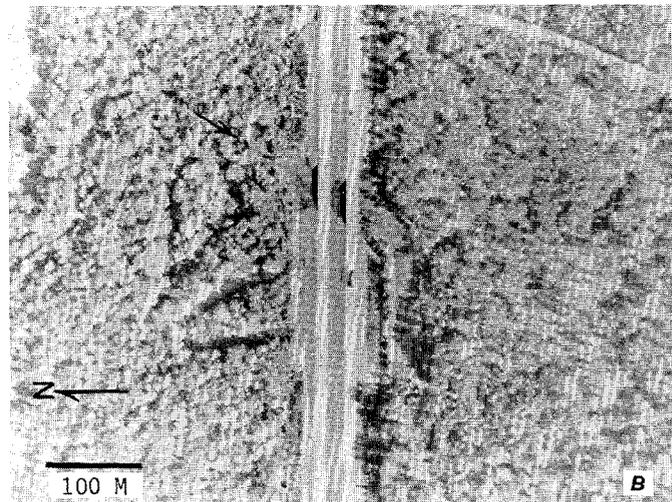
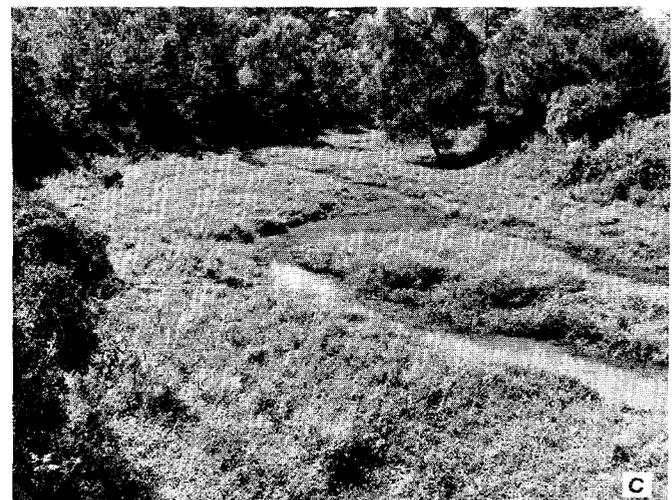
SYNOPSIS--Reach 297 m in length relocated for channel alignment with bridges; relocated reach has a length of 305 m (figs. 97A and B). Performance period, 13 yr (1967-79). Although Big Branch is ungaged, it probably had major floods in 1974, 1977, and 1979, as floods of approximate 25-yr recurrence interval were recorded for these years on the nearby Tickfaw River. No instability of the relocated channel was observed in 1979. Because of the excessive width of the relocated channel, a meandering low-flow channel has developed within it (fig. 97C).

DISCUSSION--Bottom width of the relocated channel is 17 m, as compared with a bottom width of about 4.5 m for the prior channel. Probably, this increase in width was intended to convey flood flows without the use of spur dikes. Downstream from the bridges, a meandering low-flow channel has formed and most of the channel bottom is grassed (fig. 97C). Conveyance of the channel may eventually be reduced by the growth of trees on the channel bottom.

Figure 97. Big Branch at site 42. A, Airphoto of channel relocation, in 1967. Prior channel is indicated by dashed line. B, Airphoto of relocated channel, in 1978. (From Louisiana Dept. of Transportation) C, Relocated channel as viewed downstream from I-12 bridge, in 1979.

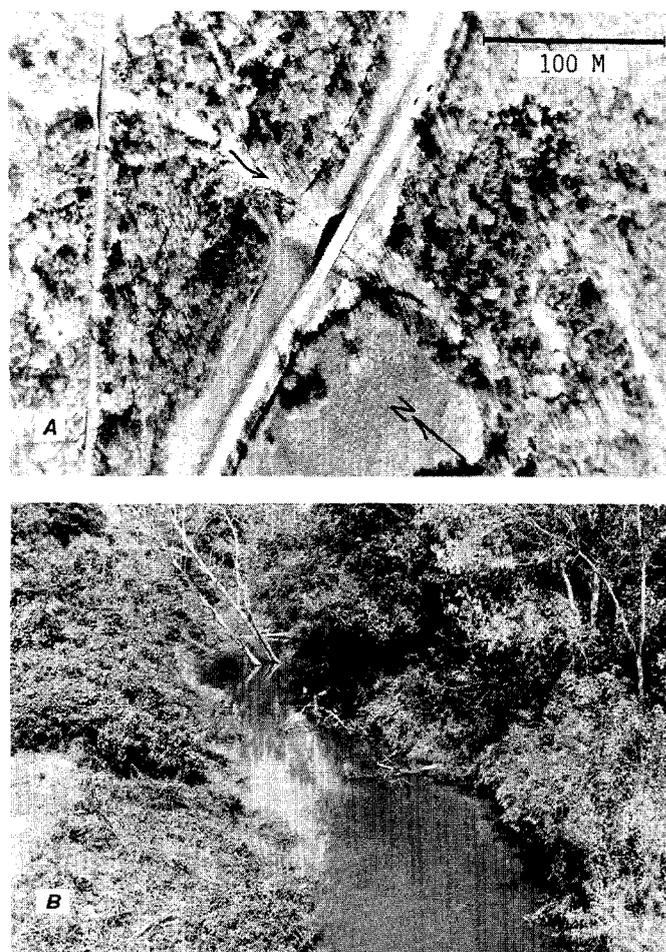
POST-ALTERATION FACTORS--Although Redwood Creek is not gaged at this site, a flood was recorded at the U.S. Geological Survey gage at Slaughter (16 km downstream) in 1977. In 1979, the banks of the relocated channel were grassed within the highway right-of-way, and elsewhere bordered by trees (fig. 99B).

DISCUSSION--In 1979, the relocated channel was somewhat more stable in aspect than sinuous reaches of the natural channel. It is doubtful if relocation had any effect on the natural channel, which tends to be somewhat unstable because of erodible banks.

Figure 99. Redwood Creek at site 43. A, Air-photo of site in 1974. (From Louisiana Dept. of Transportation). B, Creek as viewed upstream from SR-19 bridge, in 1979. Natural channel begins at trees.

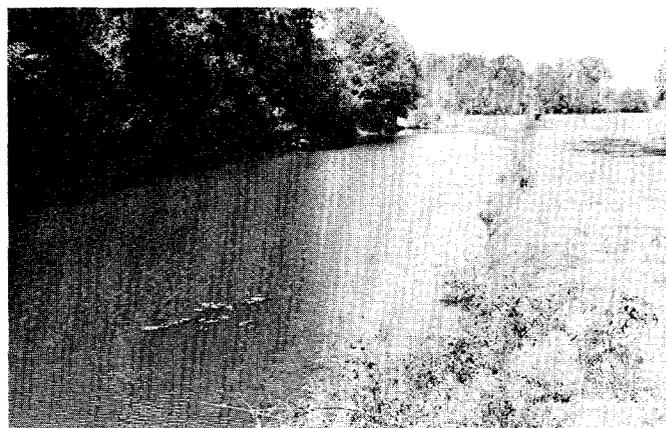
SYNOPSIS--Reach 220 m in length relocated, widened, and decreased slightly in length for purpose of alinement at bridge (fig. 100). Performance period, 31 yr (1949-79). By 1979, the relocated channel had increased in width from an as-built value of 11 m to about 13 m. The low banks were vegetated, with grass on the left bank and trees on the right (fig. 101), and were generally stable except for minor erosion at the bend just downstream from the SR-19 bridge.

Figure 101. Relocated channel of Doyle Bayou in 1979, as viewed upstream toward bridge.

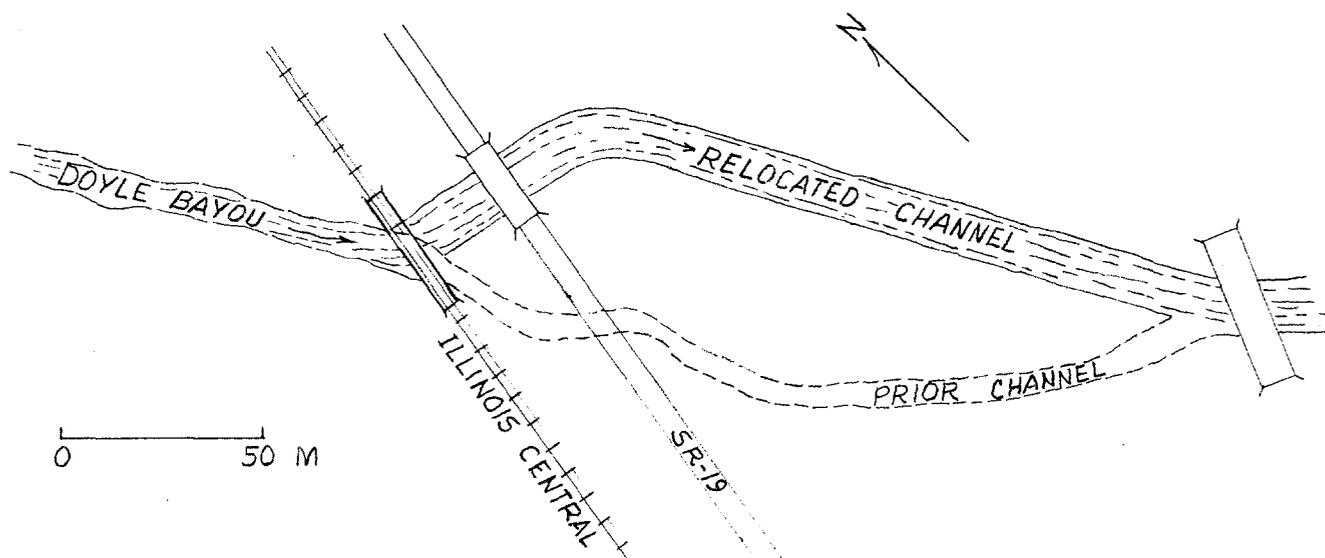
Figure 100. Plan sketch of channel relocation, Doyle Bayou.

DISCUSSION--A bend such as that in the relocated channel downstream from SR-19 bridge (fig. 100) would have induced more severe bank erosion on many streams, as would the bend at the railroad bridge. Here, water velocity at normal discharge is too low to have any erosive effect, and, because of the wide shallow cross section, velocity would not be high at bankfull stage.

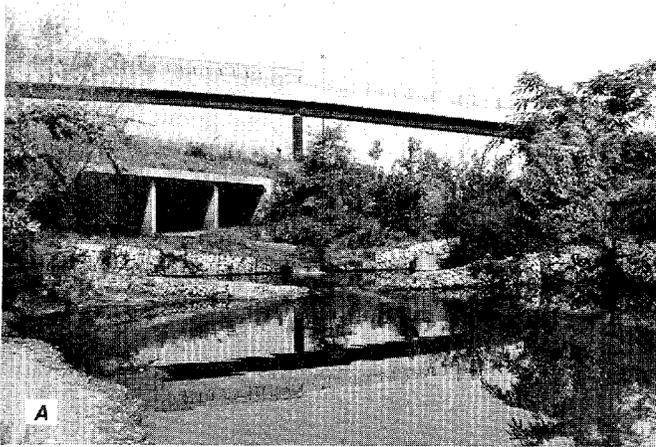
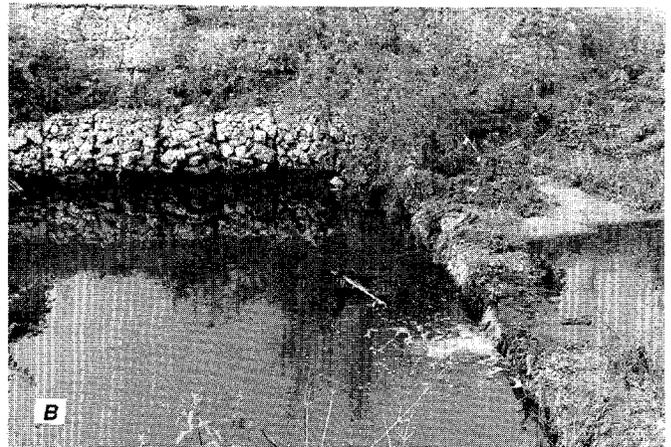
DISCUSSION--The relocated channel is well protected by countermeasures and, because of the establishment of vegetation, is likely to remain stable even if the rock-and-wire mattress should fail locally. The channel was made overly wide in order to contain, within banks, the design flood; but this has entailed the risk of reduction in capacity by encroachment of vegetation, unless it is periodically cleared.

Figure 105. Moores Run at site 46. A, View upstream of stilling basin downstream from culvert. B, Apparent undercutting of gabion at toe of side slope, on stilling pool downstream from twin bridges. Note rock-and-wire mattress in background.

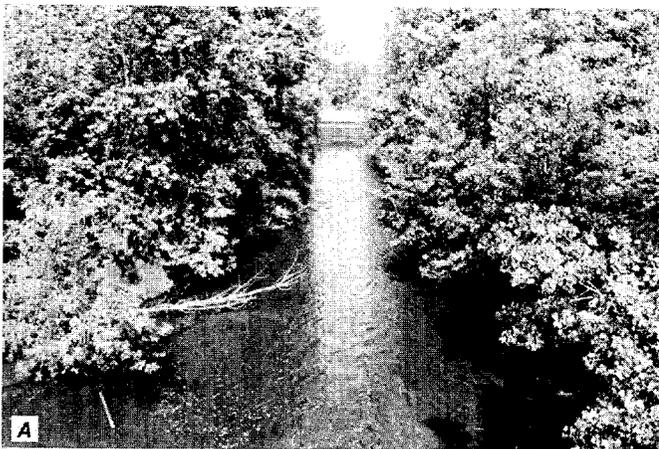
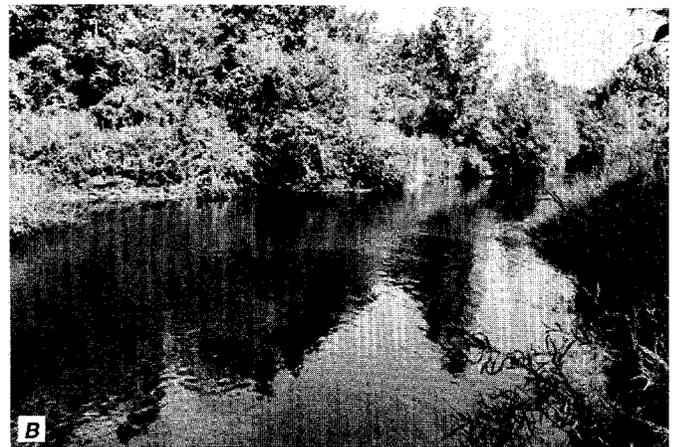
POST-ALTERATION FACTORS--In 1978, the relocated channel was bordered by well-established vegetation and there was no indication of present or past instability. Bank stability of adjacent segments of the natural channel was generally good, and similar to that observed on a 1958 airphoto.

Figure 107. South Branch Tobacco River at site 47. A, Relocated channel in 1978, as viewed downstream from bridge on southbound lane. B, Downstream junction of relocated and natural channel, in 1978.

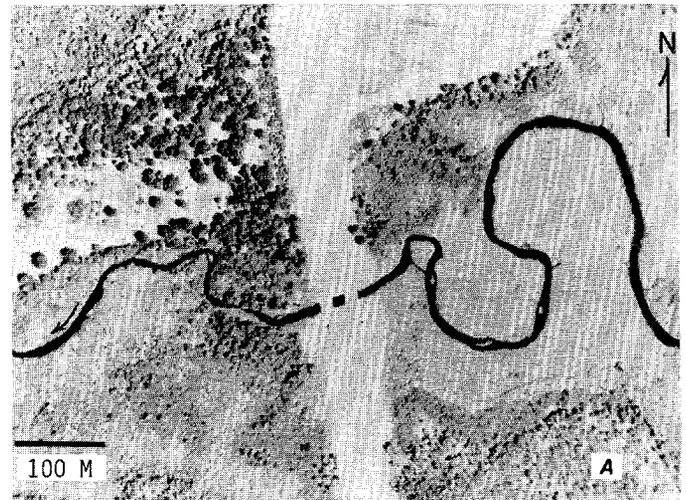
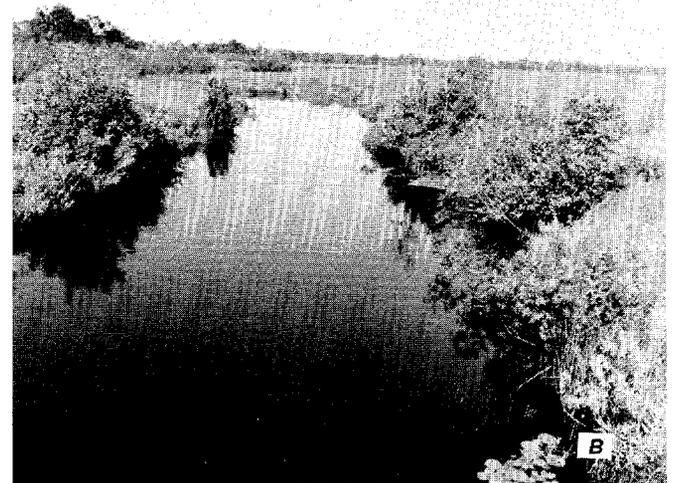
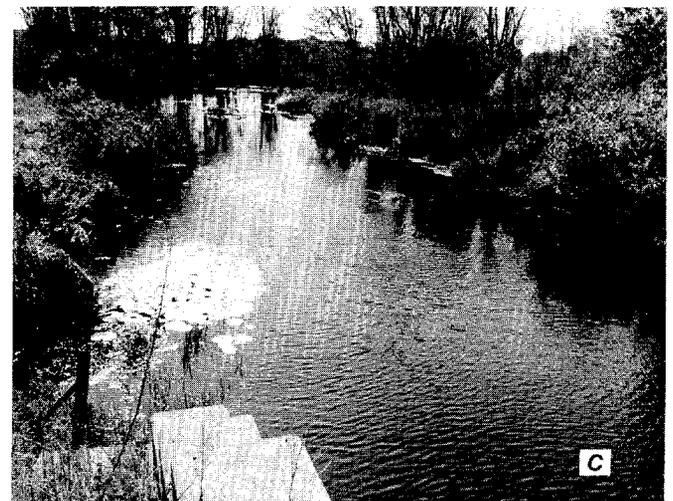
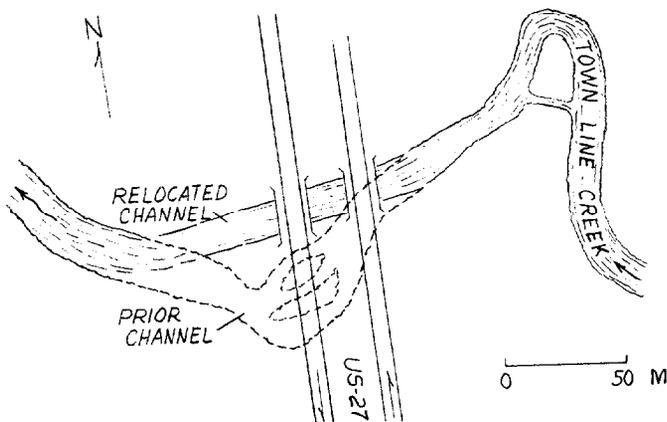
DISCUSSION--This site provides an example of an exceptionally stable natural channel that was not likely to be disturbed by relocation. All of the factors that promote channel stability are operative: coherent banks, dense vegetal cover, low channel slope, and natural regulation of flow.

Figure 109. Town Line Creek at site 48. A, Airphoto of channel relocation in 1965. (From U.S. Dept. of Agriculture) B, View downstream from bridge, in 1979, relocated channel in foreground. C, View of natural channel upstream from bridge, in 1979.

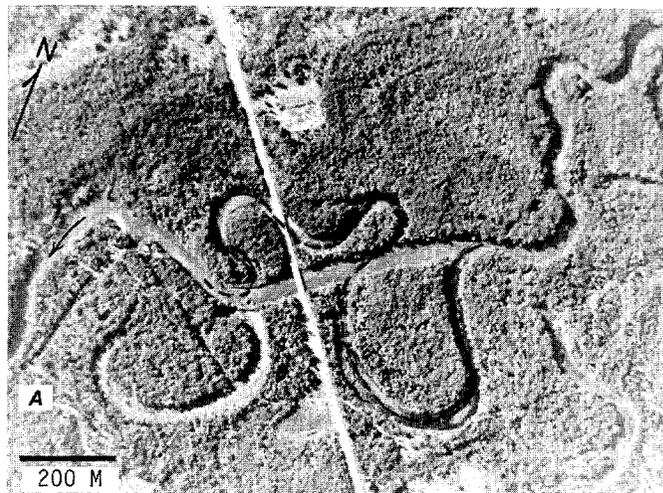
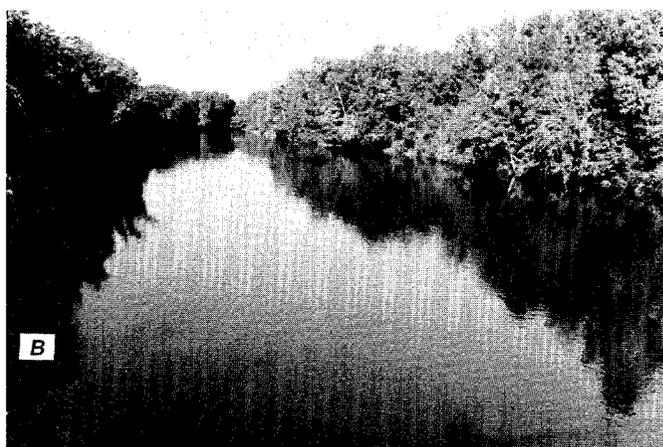
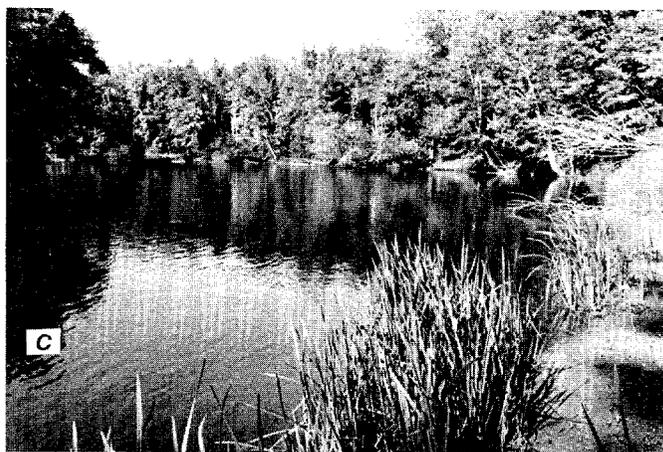
Figure 110. Muskegon River at site 49. A, Airphoto, taken in 1965, showing relocation at SR-155. (From U.S. Dept. of Agriculture) B, relocated channel downstream from bridge, in 1979. C, Natural channel at first bend downstream from relocation.

POST-ALTERATION FACTORS--At the U.S.G.S. stream gage at Evert, where bankfull stage is 12 ft (3.7 m), floods about 2 ft (0.6 m) above bankfull stage occurred in 1957, 1959, and 1976. Floods above bankfull stage probably occurred in these years at the site. In 1979, the banks of the relocated channel and surrounding areas were densely forested. There is no evidence of maintenance or installation of countermeasures at the site.

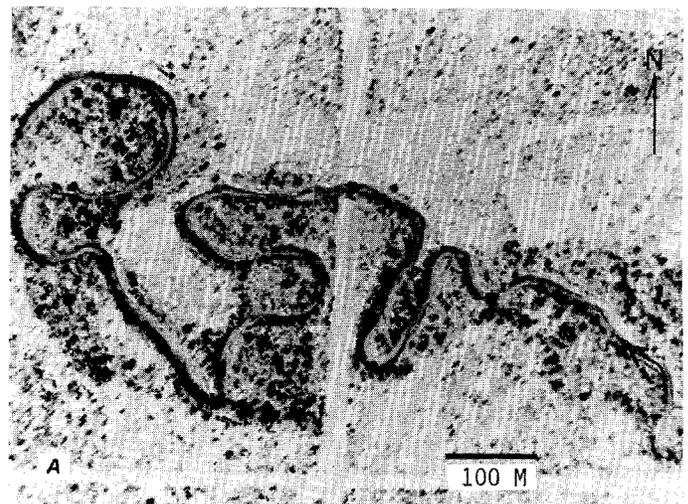
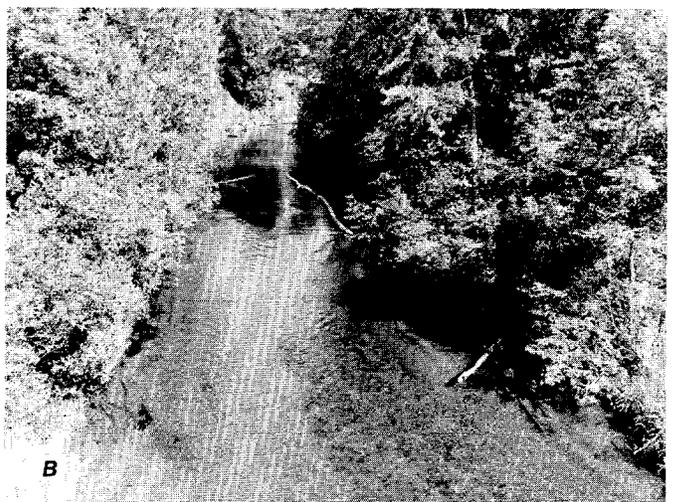
SYNOPSIS--No channel alteration was done at this site, but it provides an extraordinary example of the feasibility of dispensing with alterations on very stable streams (fig. 111A). In spite of the apparent danger that two meander loops might encroach on the railroad embankment, the railroad was built on a narrow neck of land between two loops. The railroad was probably constructed about 1900, but not later than 1911, because it is shown on its present location on a map dated 1911. No lateral migration of the loops could be discerned by comparing a 1958 airphoto with field conditions in 1979, and the loops have probably not migrated by a significant amount since construction of the railroad.

DISCUSSION--The stability of this stream is attributed to natural regulation of flow by ground- and surface-water storage, to incision, and to the dense growth of vegetation along the banks and surrounding areas. Steep unvegetated banks of non-coherent sand and gravel occur at the outside of some bends (fig. 111B), but these evidently erode very slowly.

Figure 111. Pere Marquette River at site 50. A, Airphoto of site in 1958. (From U.S. Dept. of Agriculture) B, Channel upstream from railroad bridge, in 1979.

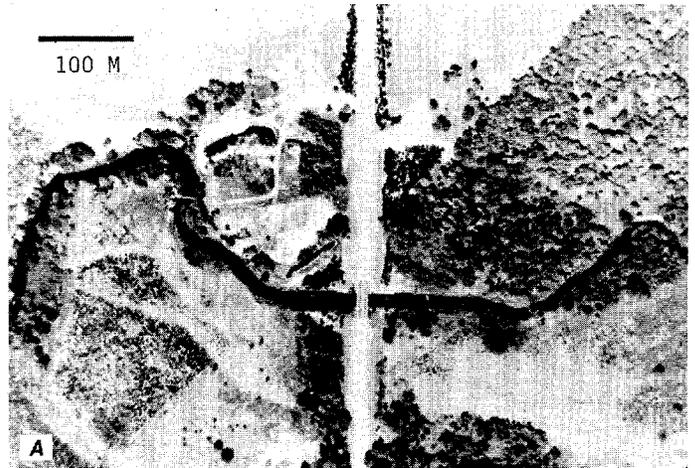
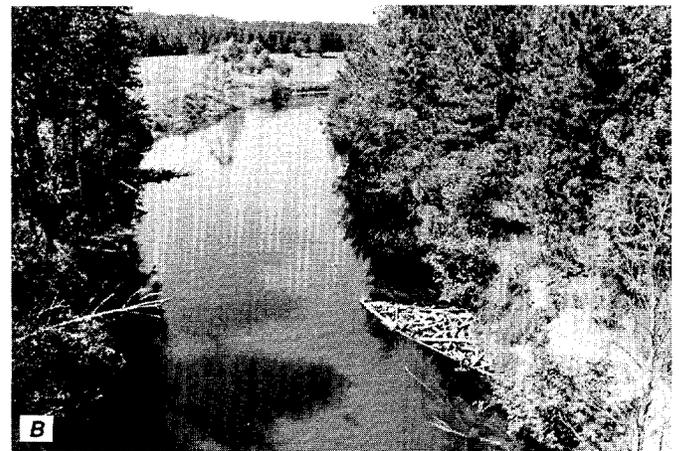
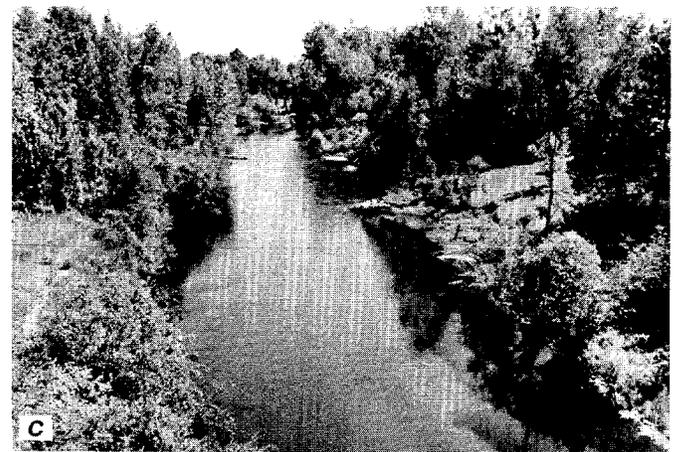
Figure 113. Betsie River at site 51. A, Air-photo of site in 1965. (From U.S. Dept. of Agriculture) B, Relocated channel downstream from bridge, in 1979. Grouted-riprap bank revetment and fish habitat structure at right. C, View upstream from bridge in 1979; relocated channel in foreground.

POST-ALTERATION FACTORS--Log spurs, probably installed by the Michigan Department of Natural Resources as fish habitat structures (fig. 113B)

were in place along the channel in 1979, but are not on a 1965 airphoto. These consist of small logs randomly placed, held together with spikes and secured to the stream bottom with log stakes. That such a structure would remain intact for several years is evidence of the low erosive power of the stream. The grouted riprap revetment, although not keyed into the sandy bank at the upstream end, has not been undercut.

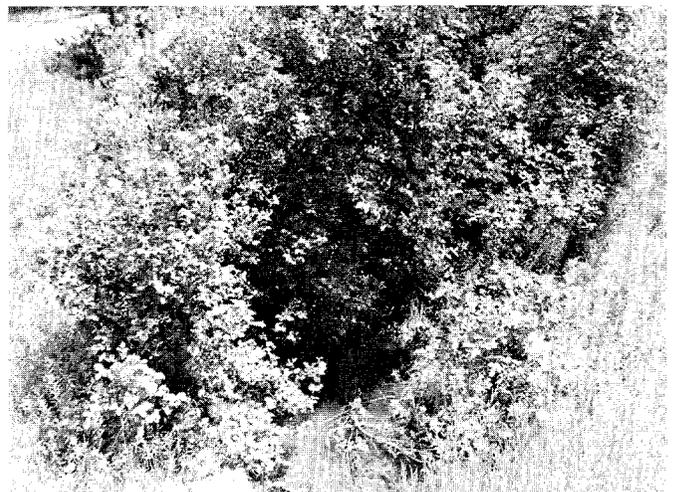
SYNOPSIS--Segment of small stream (2.5 m in width and 430 m in length) relocated and thereby shortened to 320 m, to avoid multiple crossings and to improve alignment at culvert (fig. 114). Performance period, 28 yr (1952-79). There is no record of flow, but some moderately high flows during a period of this length are probable. Banks of both relocated and natural channel were densely vegetated in 1979 (fig. 115), and there was no indication of present or past instability.

Figure 115. Relocated channel of Peterson Creek upstream from culvert, in 1979.

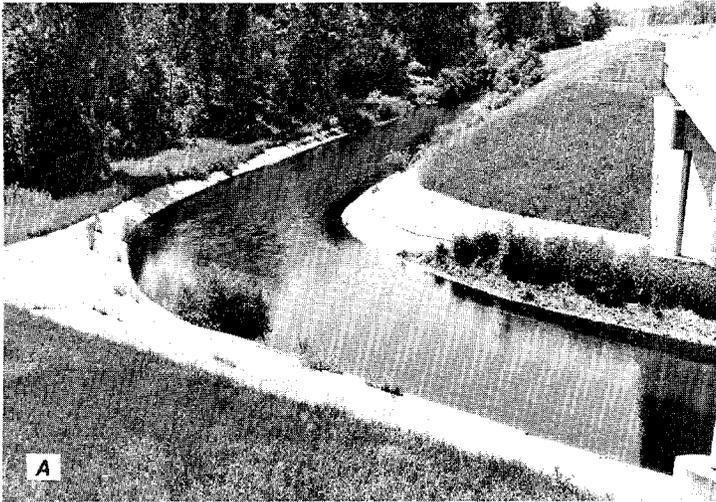
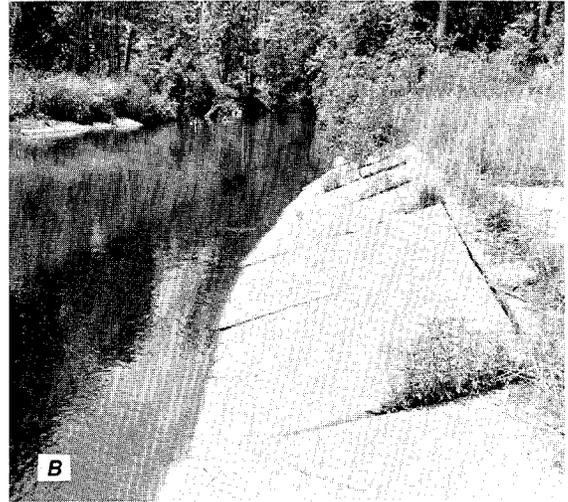
DISCUSSION--Minor subsidence of the concrete slope pavement is attributed to instability of the foundation rather than to stream erosion. The natural channel was undisturbed in the median area, and the relocated reaches were kept to a minimum length.

Figure 117. Tamarack Creek at site 53. A, View upstream from east bridge in 1979. B, View downstream from west bridge in 1979.

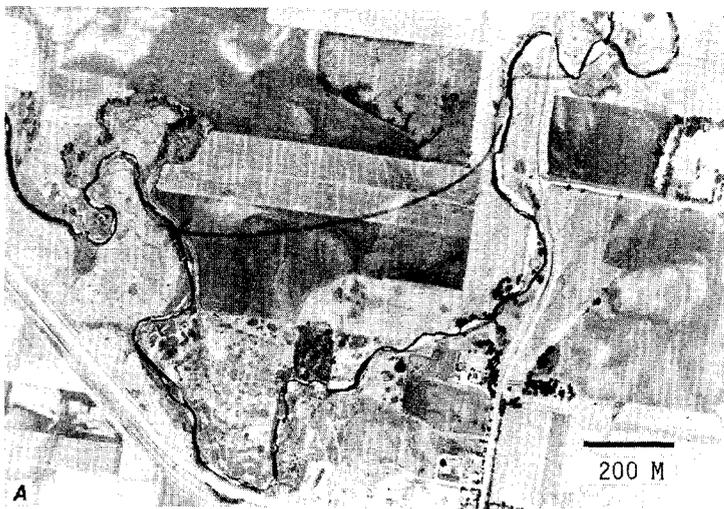
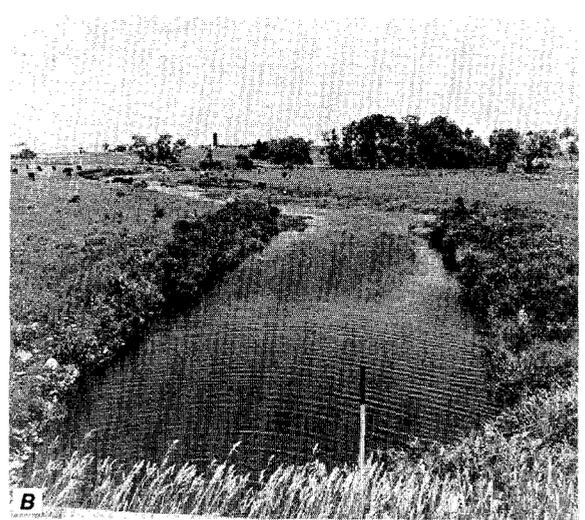
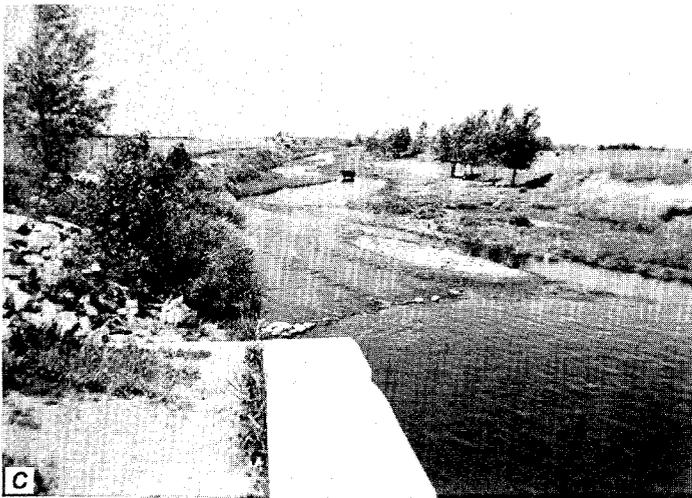
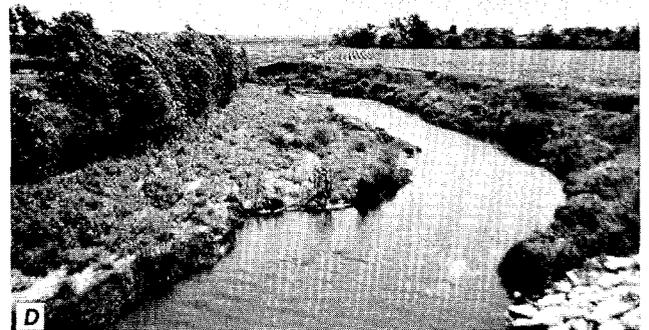
Stability class B1 for relocated channel, class D for natural channel. Critical factors in stability of the relocated channel are: (1) Use of a check dam, with an overfall of 1.35 m, to offset the increase in slope resulting from severe channel shortening. (2) The greater width of the relocated channel, relative to the natural channel has probably served to reduce bank erosion by reducing depth and velocity. However, the stream will eventually meander within this wide channel (fig. 119D), eroding banks at bends. (3) Where installed, riprap has effectively prevented bank erosion.

the culvert intended to carry base flow to the prior channel was filled with sediment, and has not functioned since. There is no record of maintenance or installation of countermeasures since 1967. The low-flow channel has shifted from the center of the relocated channel to a position along the left bank (fig. 119C).

Figure 119. Kanaranzi Creek at site 54. A, Airphoto of site in 1954, before relocation. Solid line indicates position of relocated channel. (From U.S. Dept. of Agriculture) B, Relocated channel upstream from SR-91 bridge, in 1979. C, Relocated channel downstream from check dam, in 1979. D, Downstream intersection of prior channel, foreground, with relocated channel, right background.

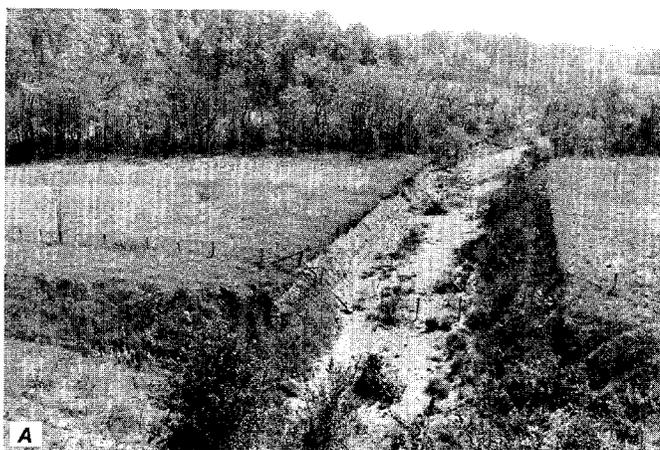
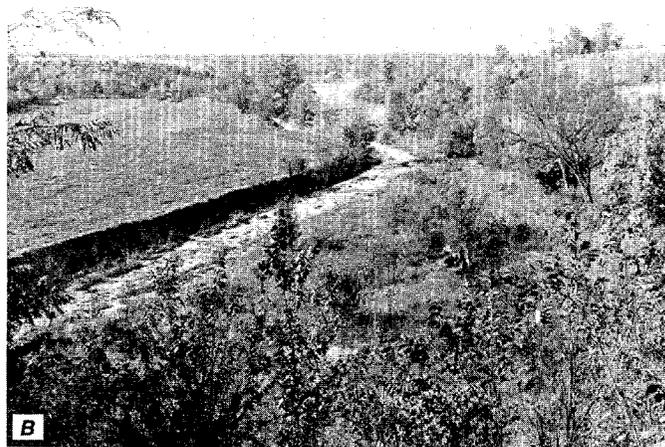
SYNOPSIS--Channel was relocated and a segment was thereby shortened from a length 550 m to 490 m, for purpose of improving channel alignment at culvert (fig. 120 ). Performance period, 18 yr (1960-78), during which two or three rainstorms of fairly high intensity occurred, and a flood of about 5 yr recurrence interval is estimated. The relocated channel was trapezoidal in cross section, with a bottom width of 9 m, side slopes of 2:1, and a channel slope of about 8 m/km. No countermeasures were used. In 1978, the channel bottom width upstream from the culvert was in the range of 9-10.5 m; the right bank was raw and nearly vertical, and the left bank was more gently sloping and stabilized by vegetation (fig. 121A). Downstream from the culvert, the

bottom width was about 12 m and the right bank was more stable than the left (fig. 121B). Channel degradation is indicated by the incised nature of the channel, but degradation has been halted by an outcrop of cherty limestone in the channel upstream from the site. Moreover, the degradation, and associated bank erosion, which is common to streams in the area, is attributed to land use practices rather than to relocation.

DISCUSSION--Although the bank on one side of the relocated channel is cut, channel top width has not increased significantly since relocation. Bottom width of the relocated channel (9 m) was only slightly greater than that of the natural channel (6-7.5 m), but the thalweg has shifted against one bank. Bank erosion could probably have been prevented by a vegetal lining or some other bank protection measure.

Figure 121. Collie Hollow at site 55. A, View upstream from I-44 embankment along relocated channel in October 1978. Line of trees in left background marks location of prior channel. B, View downstream from I-44 embankment along relocated channel in October 1978.

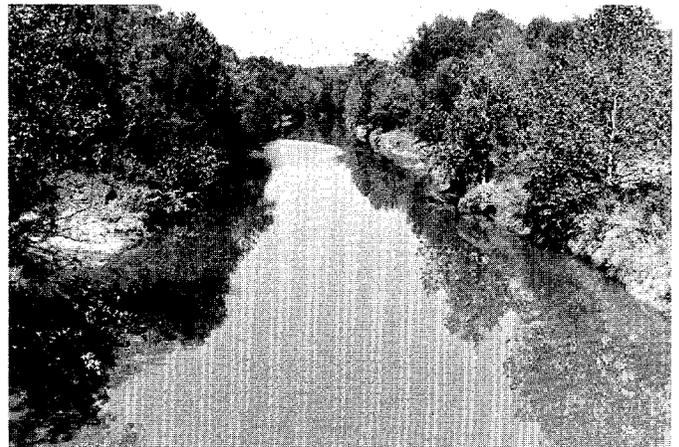
Figure 127. View along relocated channel of Bear Creek downstream from bridge, in 1979.

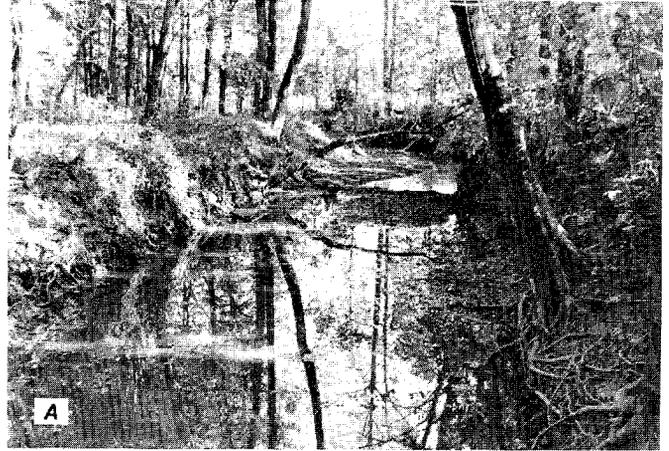
SITE FACTORS---Lat 32°19', long 89°37', at I-20, 5 km southeast of Morton, Miss., on Morton 15' map. Strong River is perennial, with a drainage area of 43 km<sup>2</sup> and an estimated 50-yr flood discharge of 121 m<sup>3</sup>/s. Channel bottom width is 5 m, bank height is 1.3 m, and channel slope is about 0.3 m/km. Equiwidth point-bar stream, alluvial, sinuosity of 1.9, valley relief of 30 m, wide flood plain (400 m in width), tree cover along bankline greater than 90 percent. Bank material is moderately coherent silt-clay, bed material is sand. As observed on a 1956 airphoto, the channel was highly sinuous but very stable in aspect, and no significant changes were observed by comparison with a 1978 airphoto.

Figure 129. Strong River at site 59. A, Natural channel upstream from relocation, in 1979. B, Relocated channel upstream from I-20 bridge, in 1979.

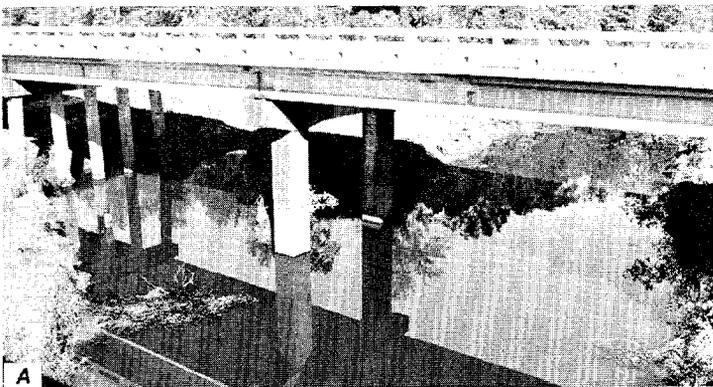
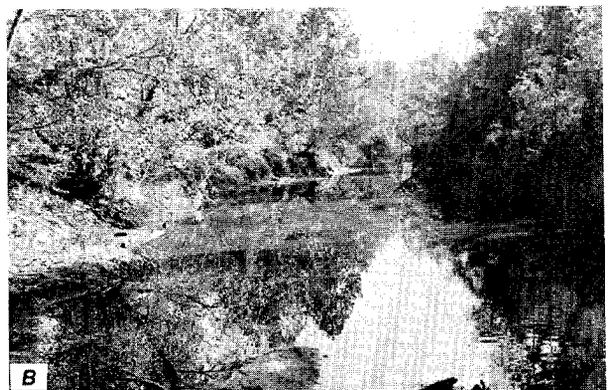
Figure 133. Oakahatta Creek at site 61. A, Channel widening at west-bound interstate bridge, as photographed in 1979. B, Relocated channel downstream from interstate bridges, in 1979.

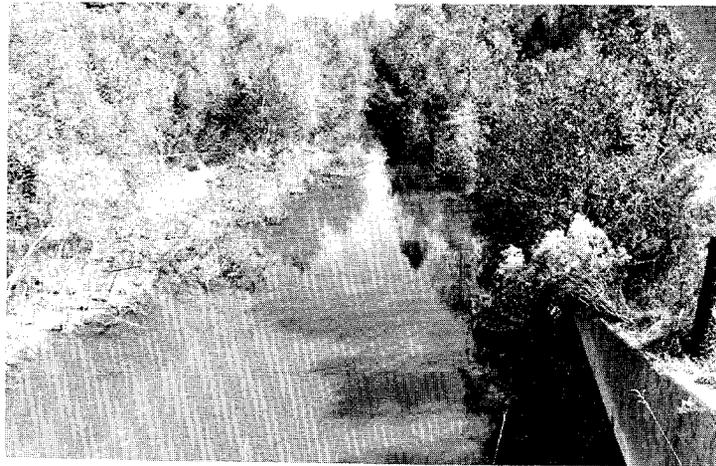
Figure 137. Relocated channel of Bogue Homo downstream from culvert, in 1979.

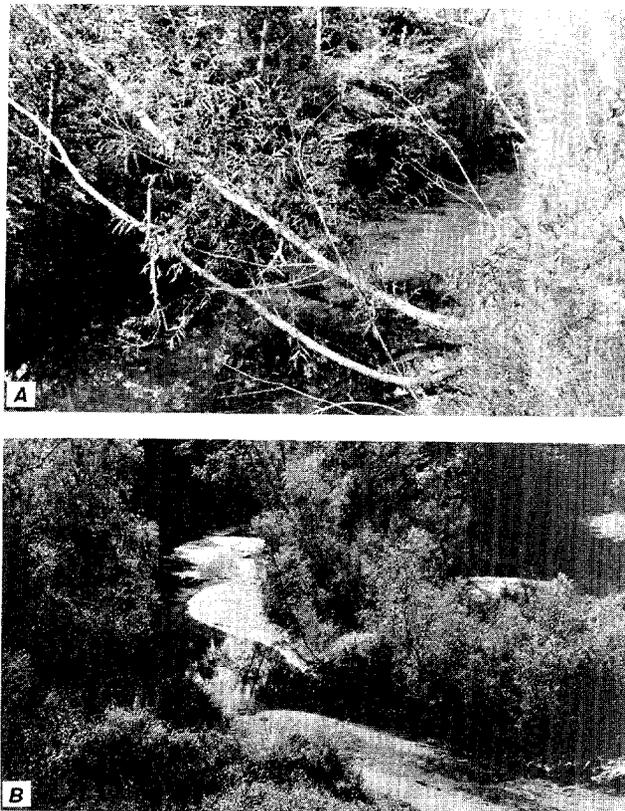
The relocated channel was trapezoidal in cross section, with a bottom width of 12 m, 2:1 side slopes, and a channel slope of about 1.3 m/km. No bank protection measures were applied. In 1979, banks of the relocated channel upstream from the bridge were stable and well vegetated (fig. 139A) and the channel downstream was also stable (fig. 139B). At the upstream transition to the natural channel, local bank erosion had increased the channel width to 20 m; but in general the natural channel was stable.

Figure 139. East Hobolochitto Creek at site 64. A, Relocated channel upstream from bridge, in 1979. B, Relocated channel downstream from bridge, in 1979.

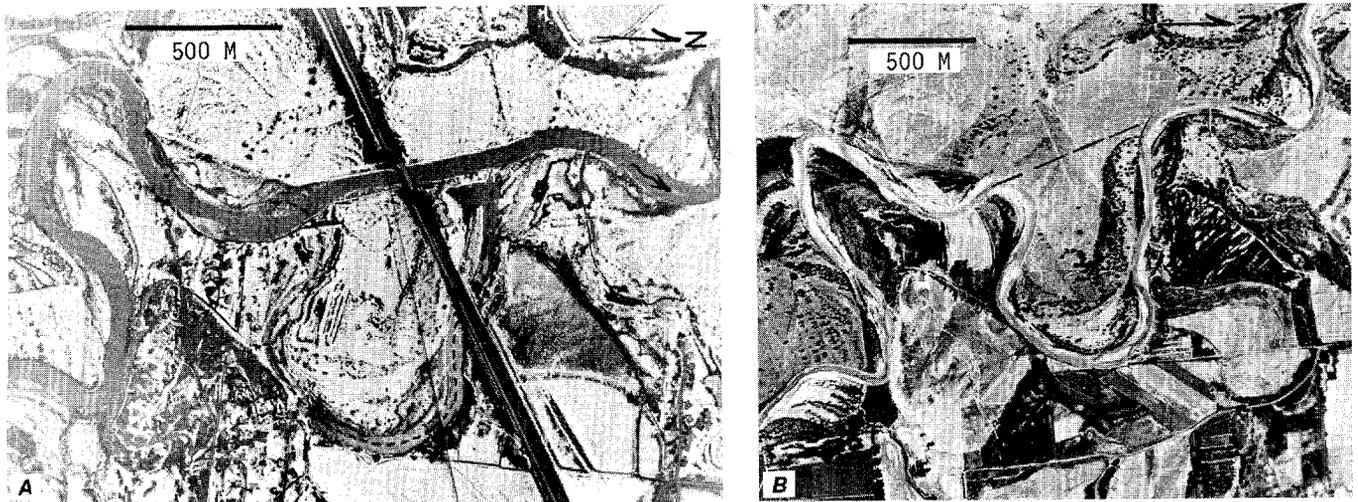
SYNOPSIS--Channel was relocated by cutting of a meander bend, reducing the length of a channel segment from 2,200 m to 600 m, for purpose of improving alinement at bridge and preventing encroachment of meander on planned roadway location (fig. 140A ). Performance period, 17 yr (1962-79). At the U.S. Geological Survey gage about 5 km upstream, the maximum peak flow ( $377 \text{ m}^3/\text{s}$ ) for a 32-yr period of record occurred in 1962; a second major flood ( $289 \text{ m}^3/\text{s}$ ), in May 1975; and another, in March of 1979. As built, the relocated channel was trapezoidal in cross section, with a bottom width of 52 m, 2:1 side slopes, and a channel slope of about 1.1 m/km. In the plans, riprap bank protection is specified only at the bridge; but large riprap, at the toe of both banks for the full length of the relocated section, is visible on a 1969 airphoto. This site was not visited in the field, but airphotos taken in 1950, 1958 (fig. 140B ), 1966, 1969, and 1979 were obtained mainly from the Montana Department of Transportation. As observed and measured on the airphotos, bottom width of the relocated channel was 56 m in 1966 and 57 m in 1979, and the banks were stable in 1979. Alternate lateral bars, which may be the precursors of meandering, had formed in the straight relocated channel by 1969. Maximum lateral erosion measured at bends on the natural channel was 8 m for the period 1950-58 and 33 m for the period 1969-79. The

Figure 140. Tongue River at site 65. A, Airphoto of channel relocation in 1979. Prior channel is shown in dotted line. (From Montana Dept. of Transportation) B, Airphoto of site in 1958. Position of relocation is shown in dashed line. (From U.S. Dept. of Agriculture)

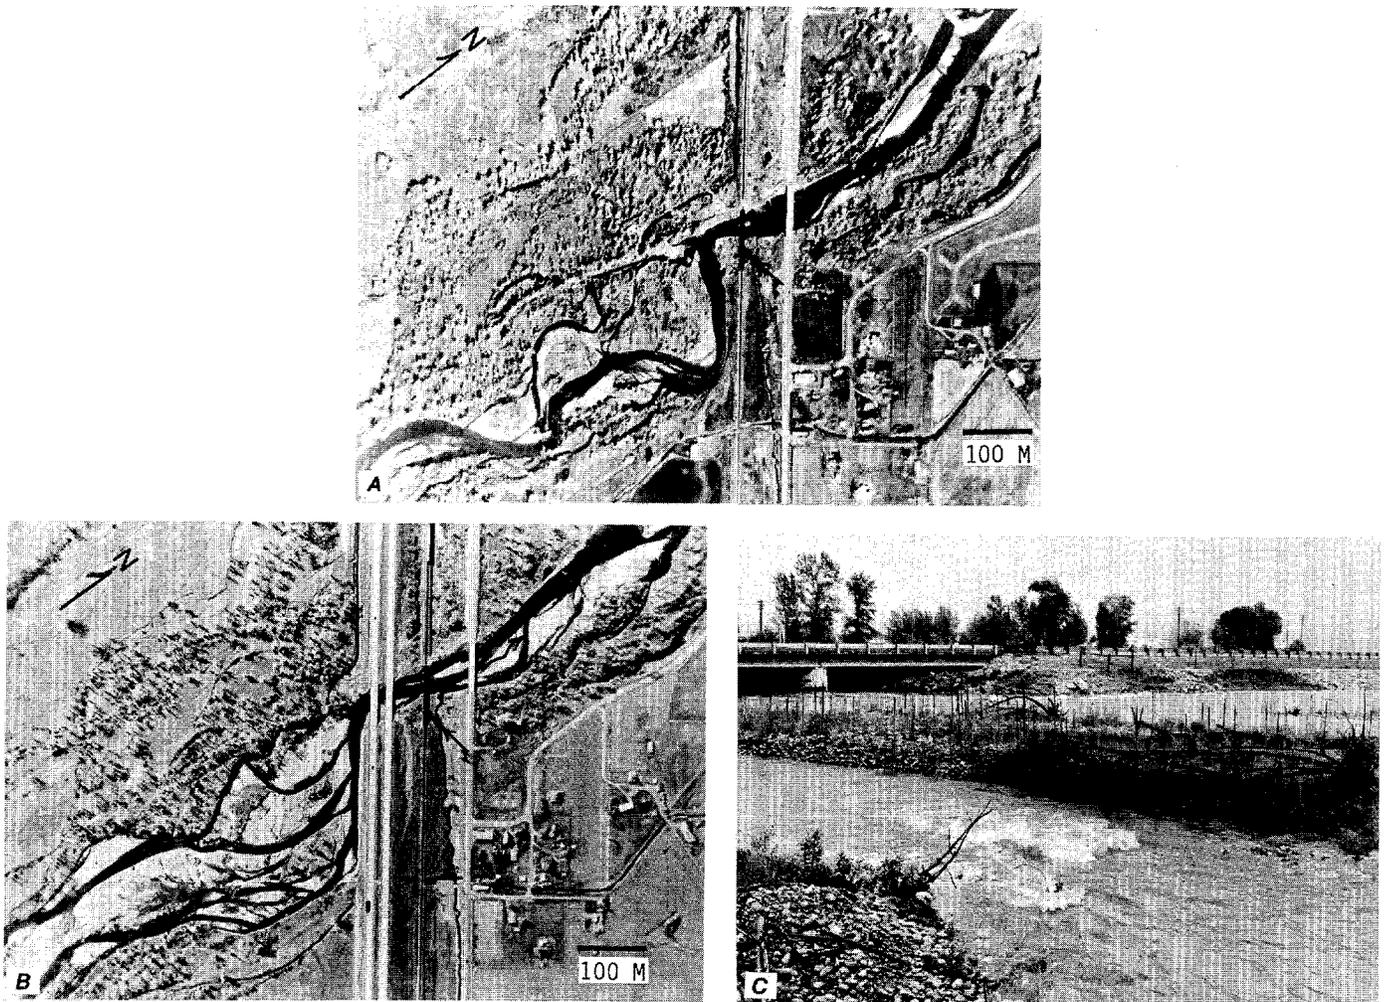
SYNOPSIS--Channel relocation, involving a main channel segment of anabranching river about 365 m in length, which was shifted to the left and shortened to 240 m; for purpose of accommodating planned roadway location, improving channel alignment at bridge and confining the stream width (fig. 141A ). Performance period, 13 yr (1966-79), during which three floods occurred. The relocated channel had a bottom width of 36.5 m and a channel slope of 6.6 m/km. Riprap was placed along the roadway embankment (fig. 141B) and along the left bank upstream from the bridge. By 1979, the anabranch at the right bank in figure 141B had been abandoned and impingement of flow directly against the riprapped roadway embankment had caused local erosion and slumping (fig. 141C). Otherwise, the streambanks were stable and the relocation appeared to be functioning as planned. Because of the minor nature of the relocation and the shifting anabranches and braids of the stream, no effect on adjacent segments would be anticipated and none was observed.

Figure 141. Gallatin River at site 66. A, Airphoto of site in 1963, position of re-located channel indicated by dashed line. Railroad bridge, indicated by arrow, is 90 m in length. (From Montana Dept. of Transportation) B, Airphoto of site in 1972. (From Montana Dept. of Transportation) C, View downstream toward interstate bridge in 1979.
