Report No. FHWA/RD-80/158

# STABILITY OF RELOCATED STREAM CHANNELS

March 1981  
Final Report

1. Report No. FHWA/RD-80/158		2. Government Accession No.		3. Recipient's Catalog No.	
4. Title and Subtitle  Stability of Relocated Stream Channels				5. Report Date March 1981

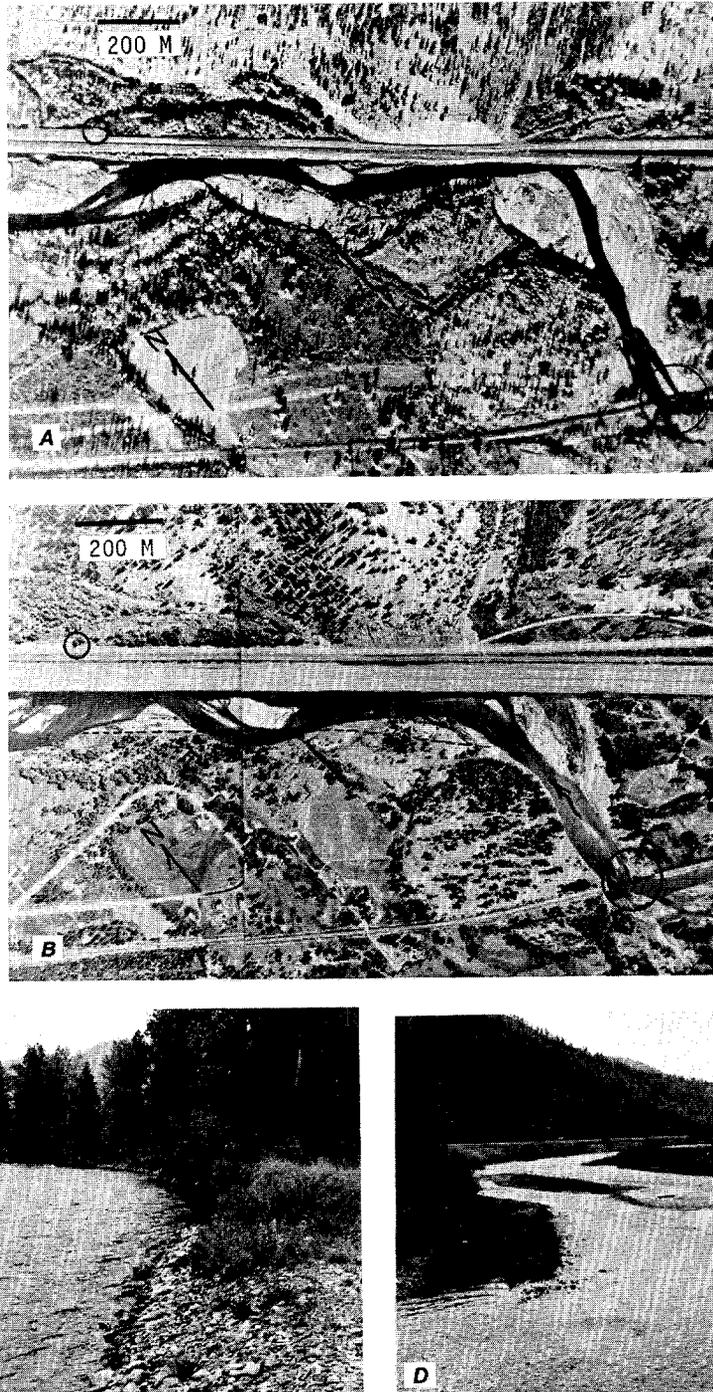
Figure 142. Clark Fork at site 67. A, Airphoto of site in 1956. Milwaukee, St. Paul, and Pacific Railroad bridge, circled at right, is 120 m in length. (From Montana Dept. of Transportation) B, Airphoto showing upstream end of relocated channel in July 1975, after major flood in June 1975. Original left bank of relocated channel is shown in dashed line. Railroad bridge is circled at right. (From Montana Dept. of Transportation) C, Eroded left bank of relocated channel in 1979. D, Upstream end of relocated channel in 1979.

1.2-m thickness of rock riprap. A rock riprap dike was constructed on the right bank at the downstream end of the relocation. During the 1975 flood, two large scallops developed in the left bank near the downstream end of the relocation, increasing the total channel width locally to 140 m (fig. 142B). The channel has shifted away from one of these scallops; but in 1979, active bank erosion was continuing at the other (fig. 142C). The banks were generally stable at the downstream end of the relocated channel (fig. 142D). The natural channel underwent significant changes during the period 1965-78, such that the entire channel length on the Bonner 7.5' map was redrawn on the 1978 photorevision of the 1965 map. However, it is doubtful that the relocation, which involved no change in channel length, had any effect on adjacent segments of the natural channel.

Stability class C3 for relocated channel for which local bank erosion had a maximum value of about 40 m for the period 1964-75. Stability class D4 for natural channel, whose instability is expressed mainly in shifts of anabranches. The immediate cause of bank erosion is the development of bars in the channel, which deflected flood flow toward the erodible and unprotected left bank.

DISCUSSION--The channel at this site had previously been relocated (by moving it laterally to the left) during construction of the Burlington Northern Railroad in the early 1900's. By 1956 (fig. 142A), the relocated channel had reached a maximum width of about 170 m, which is within the range of widths for the natural channel. The river has a natural tendency toward lateral instability, and bank erosion can be expected unless the bank is riprapped. The ability of riprap to resist lateral erosion by the river has been established by the many railroad embankments that have been protected by riprap for decades.

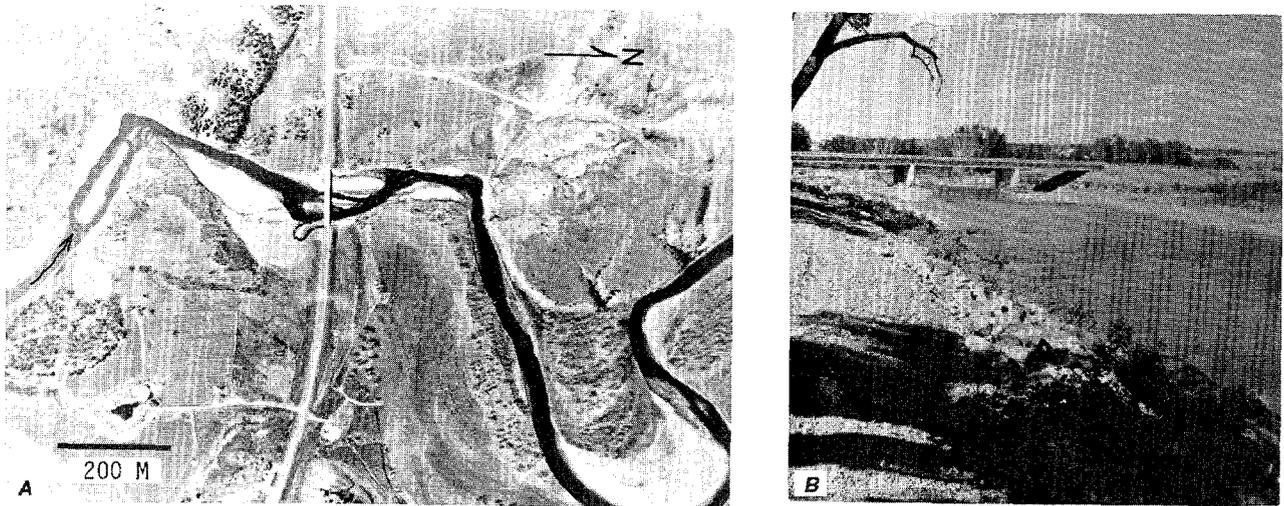
Figure 144. Musselshell River at site 68. A, Airphoto of site in 1976. Spur dike is indicated by heavy line. (From Montana Dept. of Transportation) B, Downstream view along relocated channel in 1979. Riprapped left bank is in foreground.

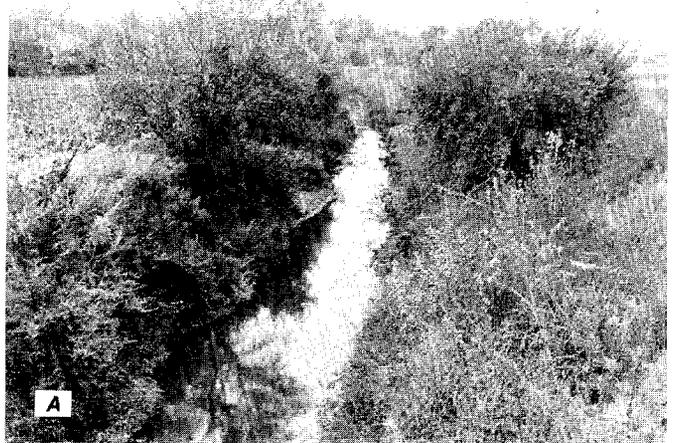
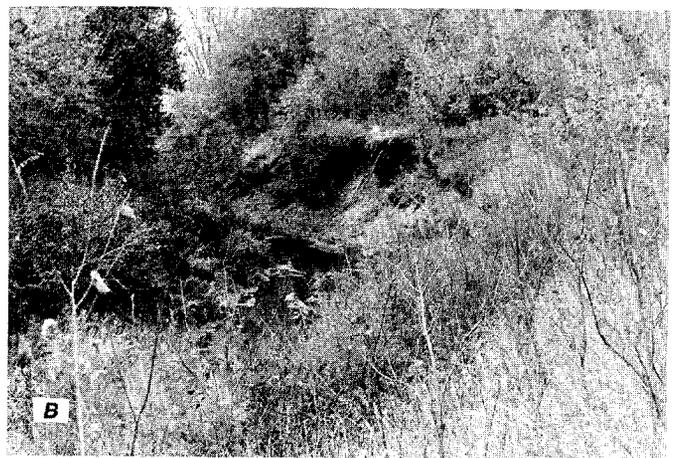
SYNOPSIS--A reach 865 m in length was relocated and thereby shortened to 475 m, for purpose of improving channel alinement at bridge and to accommodate planned interstate location (fig. 145). Performance period, 18 yrs. (1961-79), during which a flood of approximately 10-yr recurrence interval was recorded at gaging stations on nearby creeks. The relocated channel was trapezoidal in cross section, with a bottom width of 6 m, 2:1 side slopes, and a channel slope of about 2.7 m/km. Although no countermeasures are specified on the plans, a small riprap check dam was observed upstream from the bridge on a field visit in 1979, and scattered broken concrete riprap was present along the banks of the relocated channel in the vicinity of the bridge. The banks were moderately stable (fig. 146A) by comparison with banks on other streams of this type in Nebraska, but bank slumping was observed downstream from the bridge and bank erosion, at the downstream junction of natural and artificial channel (fig. 146B). On a 1955 airphoto, cut banks are visible at bends along Camp Creek and at reaches where the stream had been channelized for agricultural purposes. Channel stability had not deteriorated significantly by 1979, except at the channelized reaches, where bank erosion was severe.

Figure 146. Camp Creek at site 69. A, View of relocated channel downstream from I-80 bridge, in 1979. B, Bank erosion at downstream junction of natural and relocated channels, in 1979.

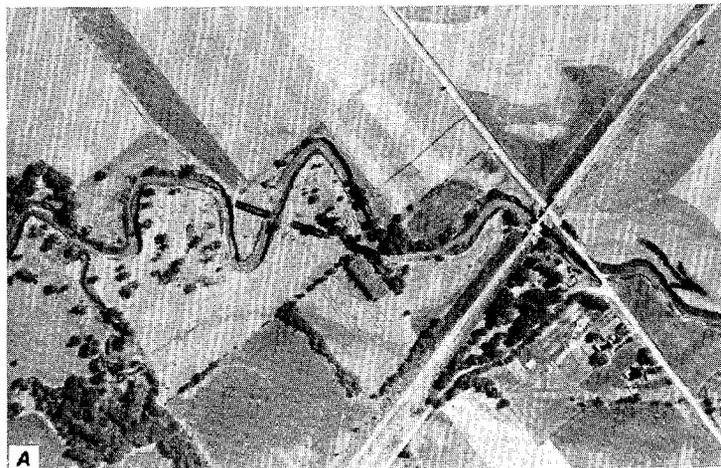
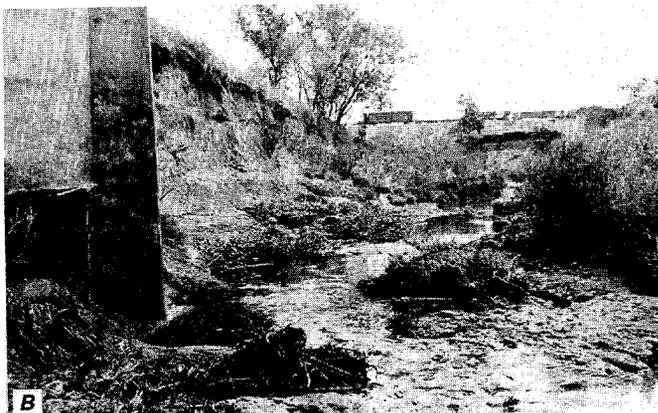
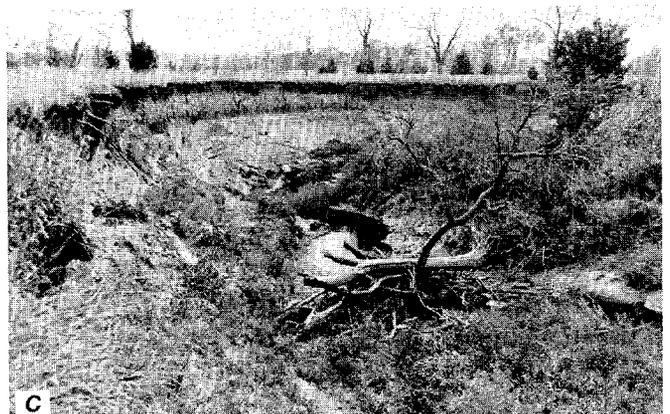
SYNOPSIS--Channel of deeply incised creek was relocated, thereby reducing the length of a channel segment from 510 m to 255 m; for purpose of improving channel alinement at bridge and accommodating planned interstate location (figs. 147A and B). Performance period, 18 yr (1961-79), during which two floods of recurrence interval in the range of 5-10 yr occurred. No countermeasures were apparent from field inspection in 1979. Channel degradation at the bridge had exposed the top of a pier footing (fig. 147B), the bankline at the pier had receded about 6 m, and bank erosion had occurred along the relocated channel downstream from the bridge. At the first bend upstream from the relocation, severe bank recession was in progress at the outside of a bend (fig. 147C). As observed on a 1955 airphoto, the banks along the natural channel were generally steep and unstable, but the relocation has probably contributed to bank erosion in adjacent segments of the channel. Channel degradation had probably already occurred along the channel prior to relocation, as indicated by countermeasures at the railroad bridge downstream.

Figure 147. Middle Creek at site 70. A, Airphoto of site in 1955, position of relocated channel shown in dashed line. (From U.S. Dept. of Agriculture) B, View upstream along relocated channel from beneath bridge, in 1979. Top of exposed pier footing is at left. C, Bank erosion at bend upstream from relocated channel, in 1979. Bank height is 7.5 m.

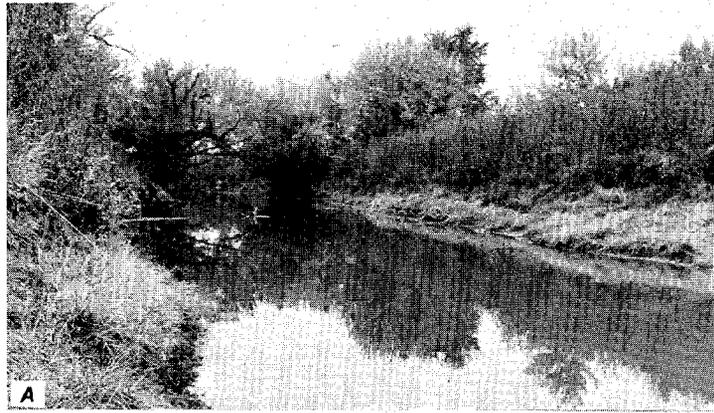
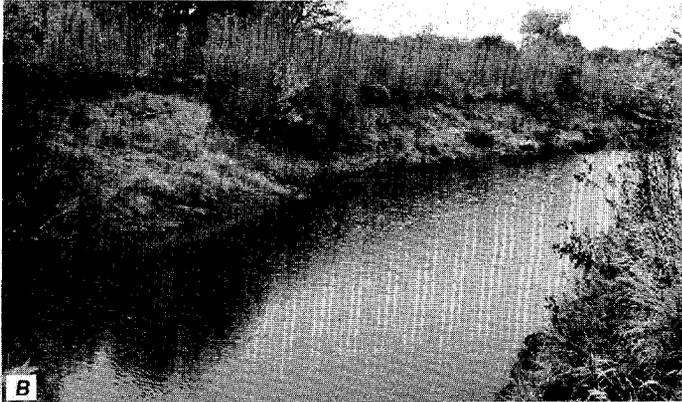
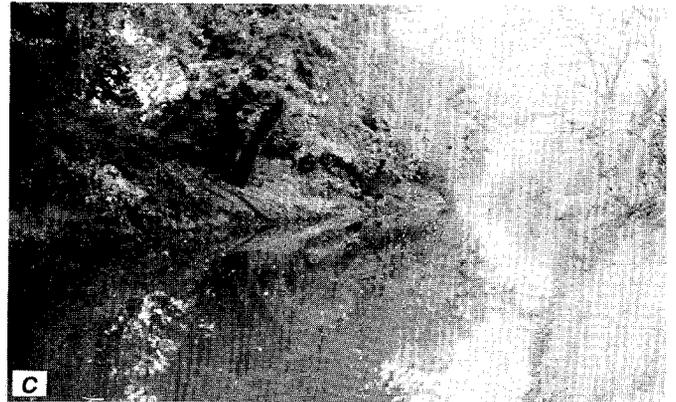
SYNOPSIS--Channel was relocated by cutting off two bends such that the relocated segments were separated by a short segment of natural channel (fig. 148). At the upstream bend, where the relocation was done to improve channel alignment at the interstate bridge, the channel was shortened from a prior length of 820 m to 400 m. At the downstream bend, where the apparent purpose of the relocation was to reduce flooding of a rest area, the channel was shortened from a prior length of 700 m to 250 m. No bank protection measures were applied. Performance period, 16 yr (1963-79) during which floods approaching a 25-yr recurrence interval occurred in 1963 and 1967. Floods of recurrence interval in the range of 5-10 yr have occurred since 1967. No plans showing the dimensions of the relocated channel were obtained, but the bottom width as measured on a 1965 airphoto was 14.5 m, narrowing to 12 m at the upstream end. In 1979, the banks of the relocated channel were generally stable (fig. 149A, except for bank slumping upstream from the interstate bridge (fig. 149B ). Prior stability of the natural channel was good, as observed on a 1955 airphoto, except for cut banks at some bends. However, meander cutoffs that appear to be natural are common along the course of the river. No effect of relocation on the natural channel was discerned (fig. 149C).

Stability class B2 for relocated channel and B1 for adjacent segments of natural channel. Channel stability is tentatively attributed to the establishment of vegetation on the graded banks, which are kept moist by the permanent flow of the stream. In addition, the banks are not high by comparison with those along many smaller streams in the area.

Figure 149. Big Blue River at site 71. A, Downstream junction of relocated channel (foreground) with natural channel, in 1979. B, Bank slumping along relocated channel upstream from bridge, in 1979. C, Natural channel along short segment between relocations, in 1979.

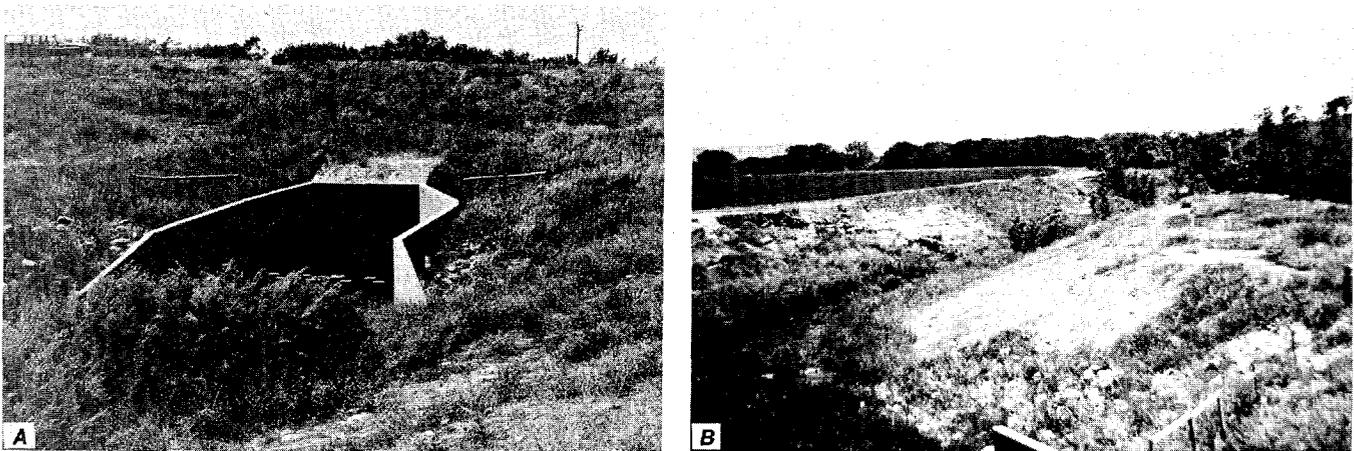
SYNOPSIS--Channel segment of intermittent stream was relocated in 1962 and thereby shortened from a length of 440 m to 370 m, for purpose of improving channel alignment at culvert entrance (fig. 150 ). During rainstorms between 1967 and 1975, bank erosion and channel degradation occurred downstream from the culvert. Riprap revetment was replaced three times. In 1975, the relocated channel was rebuilt to a lower gradient for a distance of 91 m downstream from the bridge, the box culvert was extended, and a drop structure (having a fall of 2.1 m) and a stilling basin were constructed (fig. 151-A). No significant storms have occurred since 1975. In 1979, field observations indicated that the relocated channel upstream from the culvert was stable and well vegetated. Downstream from the culvert, the channel bottom was grassed but the side slopes were mostly bare and the left bank has slumped at one place (fig. 151B). No effect of relocation on the natural channel was discerned.

Figure 151. One Mile Creek at site 72. A, Culvert and stilling basin at downstream side of roadway embankment. B, View downstream from bridge along relocated channel of One Mile Creek, in 1979.

ALTERATION AND POST-ALTERATION FACTORS--The channel as relocated in 1962 was trapezoidal in cross section with 3:1 side slopes and a bottom width of 6.1 m. For a distance of about 12 m downstream from the culvert outlet, the channel was lined with "fieldstone" riprap to a depth of 0.45 m and extending a vertical distance of 1.5 m onto the side slopes. The ends of the riprap blanket were keyed into the channel sides and bottom by a trench filled with riprap. In the 1975 reconstruction, the channel downstream from the added drop structure and stilling basin was protected with loose rock riprap installed over a filter blanket. The drop structure and stilling basin were designed to achieve a 70 percent reduction in outlet energy.

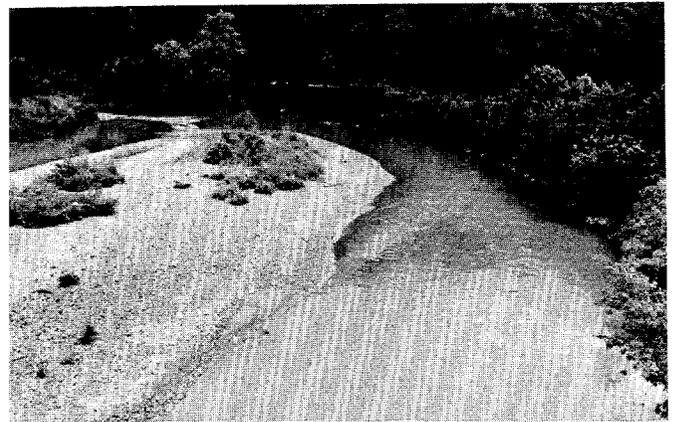
DISCUSSION--The explanation for the much greater sinuosity of the natural channel downstream from this site is not apparent, but the greater sinuosity is associated with a decided deterioration in lateral stability. With regard to the relocated channel, the large blocks of riprap along the left bank at the downstream end have apparently aided in the establishment of young trees along the bankline.

Figure 153. View of relocated channel of Hocking River downstream from US-33 bridge, in 1979.

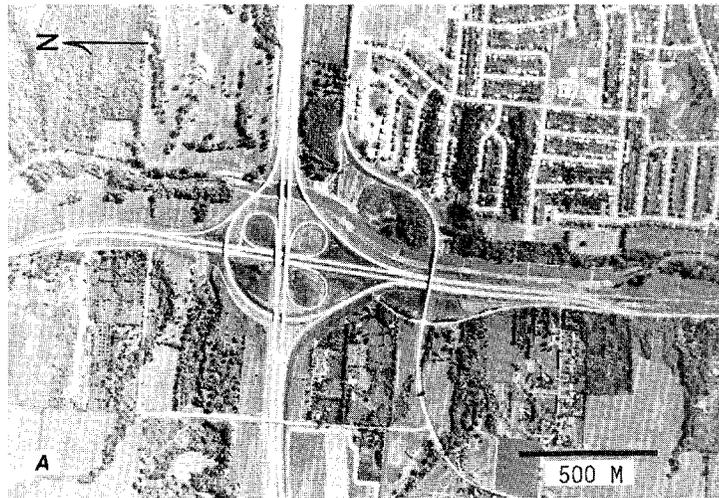
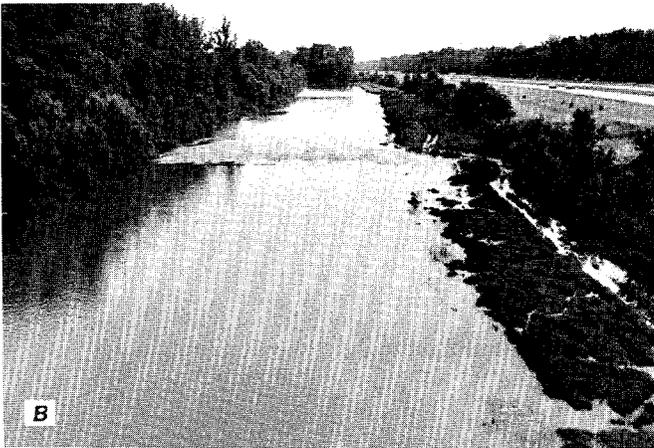
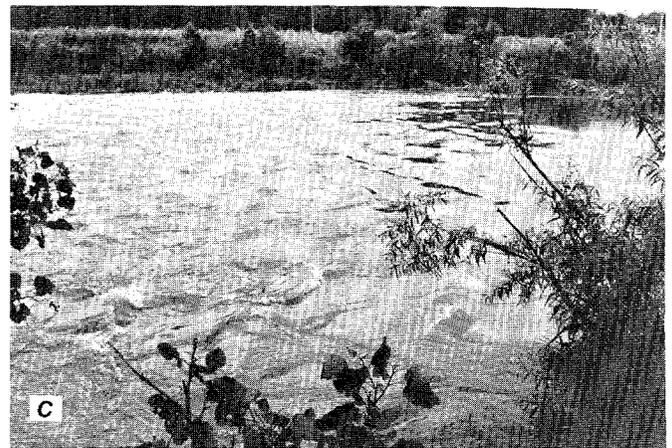
DISCUSSION--The relocated channel will probably prove to be more stable than was the prior channel, which had a sharp bend. The site is in a residential area, and the visual effects of relocation need to be considered. The less attractive appearance of the relocated channel seems mainly a result of the clearing of trees, which are becoming re-established. The riffles, if maintained, will add an element of interest not previously present.

Figure 155. Olentangy River at site 74. A, Airphoto of site in 1971. (From U.S. Dept. of Agriculture) B, View downstream along relocated channel in 1979. Riffle in background is at check dam. C, View of riffle at check dam, in 1979.

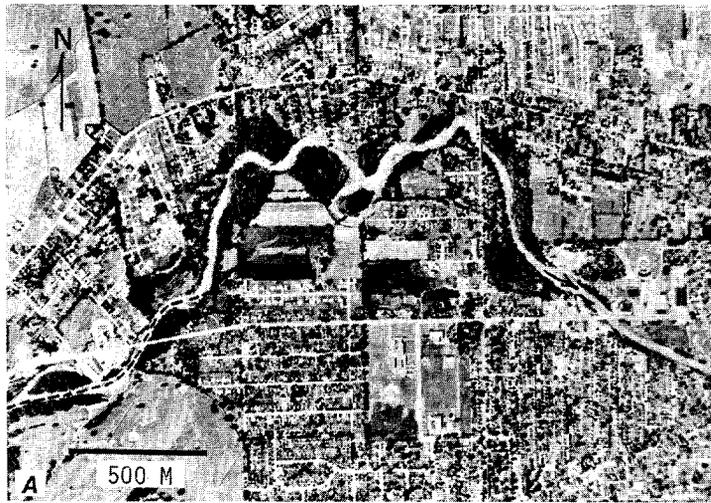
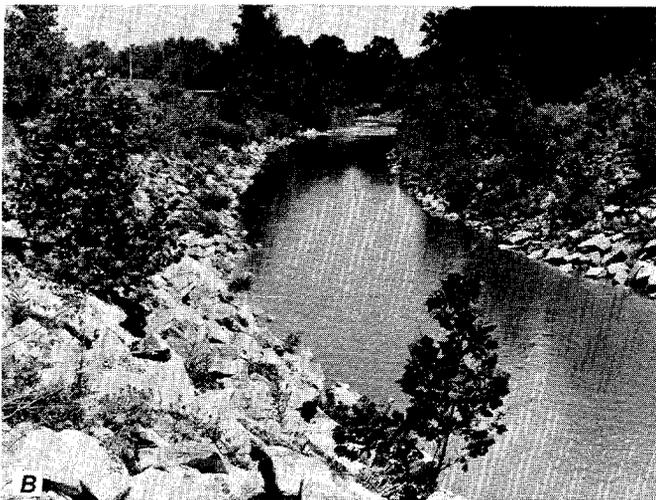
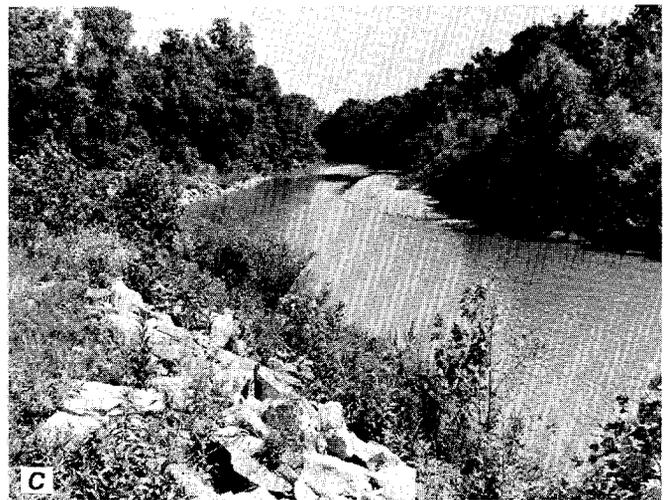
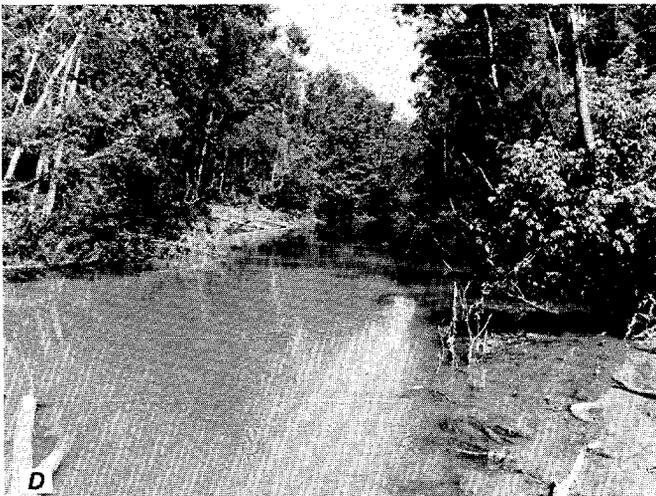
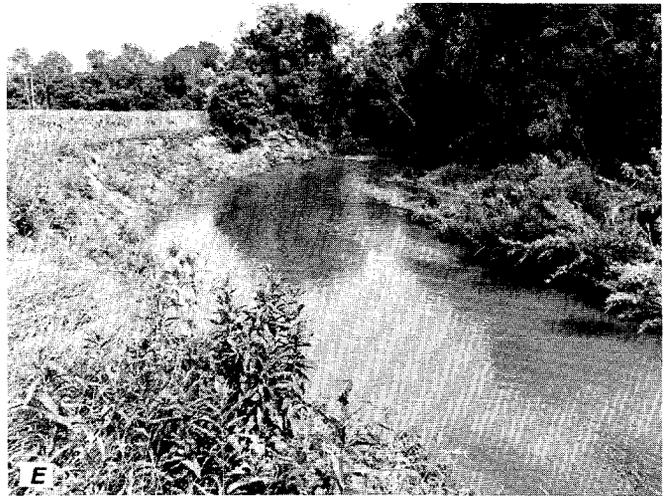
As observed in the field in 1979, the relocated channel was in many places bordered by a dense growth of trees (fig. 157D) and the banks were generally stable except for local erosion where the flow was deflected by mid-channel bars. However, a tendency for re-establishment of the meandering pattern was noted, particularly where the channel was bordered by cultivated fields (fig. 157E).

Figure 157. Raccoon Creek at site 75 and near Granville, Ohio. A, Aerial photograph of site in 1964. Approximate position of relocated channel shown in dashed line. B, Riprapped section of relocated channel, in 1979. C, Downstream junction of relocated channel with natural channel, in 1979. D, Relocated channel of Raccoon Creek near Granville, in 1979. E, Bank erosion at bend in relocated channel of Raccoon Creek near Granville, in 1979.

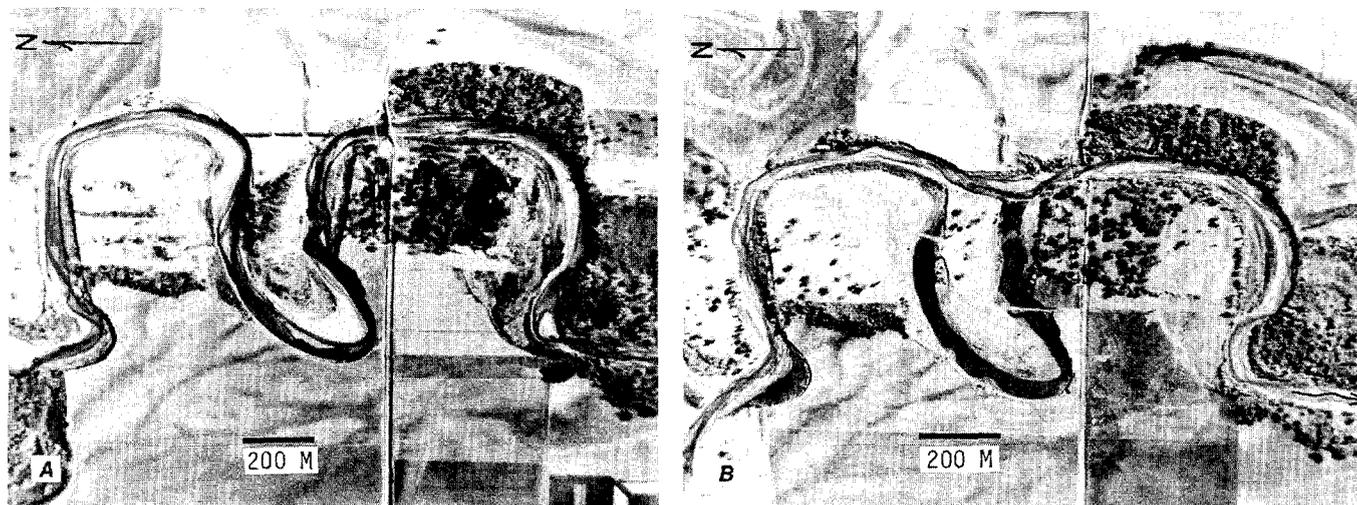
DISCUSSION--Although the relocated channel is given a low stability rating by comparison with very stable channels, its stability is good by comparison with other reaches of the Washita River. If the channel had been alined with the nearly straight adjacent segments of natural channel (fig. 158A), its stability would probably have been improved.

Figure 158. Washita River at site 76. A, Airphoto of site in 1969. Position of relocated channel is shown in dashed line. (From U.S. Dept. of Agriculture) B, Airphoto of site in 1978. (From U.S. Dept. of Agriculture)

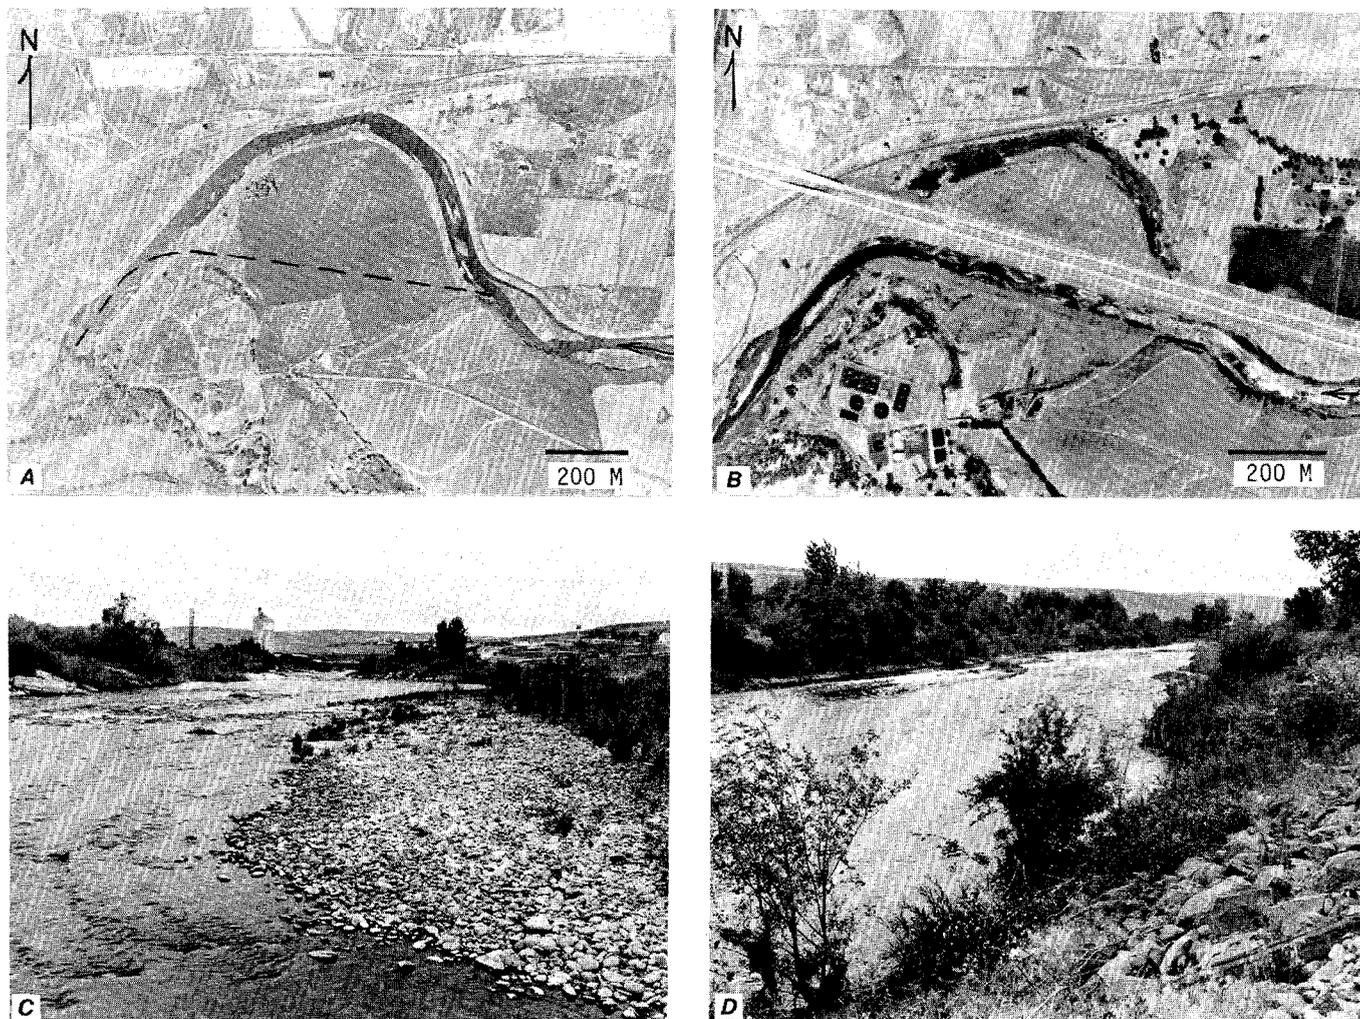
SYNOPSIS--Channel relocation, reach 1,300 m in length straightened to avoid two crossings by I-80N and thereby shortened to 975 m (fig. 159A and B). Performance period 11 yr, 1969-79. The relocated channel has been tested by a 9-yr flood in 1970, a 6-yr flood in 1972, and a 15-yr flood in 1975. The banks of the relocated channel were graded to a 4:1 slope and revetted with rock riprap. In addition, 11 spurs of heavy rock riprap were placed alternately on the left and right banks, apparently for bank protection and to induce sinuosity, thereby avoiding a canal-like aspect. By 1973, gravel bars had been deposited downstream from spurs, small-scale sinuosity (as well as a sequence of pools and riffles) had formed, and vegetation had begun to grow in the riprapped banks (fig. 159B). By 1979, vegetation was well established (fig. 159C), as were the pools and riffles. Sinuosity appeared to be somewhat diminished because the tips of

spurs had been eroded. No bank erosion was noted. Minor bank erosion along the natural channel downstream was noted (fig. 159D); this may, or may not, be related to the relocation.

Figure 159. Umatilla River at site 77. A, Airphoto in 1962, prior to relocation. Position of relocated channel shown by dashed lines. B, Airphoto of site in 1973. (From Oregon Dept. of Transportation) C, Downstream view along relocated channel in 1979, showing deposition of gravel bars, and sinuosity induced by spurs. D, Natural channel just downstream from relocated reach.

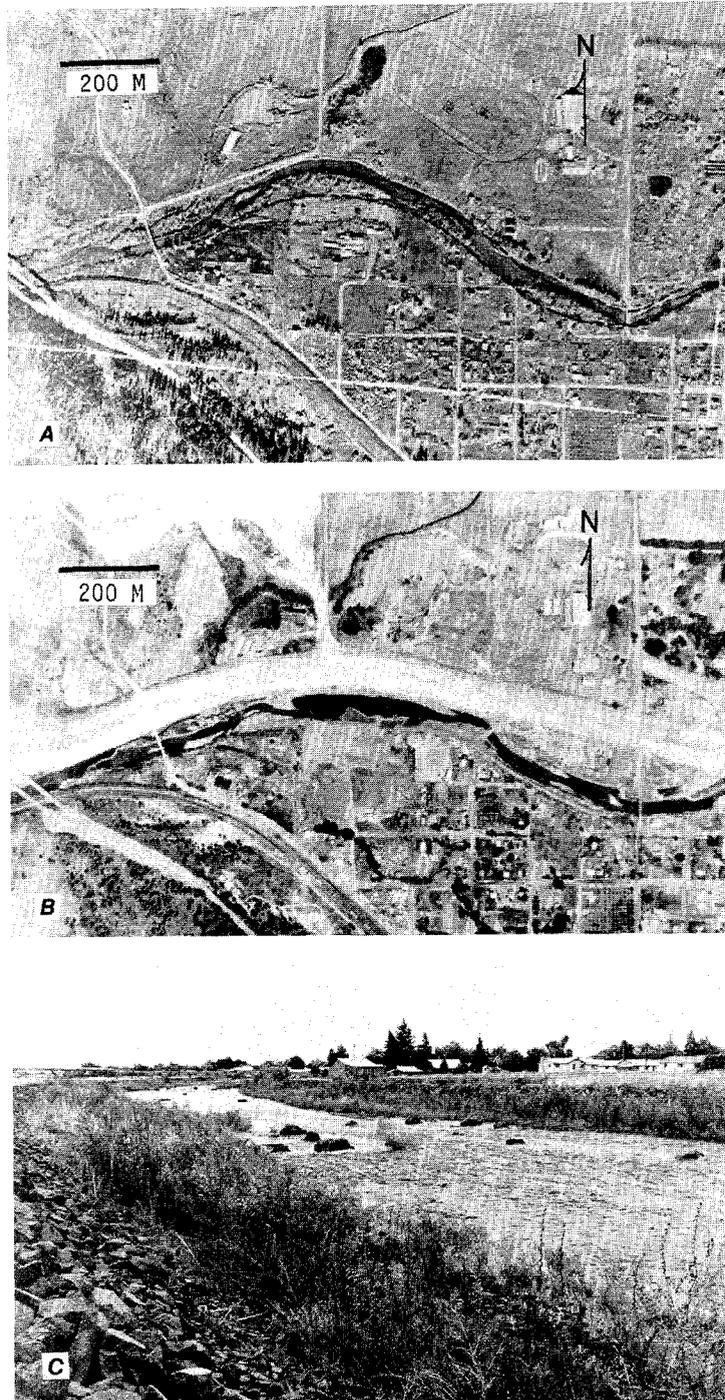
ALTERATION FACTORS--The relocated channel was designed to have a top width of 55 m, a bottom width of 46 m, 2:1 side slopes, and a depth of 2.5 m. The cross section was trapezoidal, except that the bottom sloped gently at 20:1 toward the channel centerline. Boulders were placed in the channel bottom to enhance the fish habitat. Longitudinal slope of the channel bottom was so constructed that sections of 1 m/km slope alternated with flat sections, at 90 m intervals; this feature was evidently intended to provide alternating rapids and pools, which were apparent at normal stage in 1979 (fig. 160C).

Figure 160. Grande Ronde River at site 78. A, Airphoto in 1963, prior to relocation. Position of relocated channel shown in dotted line. (From Oregon Dept. of Transportation) B, Airphoto of channel relocation under construction, in 1971. (From U.S. Dept. of Agriculture) C, View downstream near center of relocated reach, in 1979. Boulders have been placed in channel for fish habitat.

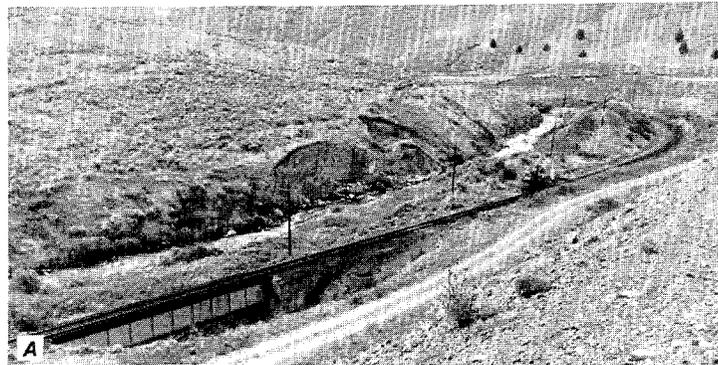
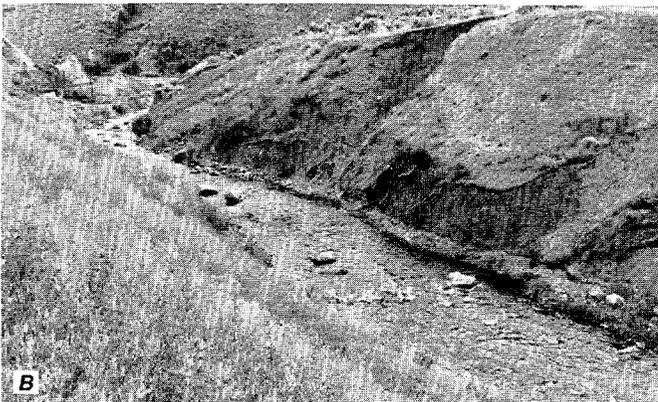
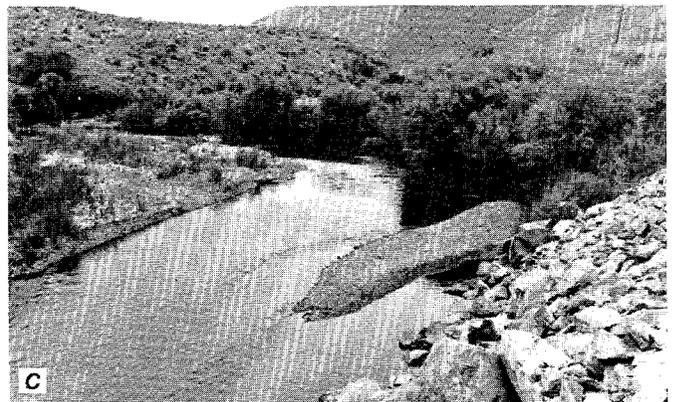
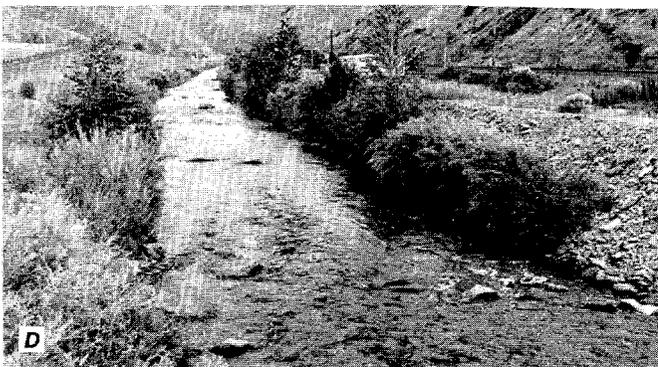
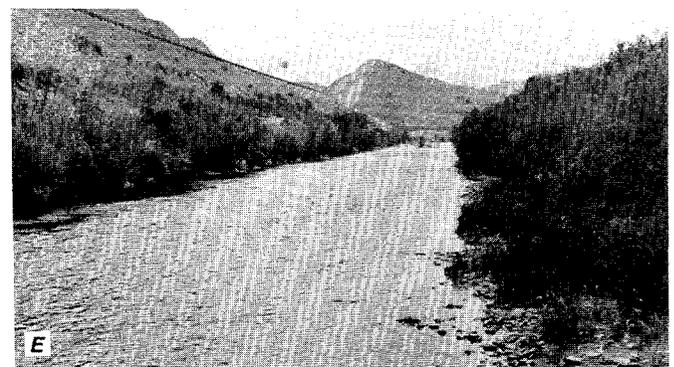
POST-ALTERATION FACTORS--In addition to the mass movement along the cut, the banks of the relocated channel have been eroded laterally (fig. 162B); but the channel has not widened significantly. Only annual vegetation (sweet clover) has been established along the bank-line.

DISCUSSION--Further movement of the slump blocks along the right side of the relocated channel is highly probable, and the largest block (fig. 162B) presents a particular hazard. This block may move gradually into the channel at a rate no faster than the toe can be removed by stream erosion, or it may move quickly and fill the entire channel.

Figure 162. Burnt River at site 79 and vicinity. A, Upstream view showing full length of relocated channel at site. Note large scale slumping along cut. B, View downstream along relocated channel at site, in 1979. At right is a large slump block which extends the full height of the cut. C, View upstream along natural channel at end of relocation. Riprap retard is in right foreground. D, Relocated channel, Burnt River at Weatherby interchange. E, Relocated channel, Burnt River just downstream from Lime.

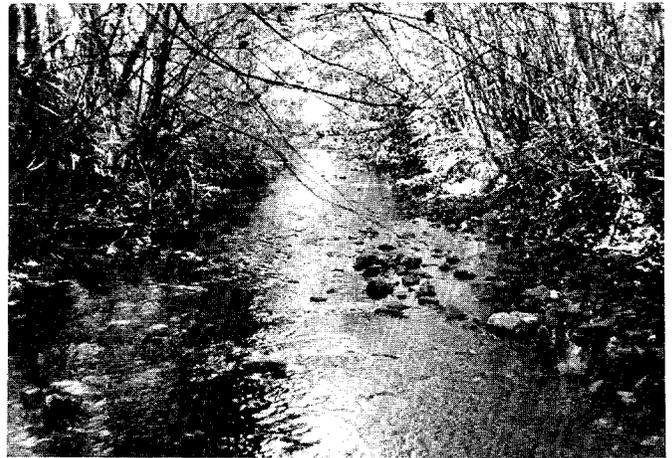
Figure 164. Typical aspect of relocated channel, Wolf Creek, in 1979.

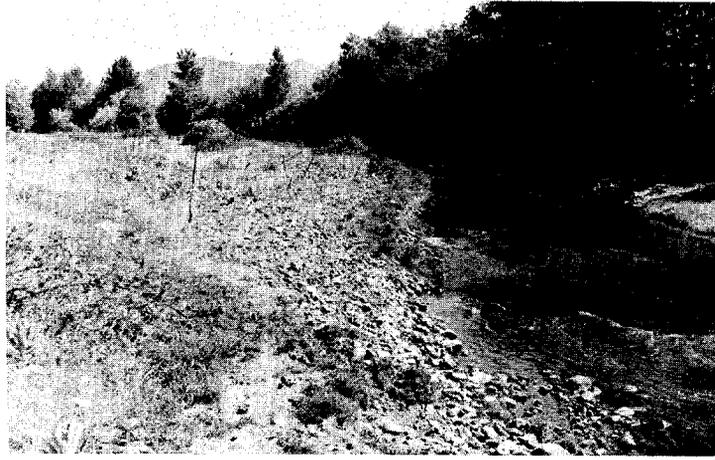
Figure 166. Low-water channel established by Bear Creek, as viewed upstream in 1979.

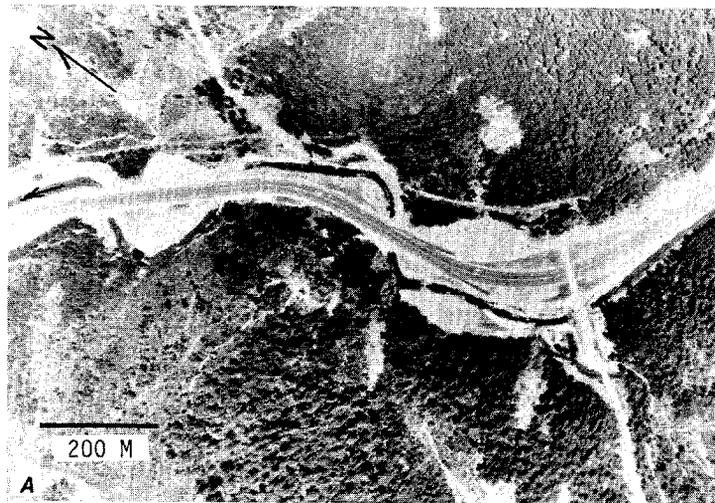
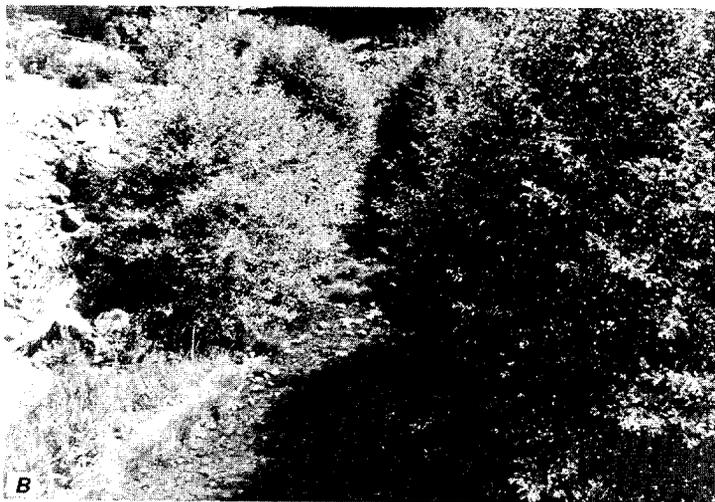
Figure 167. Canyon Creek at site 82. A, Airphoto of site in 1976. The highway overpass is at West Fork Canyon Creek, 4 km south of Canyonville. (From Oregon Dept. of Transportation) B, View downstream from culvert at I-5.

SYNOPSIS--This small stream in a narrow mountain valley was relocated, or encroached upon, for a distance of about 16 km (most of its length) for construction of I-5. The site examined in the field, which has a length of about 1 km, is considered to be representative. Because the channel had already been altered during construction of the prior road (US-99), no comparisons can be made with the natural channel. It is evident, from the narrowness of the valley and the preservation of many bends, that relocation has not involved a significant amount of shortening (fig. 167A). Performance period is 13 yr (1967-79). Canyon Creek is ungaged, but the nearby gage on Cow Creek recorded in 1974 the maximum flood in a 45 yr period of record. The relocated channel was lined with riprap, and the interstate crossings were by concrete culvert. By 1979, the bottom of the relocated channel was continuously bordered by alder trees (fig. 167B), and no erosion was evident.

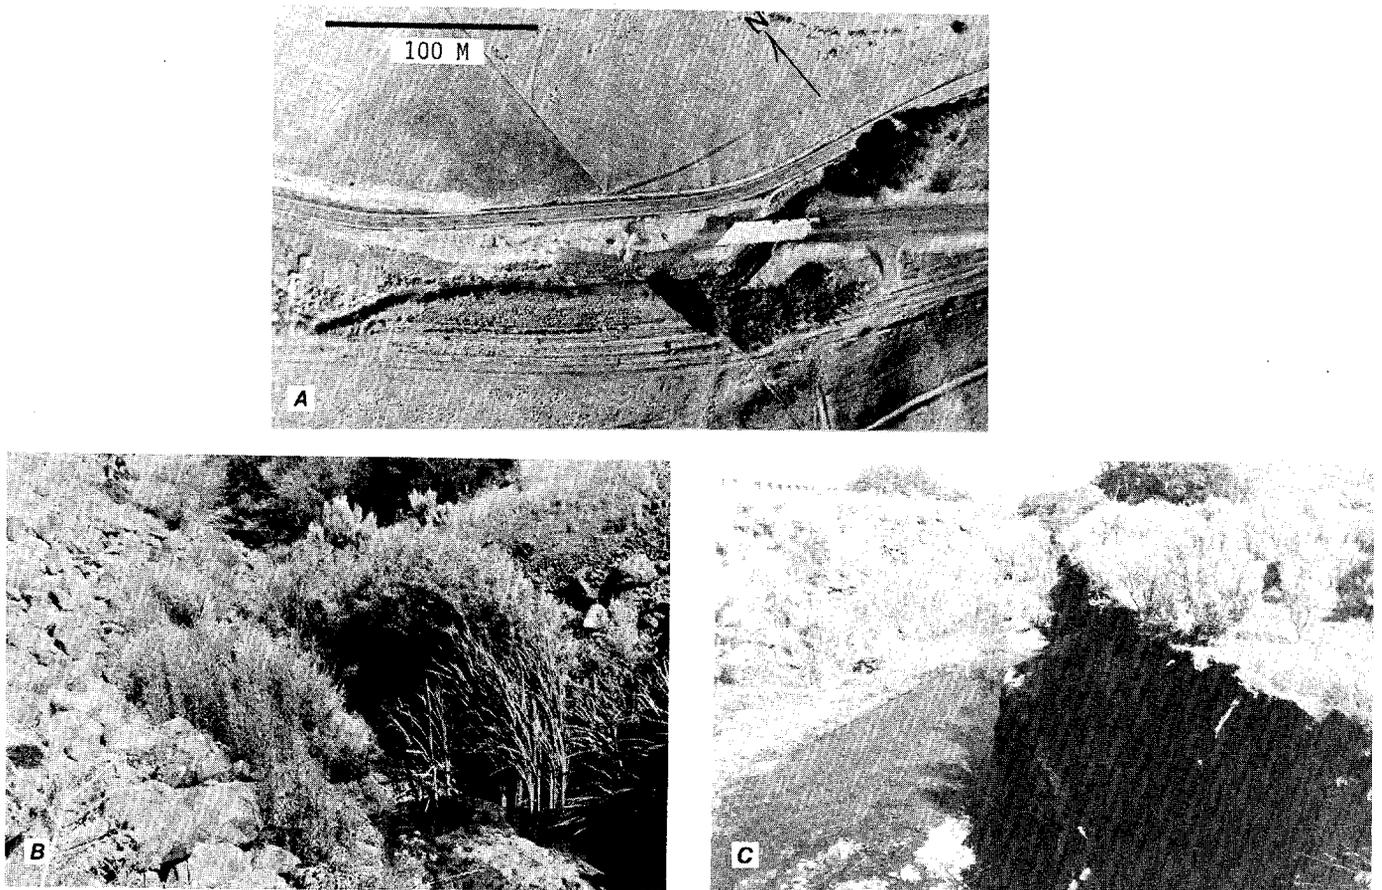
DISCUSSION--Inasmuch as the slope of the channel was not increased by relocation, and the width was increased, this relocation would probably have not contributed to bank erosion if gabion check dams had not been set against erodible materials in the right bank. The function of the gabions as fish habitat structures is unclear, in view of the shallow and intermittent nature of the stream.

Figure 169. Spanish Hollow Creek at site 83. A, Airphoto of channel relocation under construction, in 1973. (From Oregon Dept. of Transportation) B, Relocated channel upstream from US-97 bridge, in 1979. C, Bank erosion downstream from relocated channel, in 1979.

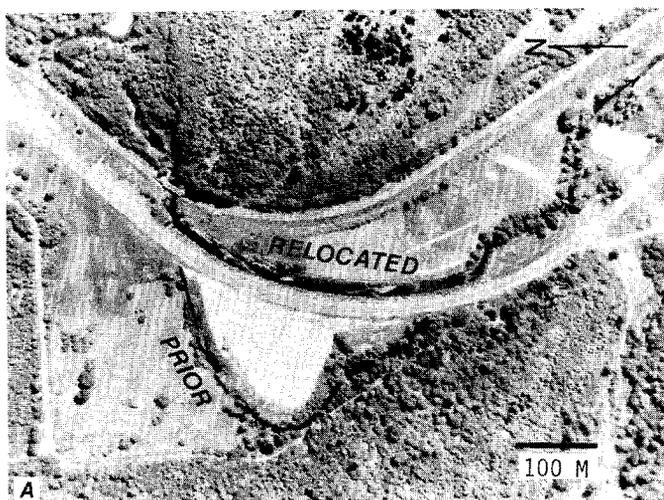
POST-ALTERATION FACTORS--As observed on a 1968 airphoto, an almost continuous strip of vegetation had become established along both banks of the relocated channel, about five years after relocation. By 1979, vegetation was becoming established on a bar along the right bank, and this bar will probably eventually induce sinuosity.

Figure 170. Wildcat Creek at site 84. A, Airphoto of site in 1968. (From U.S. Dept. of Agriculture) B, relocated channel as viewed from right bank in 1979.

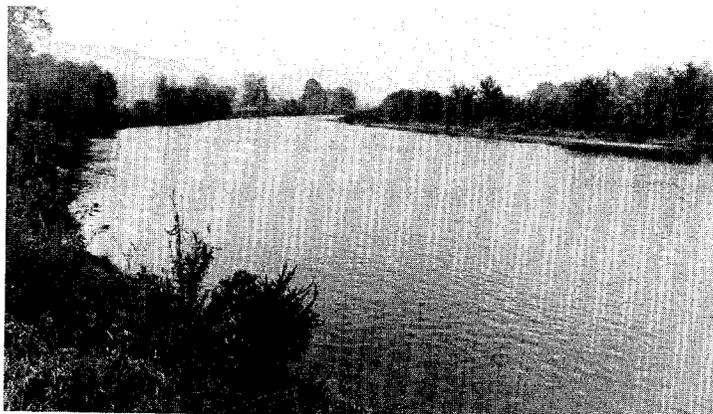
located channel. Minor bank slumping was observed along the concave bank of the relocation in 1979, and tree growth, though locally dense, was not continuous (fig. 174). Adjacent reaches of the natural channel were generally stable prior to relocation, and no effects of relocation on bank stability were observed.

Figure 174. Upstream view at bend in relocated channel, Bald Eagle Creek.

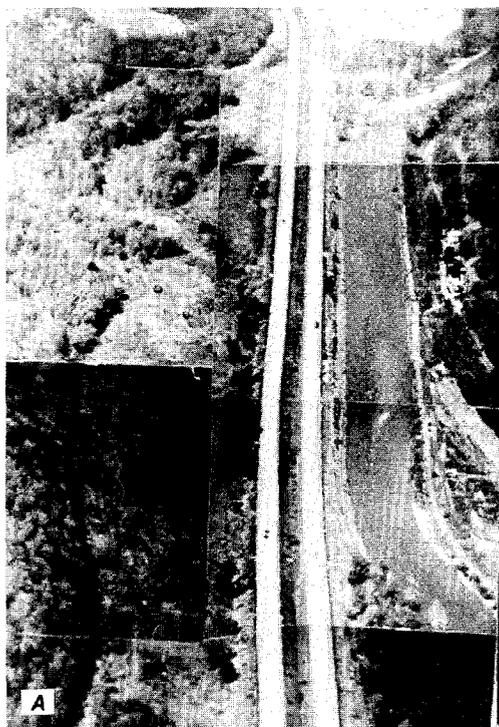
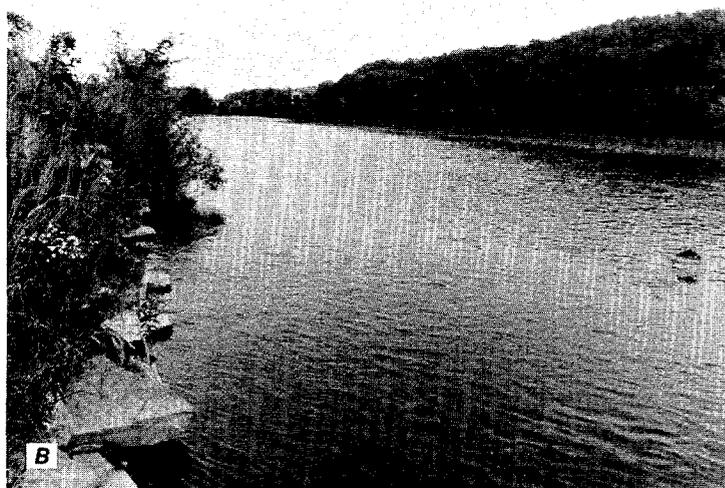
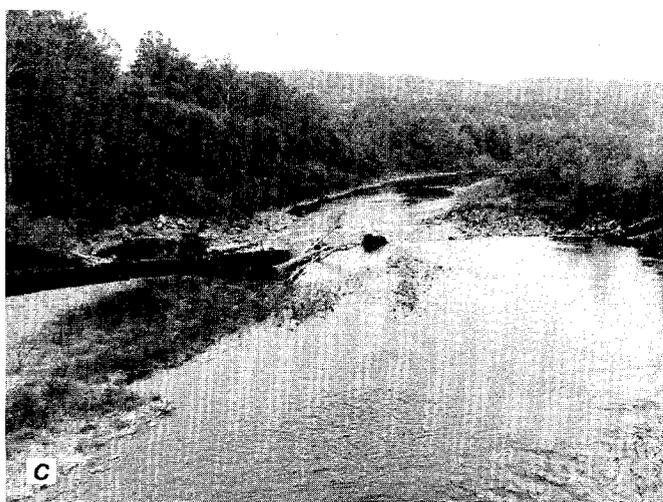
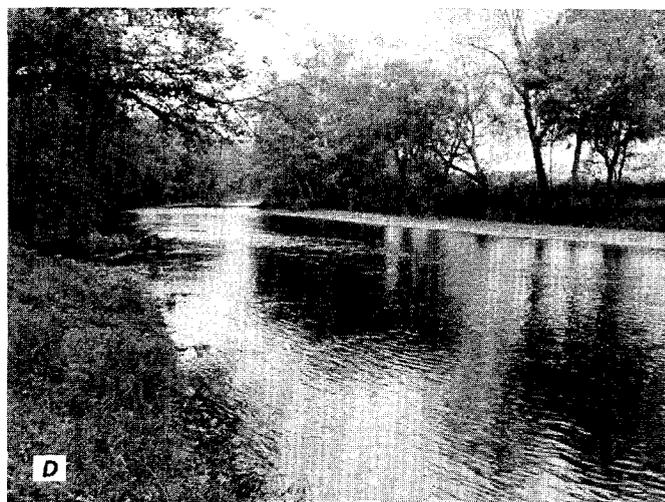
POST-ALTERATION FACTORS--The effect of two very large floods was to obliterate the low-water channel, but the flood channel was not widened significantly. By 1979, young trees were growing along the riprapped bankline (fig. 176B), but the tree cover was not continuous.

DISCUSSION--Although the flood channel is significantly wider than the natural stream channel, by a factor of 1.4, it has so far been mostly occupied by the stream at normal stage. On the 1974 airphoto, there is some indication that the thalweg had shifted toward the right bank downstream from the bend (foreground of fig. 176A). The thalweg is likely to meander broadly within the flood channel, but a bank erosion problem is unlikely because of the revetment.

Figure 176. Fishing Creek at site 87. A, Oblique airphoto, looking downstream, of relocated channel in 1974. (From Pennsylvania Dept. of Transportation) B, View upstream along relocated channel, in 1978; riprapped south bank in foreground. C, View toward upstream end of relocated channel, in 1978. Sheet-pile check dam, in foreground, is upstream from relocation. D, Natural channel downstream from relocation, in 1978.
