Report No. FHWA/RD-80/158

# STABILITY OF RELOCATED STREAM CHANNELS

March 1981  
Final Report

1. Report No. FHWA/RD-80/158		2. Government Accession No.		3. Recipient's Catalog No.	
4. Title and Subtitle  Stability of Relocated Stream Channels				5. Report Date March 1981

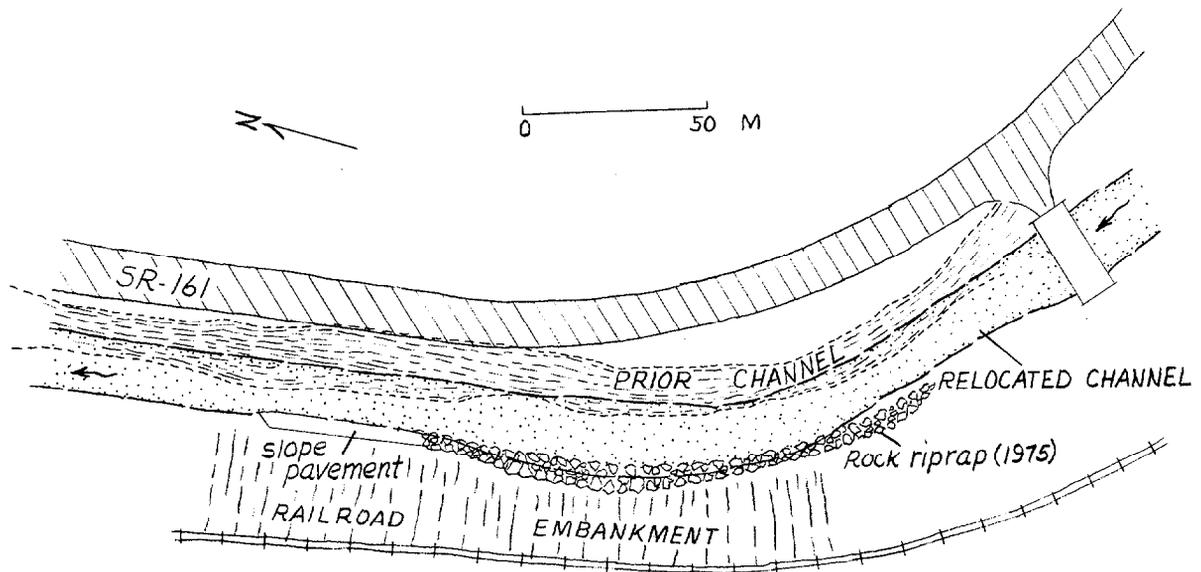
Figure 177. Plan sketch of channel relocation, Shamokin Creek.

DISCUSSION--The bank erosion was not particularly severe in view of the magnitude of the flood, and probably would not have been considered a problem if the railroad embankment had not been jeopardized.

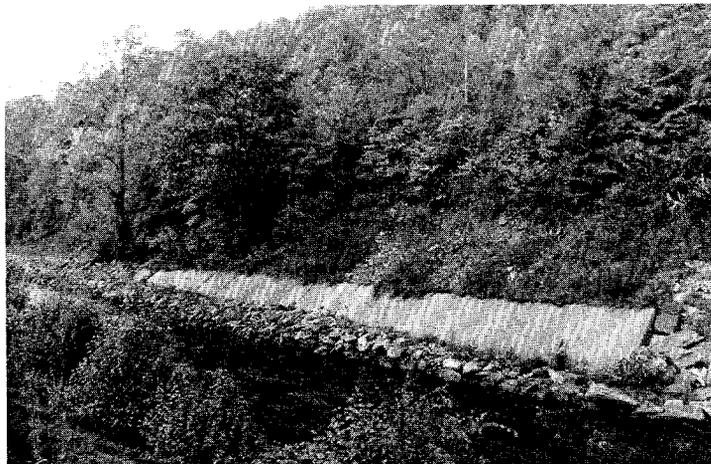
Figure 178. View upstream along Shamokin Creek, showing bank slumping above remaining concrete slope pavement, and rock riprap installed in 1972.

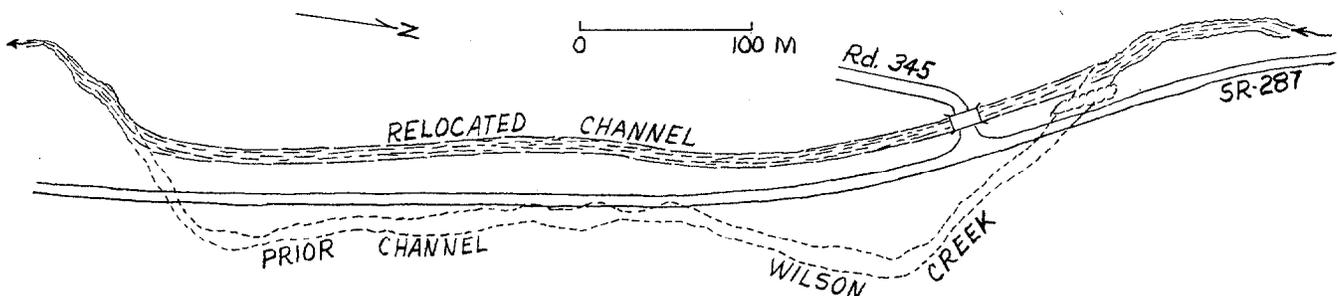
Figure 179. Plan sketch of Wilson Creek channel relocation.

SYNOPSIS--Reach 670 m in length relocated and shortened to 595 m, to avoid two stream crossings (fig. 179). Performance period 6 yr (1973-79). The channel was subjected to a major flood during construction in 1972, to another on September 26, 1975, and to subsequent smaller floods. The channel was designed to have a bottom width of 9 m, and the banks were protected locally by four short spurs of rock riprap and by discontinuous segments of riprap channel lining. "Fish boulders" were placed on the channel bed. The channel began to degrade and to widen soon after construction. The maximum amount of channel widening between July, 1974, and September, 1975, was 2.1 m. Some changes in the channel since construction are shown in figure 180. Dumped rock riprap was placed along the eroding left bank in 1976 or 1977, but the right bank was eroding in 1979.

DISCUSSION--The slope of the natural channel was in the range of 17-20 m/km but was not uniform, probably because of bedrock outcrops from place to place. The bedrock consists of almost horizontal beds of sandstone, shale, and conglomerate, susceptible to erosion because of well-defined joints and thin bedding. Instability of the relocated channel is not attributed to the increase in slope relative to that of the natural channel, which was slight. The major floods that occurred during and soon after construction steepened the weakly coherent banks and probably formed scarps in the channel bottom, thus initiating progressive bank erosion and degradation. The bed of the natural channel was well armored with boulders and the low banks were well vegetated, as shown in ground photographs taken prior to relocation (fig. 180E).

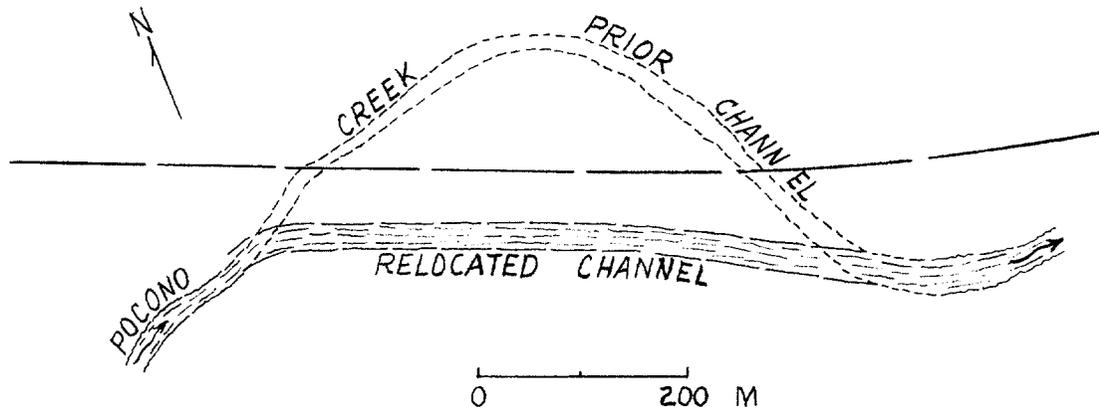
Figure 181. Plan sketch of Pocono Creek channel relocation.

SYNOPSIS--Channel relocation, reach 810 m in length straightened and shortened to 670 m in order to avoid two stream crossings (fig. 181). Performance period, 16 yr (1962-78). Relocated channel was subjected to a major flood in 1969. Although the channel bottom along much of the relocation is on bedrock, erosion occurred in unconsolidated material at the right bank, which is along the roadway embankment. Dumped rock riprap, which had been placed to a thickness of 3 m on the bank, was removed by erosion, apparently because it was not keyed into the streambed. In 1977, rock-filled gabions were installed to replace the riprap (fig. 182A). Downstream from the relocation, the natural channel is stable (fig. 182B).

Stability class A2 for relocated channel, A1 for downstream segment of natural channel. The critical factor in the localized bank erosion and failure of the riprap was apparently the height and steepness of the embankment, which probably slumped when undercut at the toe.

DISCUSSION--Although the relocated channel is 670 m in length, bank erosion occurred only at one bend, for a length of about 50 m, where there is no bend in the channel. This suggests that the toe of the riprapped bank was undercut, and that failure occurred by mass movement. The size of the failed riprap is not specified in the plans, but remnants of half-ton (500 kg) size are in the channel.

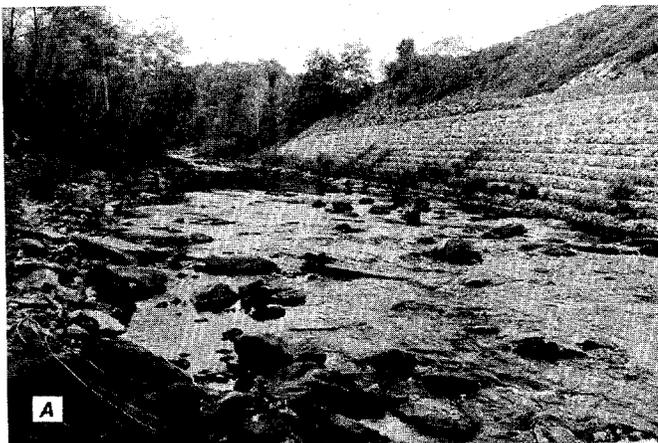
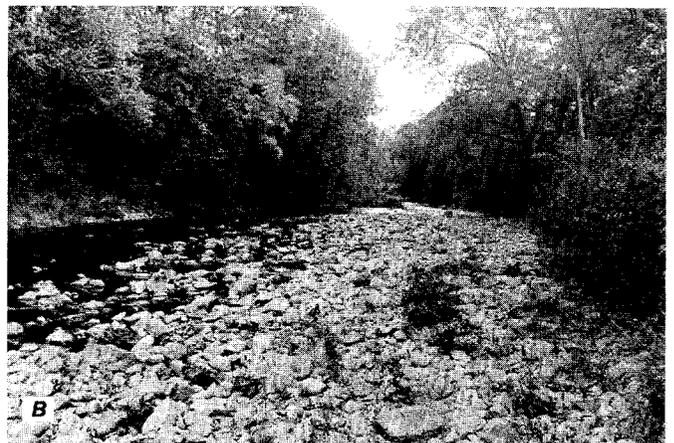
Figure 182. Pocono Creek at site 90. A, View upstream toward gabions on left bank, in 1978. B, View of natural channel downstream from relocation, in 1978.

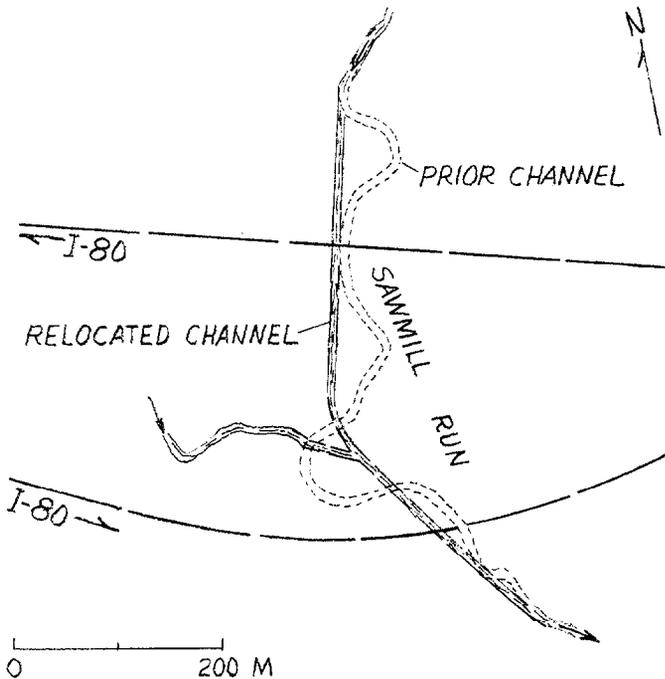
Figure 183. Plan sketch of Sawmill Run channel relocation.

DISCUSSION--Except for minor accumulation upstream from the tributary entrance in the median (figs. 183 and 184A), the concrete-lined channel contains little bed material. Its width, about 4 m, is somewhat narrower than the bottom width of the natural channel, and water velocities consequent upon its width and slope (about 50 m/km) have proved sufficient to transport coarse bed material without aggradation.

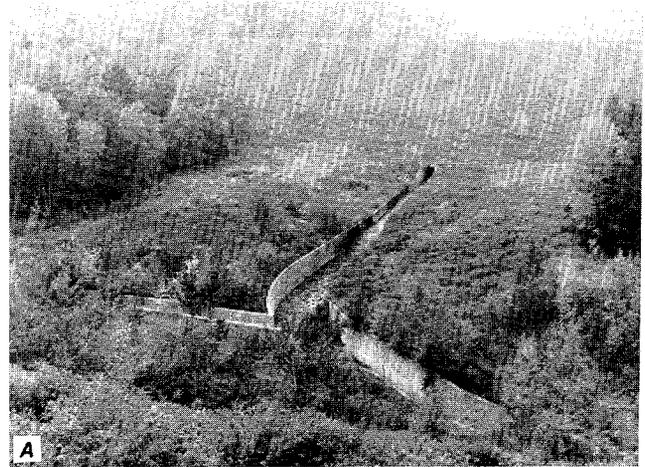
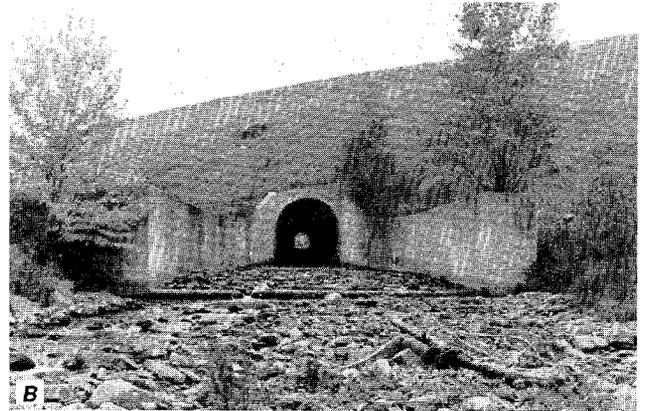
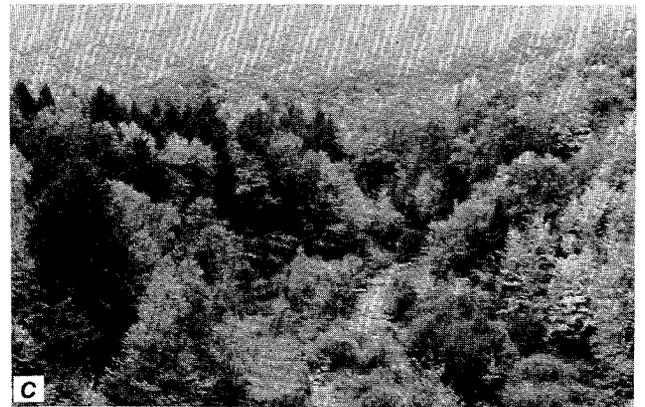
Figure 184. Sawmill Run at site 91. A, Upstream view of concrete-lined channel in highway median area, in 1978. B, Upstream view of culvert, near end of relocation. C, Natural channel downstream from relocation.

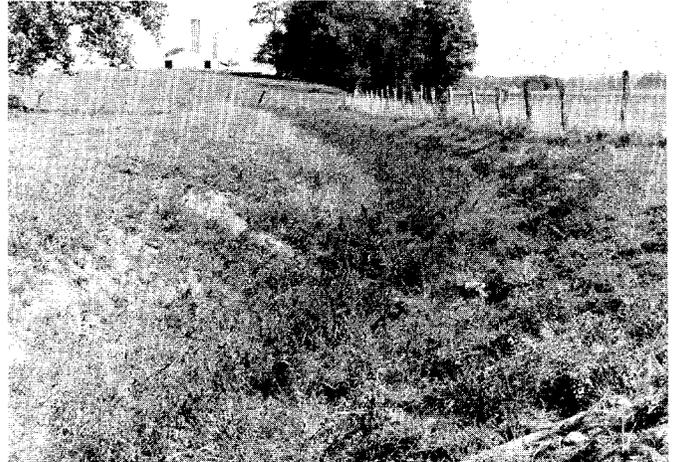
SYNOPSIS--Reach 245 m in length relocated, with no change in length, for purpose of channel alignment at interstate crossing (fig. 185 ). Performance period, 15 yr.(1963-78). The stream is ungaged, but a major flood affected streams of this region in 1972. The relocated channel was trapezoidal in cross section with a bottom width of 6.7 m at the bridge; bottom width elsewhere is not specified in the available plans, but field study in 1978 indicates that it tapered to 2.3m upstream and downstream from the bridge. No countermeasures were used except for a short length of riprapped bank at the upstream junction with the backfilled prior channel. In 1978, the relocated channel was grassed (fig. 186 ), the banks were generally stable, and only minor previous erosion of bed or banks was evident.

Figure 186. View upstream along relocated channel of Mountain Run.

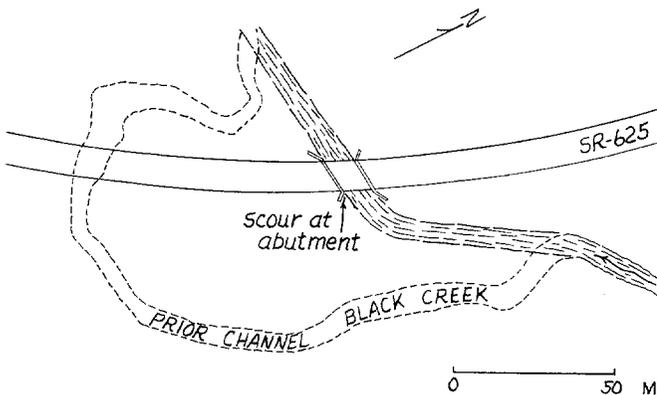
Figure 187. Plan sketch of Black Creek channel relocation.

SYNOPSIS--Channel relocation, reach 302 m in length straightened and shortened to 140 m, apparently to prevent migration of meander against roadway. Performance period, 47 yr (1931-78). Black Creek is unged; but at the nearby gage on Conestoga Creek the largest flood of record occurred in 1972, and the second largest, in January of 1978. Scour at the upstream footing of the left bridge abutment (figs. 187 and 188A) caused subsidence and consequent closure of the bridge in January of 1978. This scour is mainly localized at the outside of the curve in the relocated channel, although some degradation has occurred. Upstream progression of the degradation has evidently been halted by large boulders in the channel just upstream from the bridge.

Stability class B2 for relocated channel. Although the bridge failed because of large floods, placement at a bend, and spread footings, the performance and stability of the relocated channel is not bad. Lateral erosion has been held in check by resistant bank materials, consisting of gravel and boulders in a coherent silt-clay matrix; and degradation, by large boulders and possibly by a concealed bedrock outcrop in the channel.

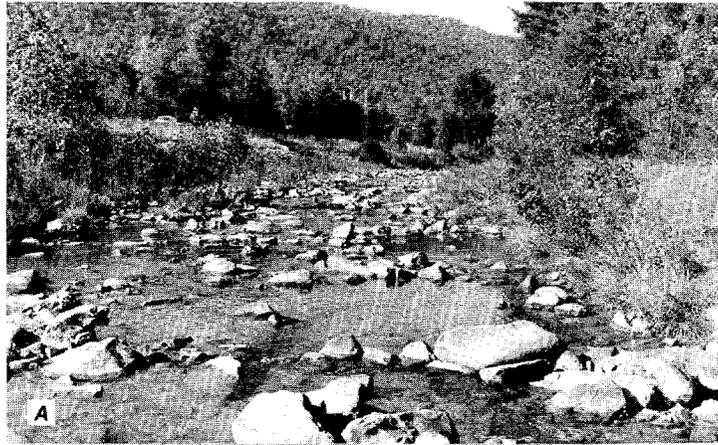
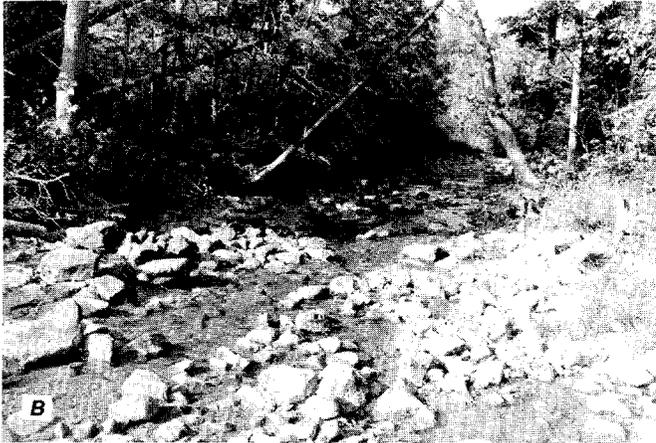
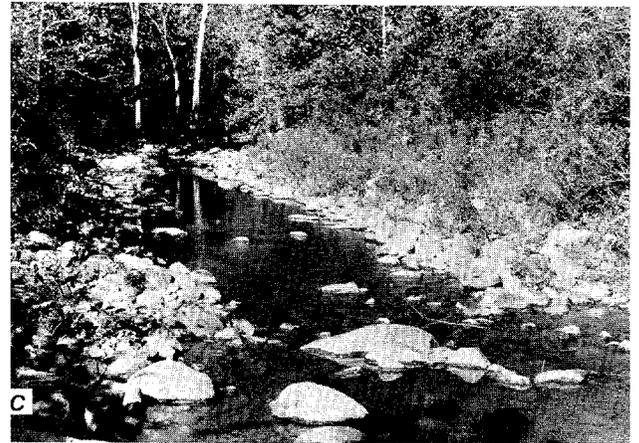
DISCUSSION--Shade Creek is generally similar in form and setting to Wilson Creek (site 89), and the length and degree of shortening by relocation is also similar; yet it has remained stable and Wilson Creek has not. The bottom of Shade Creek has a rather continuous armor of boulders; but the bottom of Wilson Creek is less well armored and its banks are less bouldery and more erodible. No other factors are apparent to account for the differences in stability.

Figure 190. Shade Creek at site 94. A, Downstream view of relocated channel, in 1978. B, Downstream junction of relocated channel with natural channel, in 1978. C, Natural channel downstream from relocation, in 1978.

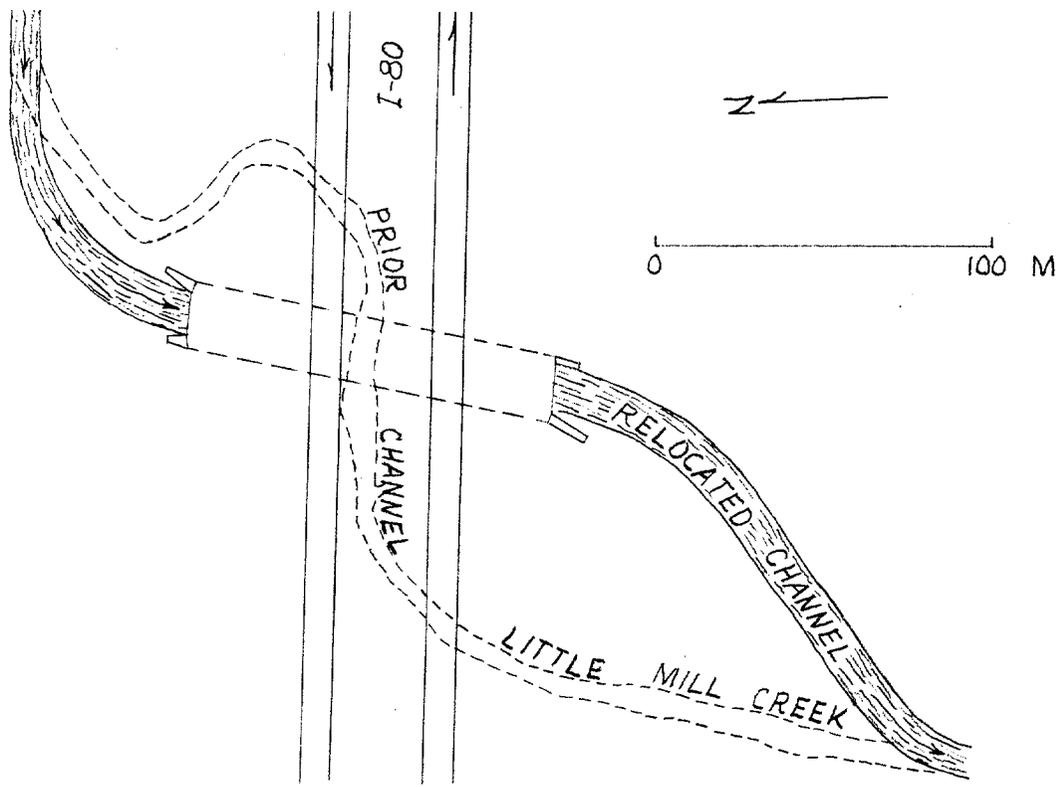
Figure 191. Plan sketch of channel relocation, Little Mill Creek.

SYNOPSIS--Channel relocation, reach 450 m in length shortened and straightened to a length of 400 m, to accommodate roadway alignment and to improve entrance angle of flow at culvert (fig. 191). Performance period, 15 yrs (1963-78). Relocated channel has been subjected to a very large flood in 1972 and a lesser flood in 1977. The relocated channel was built to a trapezoidal cross section, with a bottom width of 7.5-12 m, 1.5:1 side slopes, and a longitudinal slope of about 8 m/km. No bank protection measures were installed. In 1978, the relocated channel was stable except for an unvegetated high bank (fig. 192A) just upstream from the crossing; this bank was probably eroded during past floods, but erosion did not appear to be progressing at the time of inspection. Downstream from the relocation, one cut bank was observed (fig. 192B). Stability class B2 for relocated channel and adjacent

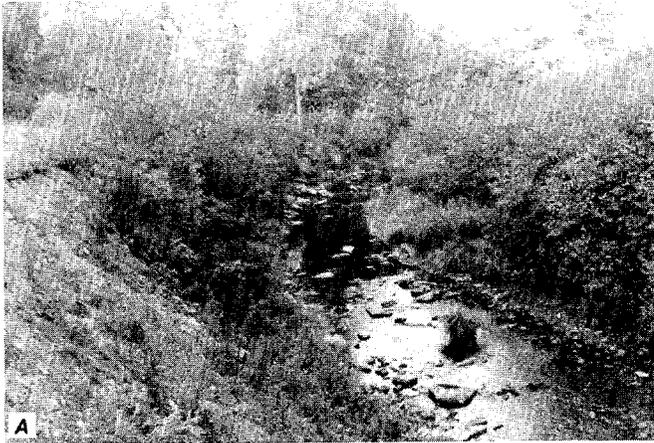
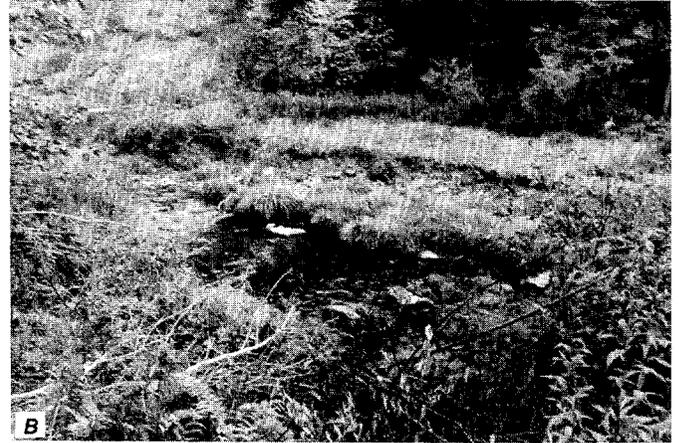
Figure 192. Little Mill Creek at site 95. A, Unvegetated bank at curve in relocated channel, upstream from I-80 crossing of Little Mill Creek, in 1978. B, Natural channel about 100 m downstream from crossing, in 1978.

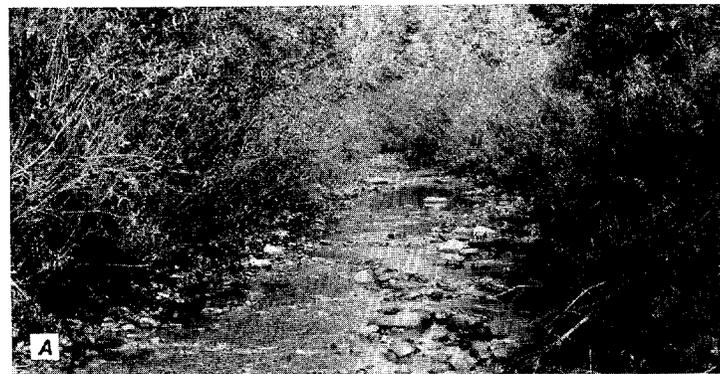
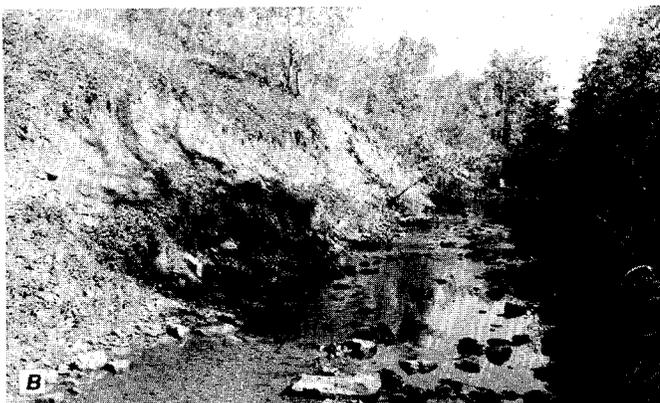
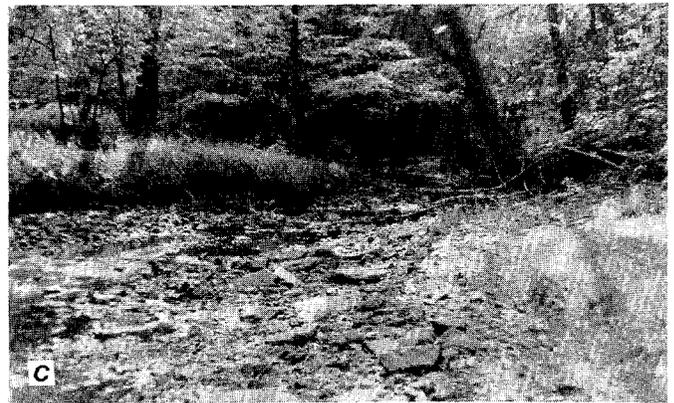
small amount of degradation is probable, upstream from a bedrock outcrop in the channel near sta. 770. Downstream from the relocation, the natural channel is generally stable, and the cut banks that occur at bends may have been present prior to relocation (fig. 196C).

Stability class C2 for upstream part of relocation, B1 for downstream part and for adjacent segments of the natural channel. Channel degradation has probably been inhibited by boulders on the streambed. Bank erosion, mainly by slumping, is restricted to places where the banks are higher than about 2 m, and elsewhere has been controlled by vegetation and by boulders along the bankline.

Figure 196. Five Mile Run at site 97. A, View upstream along relocated channel in vicinity of sta. 770. B, Unstable bank along relocated channel in vicinity of sta. 795. C, Natural channel just downstream from sta. 770.

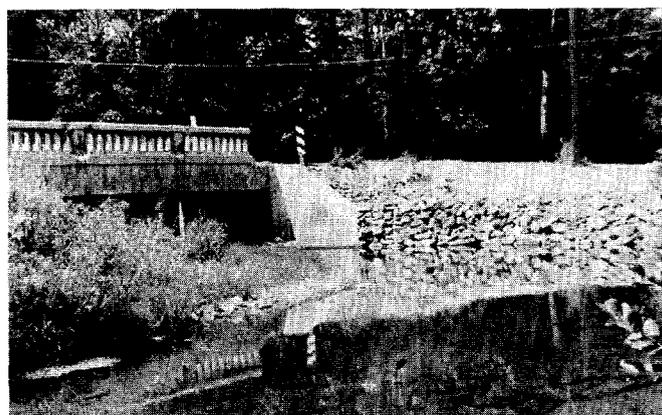
SYNOPSIS--Anabranching channel segment, 134 m in length, was relocated as a single channel and lengthened to 143 m, to avoid a second crossing and to improve channel alinement at bridge (fig. 197). Performance period, 50 yr (1926-1976). Relocated channel was subjected to a 30-yr flood in 1970 and a 70-yr flood in 1972. Because of difficulties in changing the alinement of the roadway, which is in a narrow valley, the relocated channel was built with a sharp bend upstream from the bridge. As observed on a 1968 airphoto, this bend had migrated downstream by a few meters, but the alinement of the approach channel with the bridge was not significantly changed. During the 1972 flood, the bend moved downstream and a large area was eroded at the right abutment. This area was backfilled and the channel was, by 1975, fixed with riprap at the alinement indicated in figure 197 (see also fig. 198).

Figure 198. Bankline of Hunters Run as protected with hand-placed riprap and as established after the flood of 1972 (Photograph of July 1976).

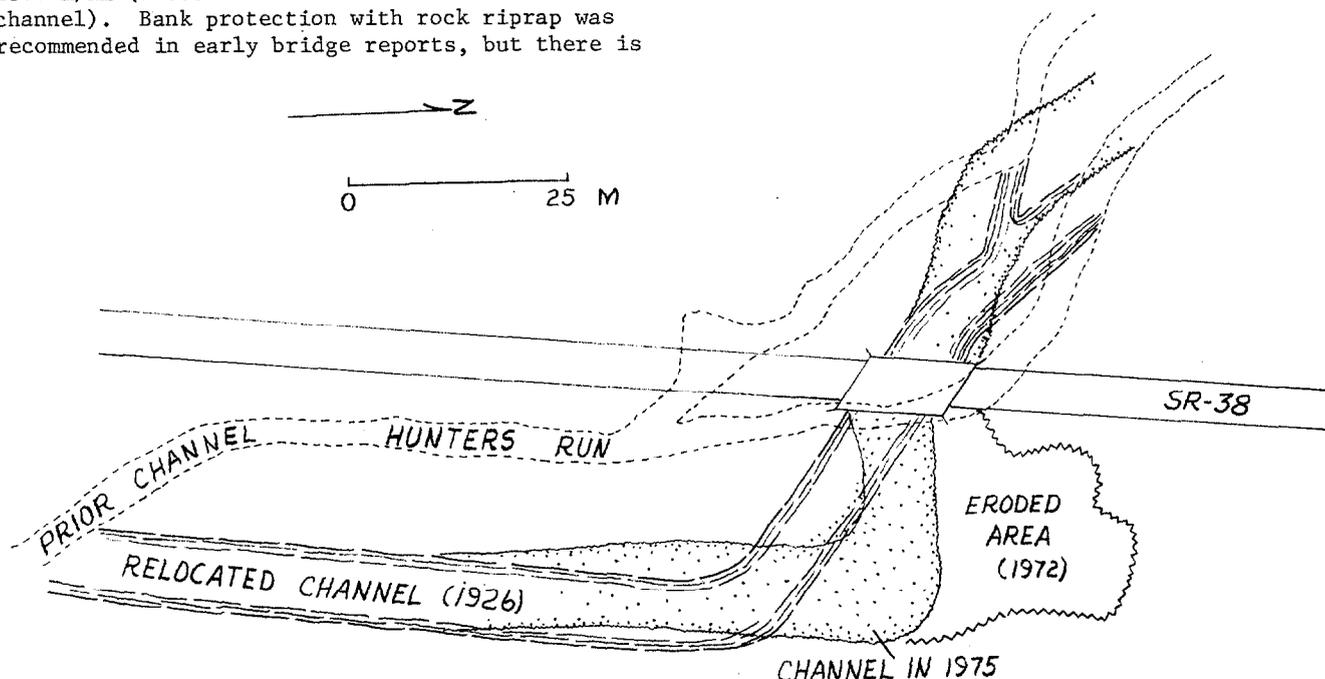
no record or evidence of installation. On an airphoto taken in 1968, the banks of the relocated channel, particularly at the bend, appear to be cut and tree cover along the channel is scant. During the flood of 1972, a large area was eroded at the bend, and the right approach roadway was nearly breached.

DISCUSSION--The nearly parallel trends of stream and roadway, in a narrow valley, presented a difficult problem in crossing location and it was difficult to avoid the bend in the relocated channel. In spite of the sharpness of the bend, it did not erode seriously until the major floods in 1970 and 1972. The damage that resulted could probably have been prevented, or greatly diminished, by bank protection and the establishment of vegetation.

Figure 197. Plan sketch of Hunters Run channel relocation, and of bank erosion that occurred during the flood of 1972.

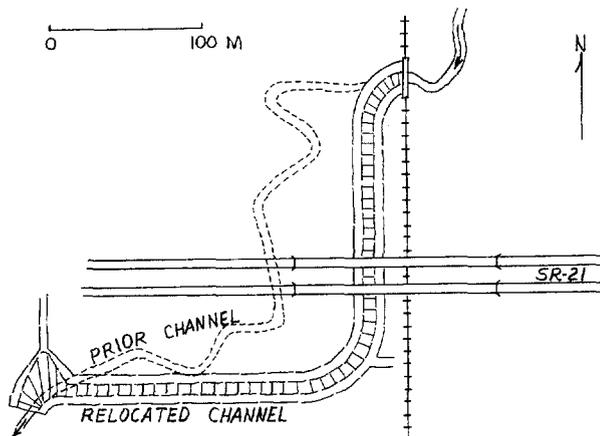
Figure 199. Plan sketch of Gills Branch channel relocation.

DISCUSSION--Local failure of the concrete channel lining is tentatively attributed to the lack of weep holes for relief of hydrostatic pressures. Upstream and downstream transitions between a natural channel and a concrete-lined channel are potential problem areas because

there can be no adjustment, either in slope or cross-section, of the lined channel.

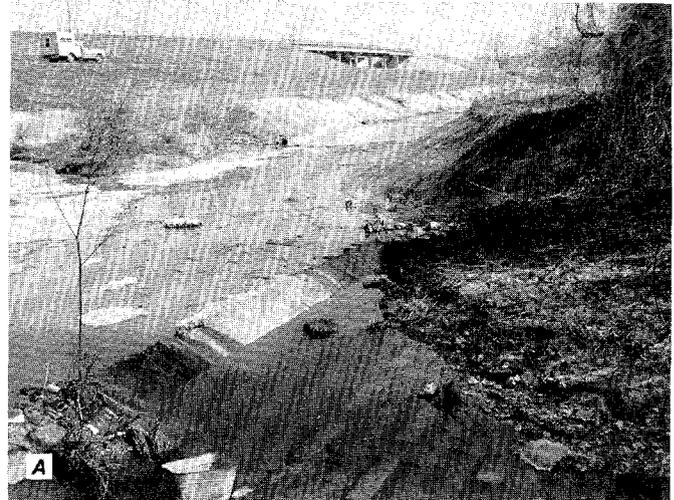
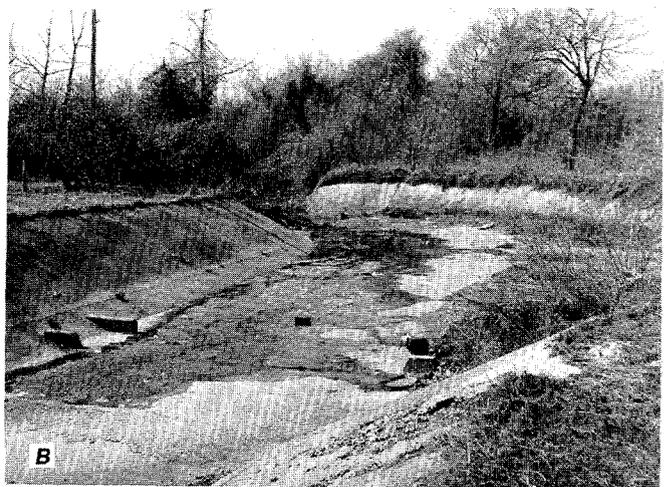
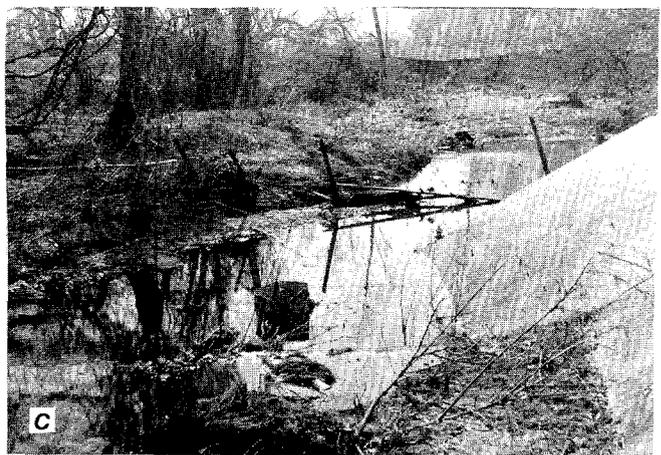
Figure 200. Gills Branch at site 99. A, View along relocated channel, upstream toward bridge, in 1977. B, View downstream toward end of relocated channel, in 1977. Scour hole is at terminus of concrete pavement. C, Natural channel downstream from relocation, in 1977.

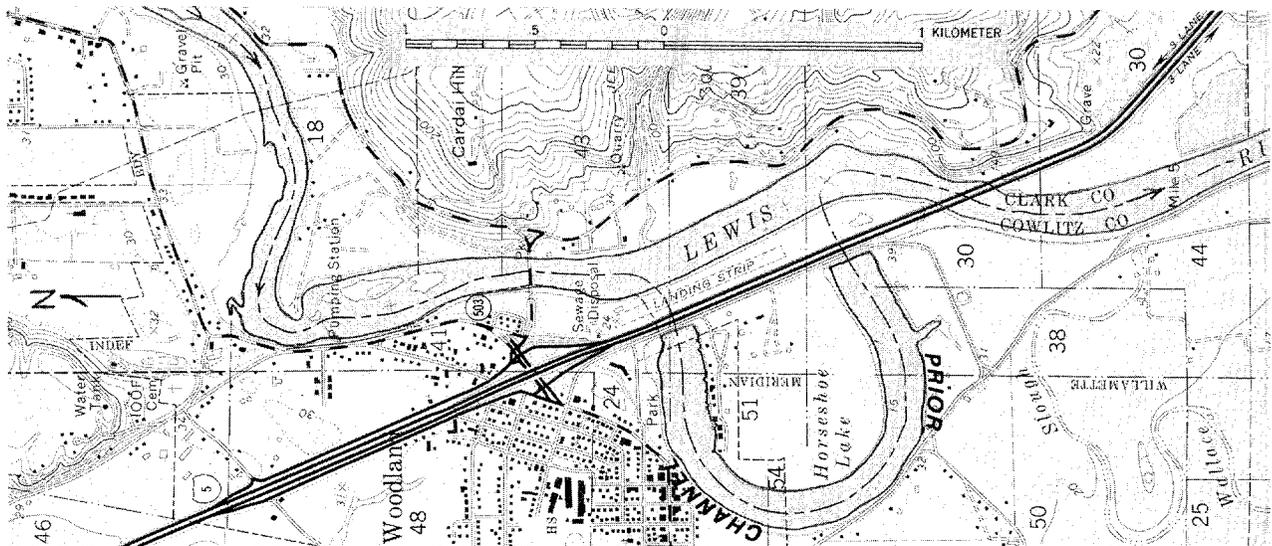
Figure 201. Topographic map of channel relocation, Lewis River. (From U.S. Geological Survey Woodland, Wash., 7.5' quadrangle, contour interval 20 ft, from aerial photographs taken in 1952 and 1970)

DISCUSSION--At the relocated segment, channel length was reduced by a factor of 0.3, and channel slope was correspondingly increased. Comparable meander cutoffs that occur on natural channels are commonly accompanied by a local increase in width and by an increase in growth rate of adjoining meanders; but neither of these effects is apparent at this site. The site is on the flood plain of the Columbia River, about 7 km upstream from the confluence of the Lewis and Columbia Rivers; and the generally low channel slope is probably the main factor in channel stability.

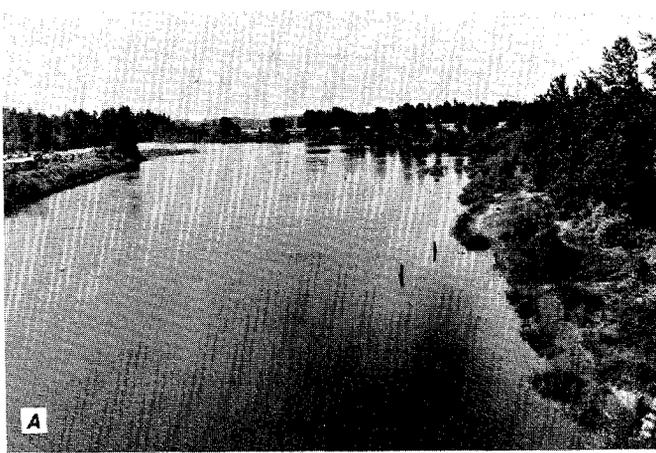
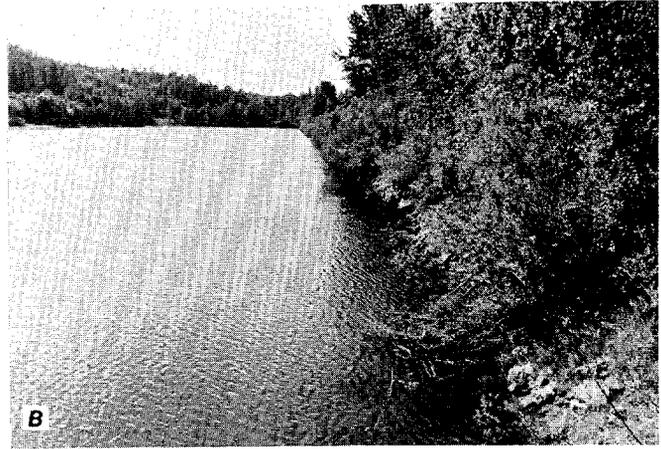
SYNOPSIS--Channel was relocated by cutting off a meander, which shortened the channel segment from a length of 2,800 m to 840 m; the purpose was to avoid a river crossing (fig. 201 ). Performance period, 39 yr. (1940-1979). Since relocation, several large peak discharges have been recorded at the U.S.G.S. gage at Ariel (21 km upstream), but the river has been regulated since 1931 and is not subject to overflow at Ariel. As built, the relocated channel was trapezoidal in cross section, with a bottom width of 152 m, 2:1 side slopes, and a longitudinal slope of 0.6 m/km. According to the plans, the right (west) bank was riprapped to a thickness of 0.6 m and to a height of 4 m above low water; the toe of the riprap blanket was thickened but not extended below the streambed. In 1979, riprap was also observed along the left bank, but the date of placement is not known. Both banks of the relocated channel were stable (fig. 202A ), and trees were well established along the riprapped right bank (fig. 202B ). As measured on a 1970 airphoto, taken at low river stage, the water surface width of the relocated channel ranged from 157 m to 172 m, which is the same, or slightly greater, than the as-built channel width at average water stage. Adjacent segments of the natural channel showed little change in width or configuration during the period 1951-1979, as determined by comparison of airphotos, but cut banks occur at bends.

Figure 202. Lewis River at site 100. A, Relocated channel as viewed downstream from bridge at Woodland, in 1979. B, Growth of vegetation on riprapped right bank of relocated channel, in 1979.

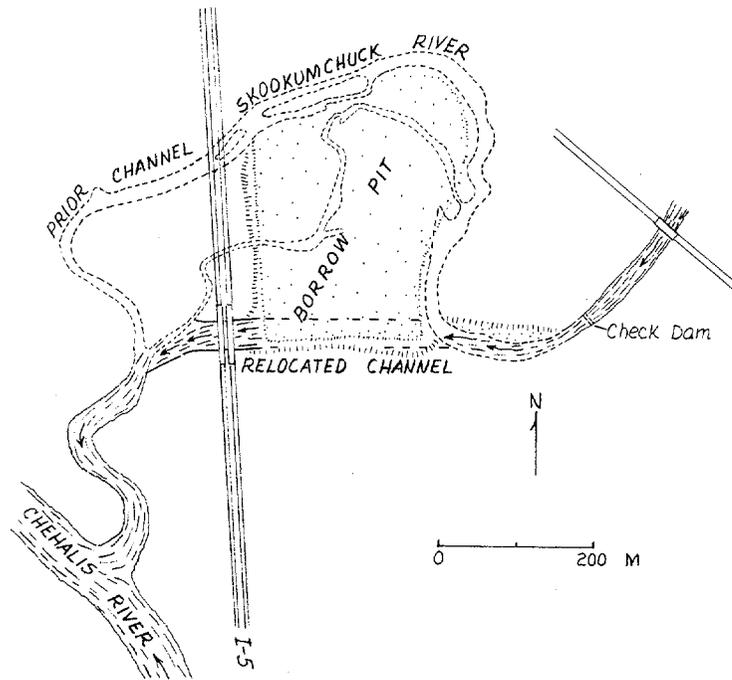
SYNOPSIS--Anabranch channel segment 1,340 m in length was relocated and shortened to 565 m, apparently to avoid crossing of an anabranch and to accommodate excavation of a borrow pit (fig. 203). Performance period, 23 yrs(1952-79). At the nearest U.S.G.S. gage, 19 km upstream, the maximum flood in a 42-yr period of record occurred in 1953. The relocation was connected with a borrow pit operation, and a berm was maintained between the borrow pit and the river channel until diversion of the stream through the south end of the borrow pit and under the I-5 bridge. Thus the south bank of the relocated channel was the south embankment of the borrow pit; and the north bank was indefinite except in the vicinity of the bridge, where the channel was trapezoidal in cross section, with a bottom width of 40 m. As shown on an airphoto taken in 1960 (fig. 204A), the relocated channel was largely blocked with gravel bars and much of the flow was apparently diverted into the water-filled borrow pit. In 1979, boundaries of the relocated channel were more definite and tree-lined, and the channel was somewhat natural in aspect (fig. 204B ). Channel degradation has apparently been inhibited by a massive riprap check dam, which extends to a depth of 10 ft below the channel bottom (fig. 204-C). Rapid bank erosion occurred along the natural channel at the first bend upstream from the relocation (fig. 204A) during the period 1948-1960, but in 1979 the banks had been stabilized with riprap.

Figure 203. Plan sketch of channel relocation, Skookumchuck River.

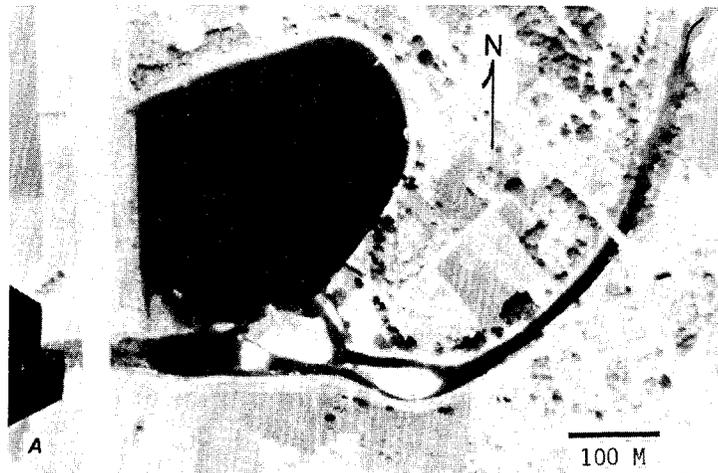
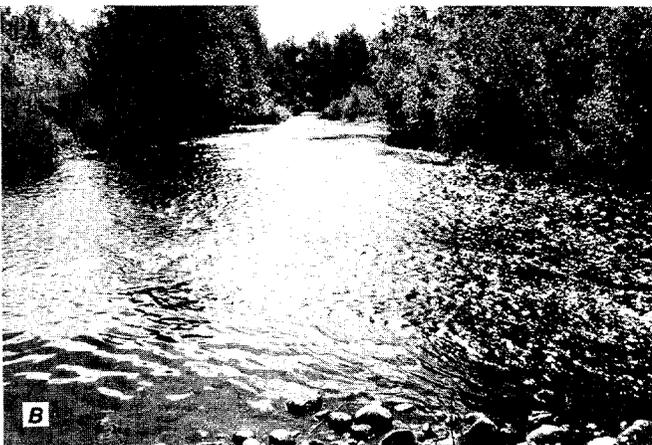
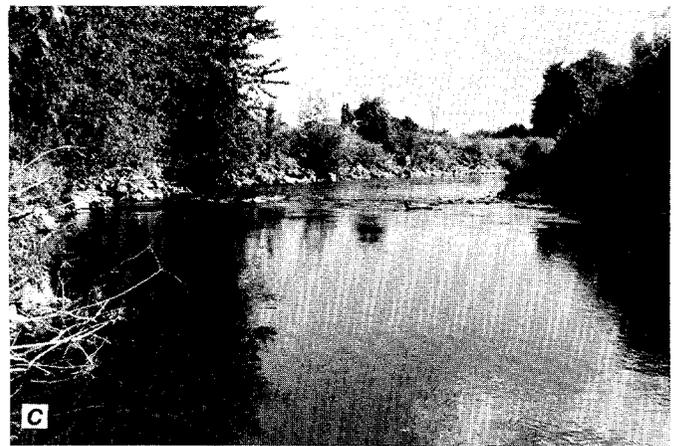
Stability class A2 for relocated channel, which has narrowed in width since relocation; and class B3 for adjacent segments of natural channel. Critical factors in channel performance are the check dam, which has reduced channel degradation; and the flow regimen of the stream, whose annual peak flow does not vary greatly from one year to the next and does not include any extremes during a 42-yr period of record.

DISCUSSION--Relocation by diversion through a borrow pit is an uncommon procedure, which created an artificial lake and a rather indefinite stream channel. Backwater flooding was precluded by the large bridge opening, which had a bottom width about 2.5 times greater than the natural channel. Despite the sharp reduction in channel length, with consequent increase in slope, major degradation was prevented by a massive riprap check dam. Flexible check dams of this sort are probably preferable to rigid structures, in that they are less likely to induce scour and bank erosion at the overfall. As built, this dam in cross section had a surface width of 8 m, which tapered to a width of 1.8 m at a depth of 3 meters below the streambed. Nevertheless, some degradation (estimated at 1 m or less) occurred, which evidently induced bank erosion at upstream bends.

Figure 204. Skookumchuck River at site 101. A, Airphoto of relocation in 1960. Dark area is water-filled borrow pit. (From U.S. Dept. of Agriculture) B, View downstream in 1979 along relocated channel, which follows south end of borrow pit. C, Natural channel just upstream from relocation. Check dam forms riffle in background.

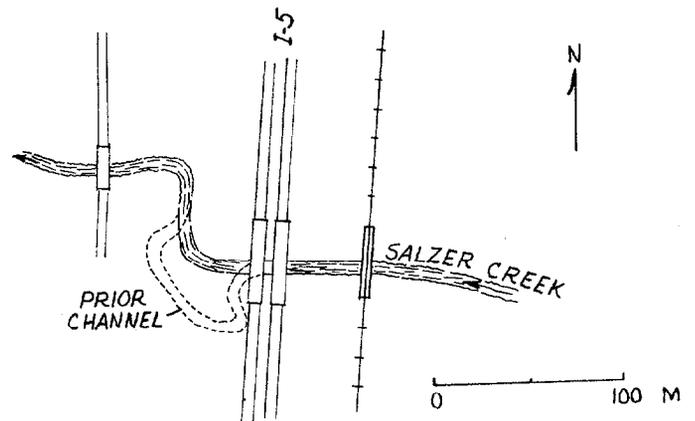
SYNOPSIS--Channel was relocated by shortening a bend, thereby reducing its length from 110 m to 60 m, for purpose of improving alinement of channel at bridge and to accommodate roadway location (fig. 205). Performance period, 23 yr (1952-79). Salzer Creek is ungaged, but a high peak flow was recorded in 1972 at a nearby gage on the Newaukum River. No data were obtained on the as-built cross section of the relocated channel, but the bottom width as observed in 1979 was about 5 m, which is the width of the natural channel. The banks were stable and grassed (fig. 206) and it is unlikely that any significant widening has occurred. No bank protection measures were observed.

Figure 205. Plan sketch of Salzer Creek channel relocation.

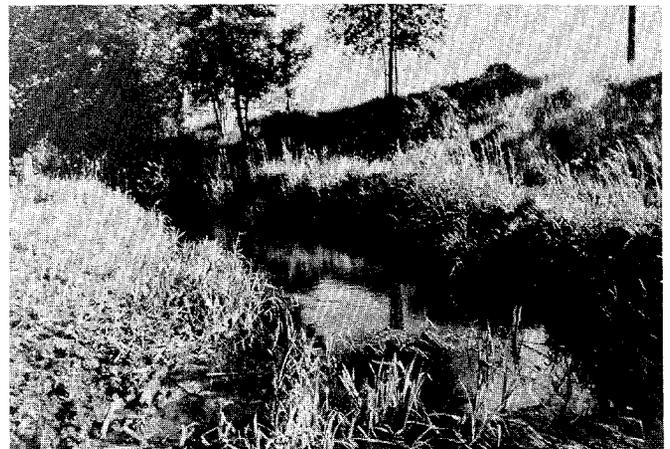
Figure 206. Upstream view of bend in relocated channel, Salzer Creek.

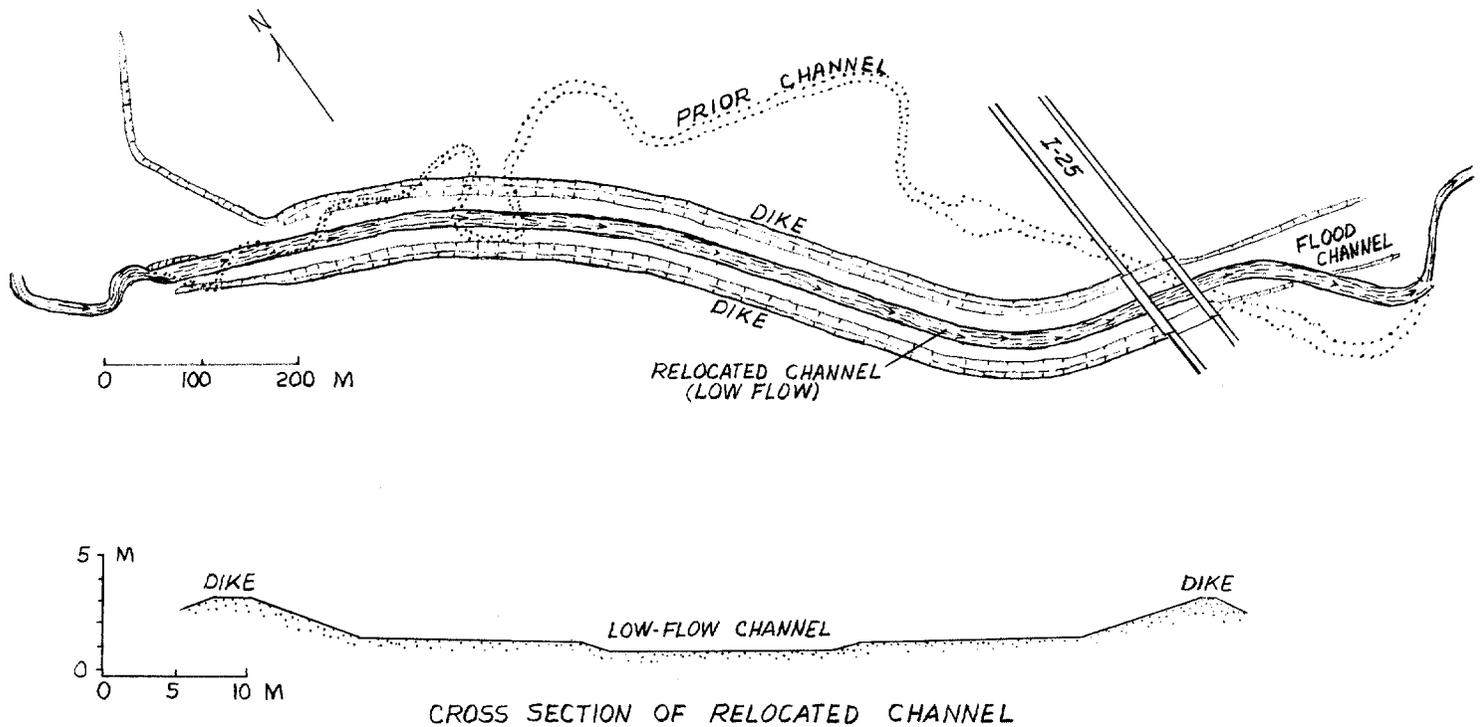
SYNOPSIS--A channel segment about 1,900 m in length was relocated and shortened by a factor of 0.7, for purpose of improving channel alinement at bridge and apparently to facilitate relocation of irrigation ditches (fig. 207). Performance period, 15 yr (1964-79), during which one 10-yr flood occurred. The relocated channel has a bottom width of 15 m and is bordered by dikes (fig. 208-A). Riprap was placed along the banks at the upstream end, and at the curve downstream from the bridge. In 1979, no bank erosion was seen along the relocated channel (figs. 208A and B), and bank stability of adjacent reaches of the natural channel was similar to that observed on an air-photo taken in 1949.

Figure 207. Plan sketch of channel relocation, North Laramie River.

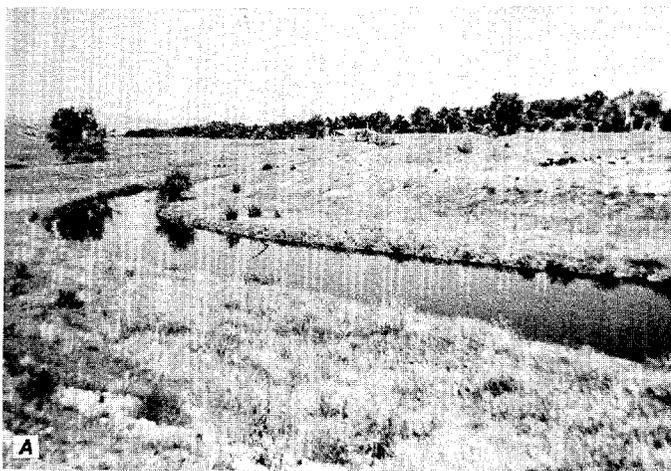
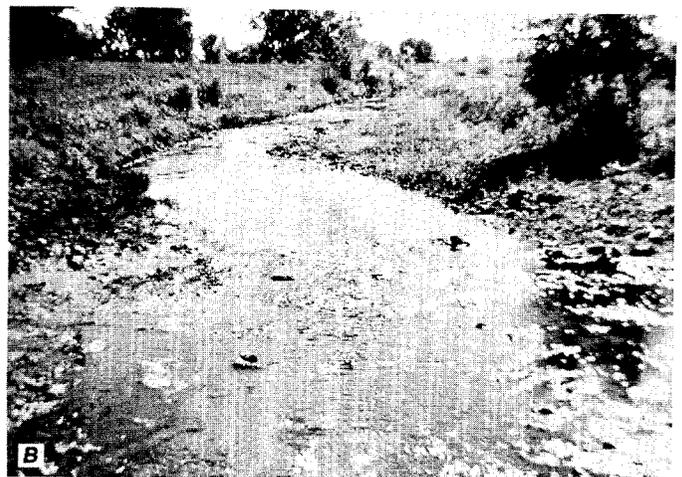
Figure 208. North Laramie River at site 103. A, Relocated channel, as viewed upstream from I-25 bridge, in 1979. B, Relocated channel as viewed from upstream end, in 1979.

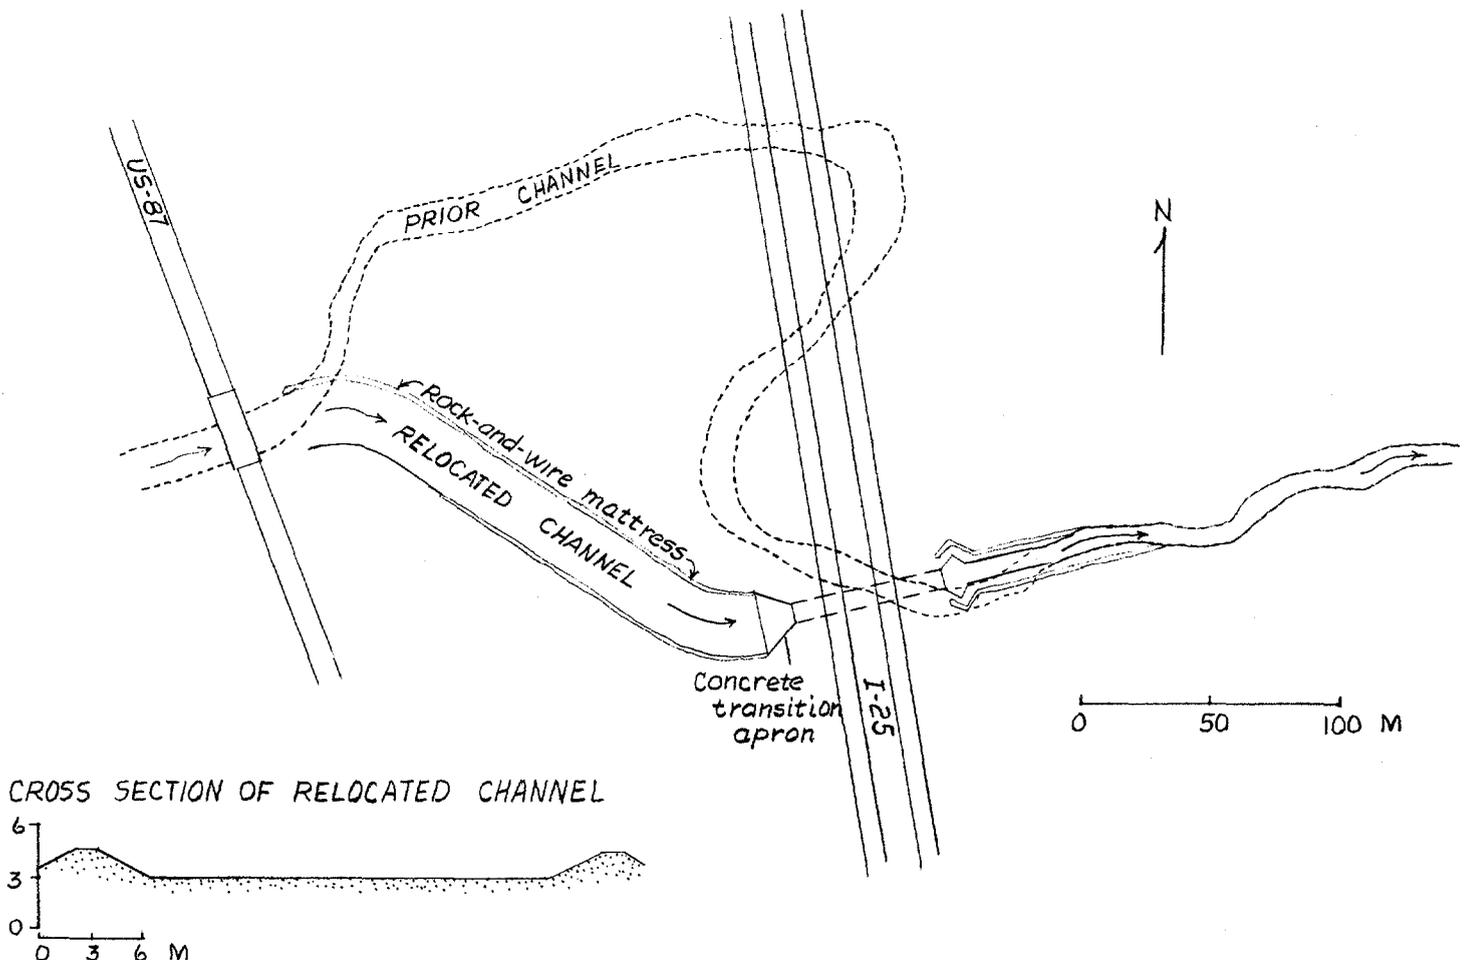
SYNOPSIS--Channel relocation, reach 663 m in length shortened to 417 m, to avoid two stream crossings and to improve alinement of channel with culvert (fig. 209). Performance period, 18 yr (1962-79). At the gaging station on Clear Creek 6.5 km west of Buffalo, a flood having a recurrence interval greater than 100 yr was recorded in 1963, and a 25-yr flood was recorded in 1968. Minor bank erosion has occurred at upstream bend in relocated channel (fig. 210A), but no significant change in channel dimensions. No effect of relocation on adjacent segments of the natural channel could be discerned (fig. 210B).

Figure 209. Plan sketch of Clear Creek channel relocation.

POST-ALTERATION FACTORS--A flood having an estimated recurrence interval of 100 yr occurred shortly after construction. At the culvert transition, bank material was washed out behind the rock-and-wire mattress. To remedy this problem, the mattress was pressure grouted and the wingwalls were extended into the dikes along the sides of the relocated channel. A line of trees, which appear to have been planted, extends along the relocated channel except at the outside of the upstream

curve. Here, bank erosion has progressed about a meter beyond the mattress. In addition, a well-defined point bar has developed at the inside of the bend.

DISCUSSION--The relocated channel has performed well, but bank erosion and meander development may progress at its upstream curve unless the rock-and-wire mattress is maintained.
