Report No. FHWA/RD-80/158

# STABILITY OF RELOCATED STREAM CHANNELS

March 1981  
Final Report

1. Report No. FHWA/RD-80/158		2. Government Accession No.		3. Recipient's Catalog No.	
4. Title and Subtitle  Stability of Relocated Stream Channels				5. Report Date March 1981

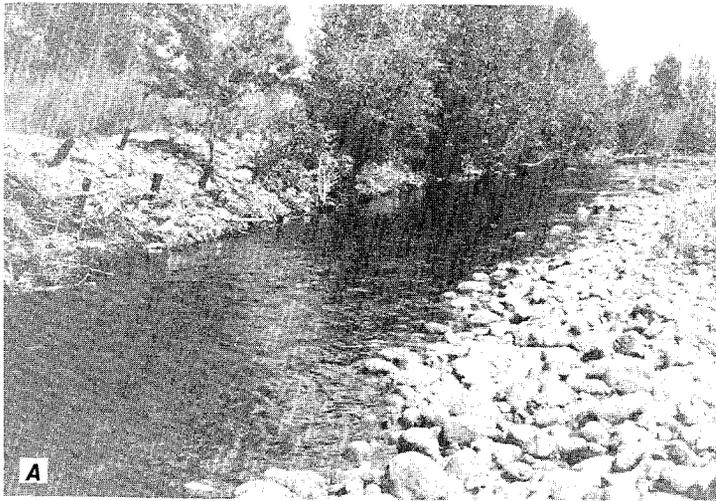
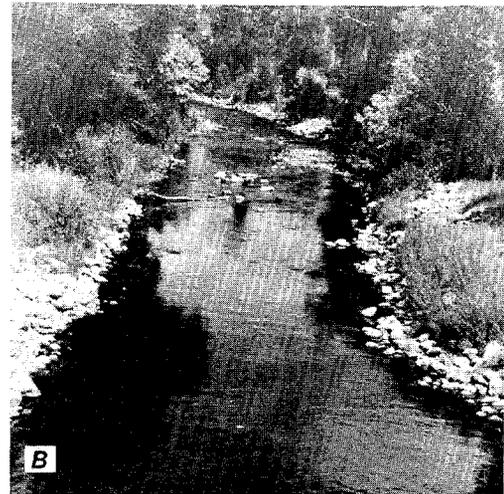
SYNOPSIS--Channel relocation, reach 663 m in length shortened to 417 m, to avoid two stream crossings and to improve alinement of channel with culvert (fig. 209). Performance period, 18 yr (1962-79). At the gaging station on Clear Creek 6.5 km west of Buffalo, a flood having a recurrence interval greater than 100 yr was recorded in 1963, and a 25-yr flood was recorded in 1968. Minor bank erosion has occurred at upstream bend in relocated channel (fig. 210A), but no significant change in channel dimensions. No effect of relocation on adjacent segments of the natural channel could be discerned (fig. 210B).

Figure 210. Clear Creek at site 104. A, View of relocated channel downstream from US-87 bridge, in 1979. B, View of channel downstream from culvert beneath I-5.
