DP-68

PERMANENT GROUND ANCHORS

Volume 1, FINAL REPORT

FHWA-DP-90-068-003
April 1990

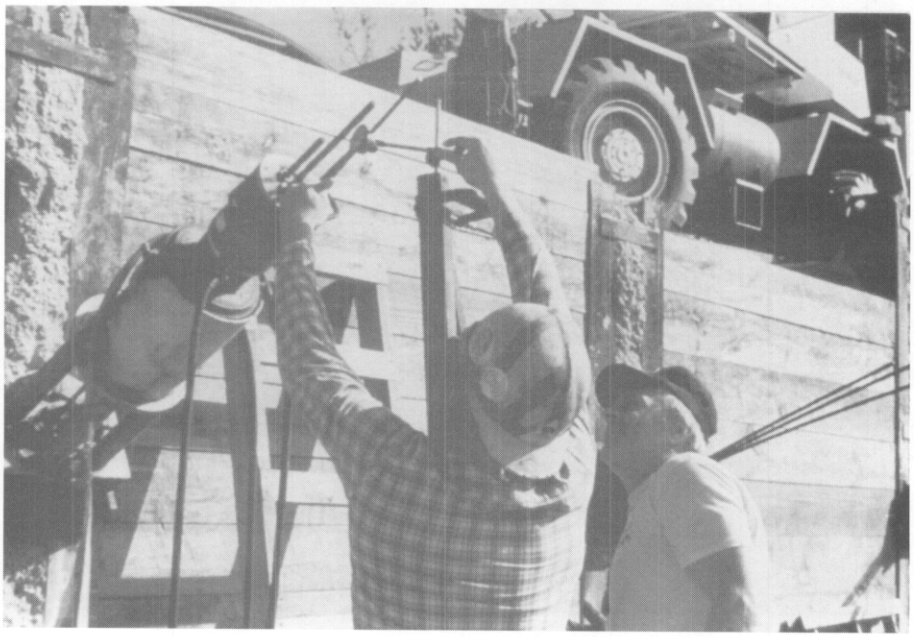
3A.--Testing of First Anchor Row

Figures 3A to 3E show three stages of construction of the anchored wall including the finished product in 1984 and 1988. All visual observations and instrument measurements confirm that the wall and anchors are performing as anticipated in design. Long-term measurements were taken on 60 vertical and horizontal survey points established on or behind the wall during construction. The measurements showed that the movements which occurred indicated active earth pressure conditions and ceased shortly after construction was completed. The survey points still available for reading indicate no definable wall or ground movement has occurred since 1983.

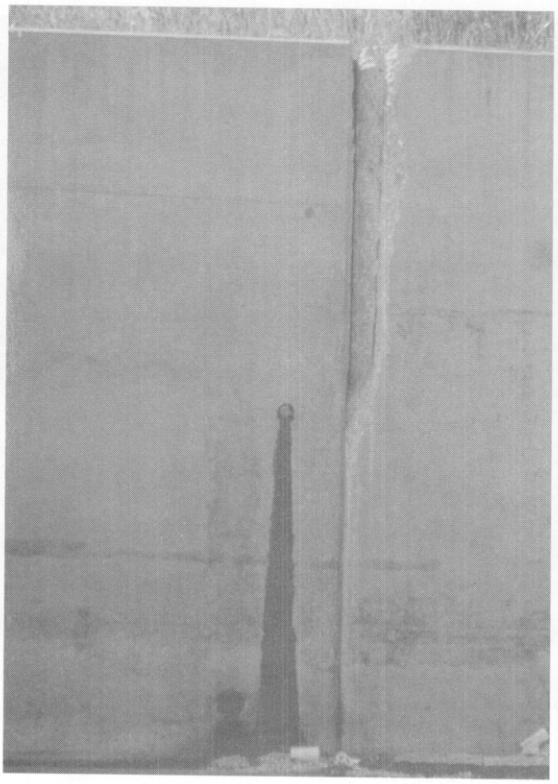
was placed as backfill for the wall, effectively preventing any drainage. Over a 4-year period, the natural water surface behind the wall rose from below the wall footing to within 1 foot of the backslope surface. The hydrostatic pressure increase caused substantial movement of the wall. Spalling of wall joints and base translation caused an upheaval of the I-95 pavement when the passive resistance in front of the wall was exceeded (see Figures 4A-4B). Slope inclinometers, which were installed shortly after movement began, showed the location of the active and passive failure surfaces.

Figure 4A.--Wall Joint Spalling, 1980

The State immediately installed horizontal drains to lower the water level and temporarily stabilize the movement. Analysis of the structural condition of the wall disclosed no major planes of weakness. A lateral earth pressure analysis disclosed that additional lateral assistance was required to establish an adequate minimum safety factor of 1.5 against future sliding. The method chosen for wall repair could neither disturb the ground behind the wall nor infringe on the safe clearance distance to the I-95 pavement. The Interstate Division of Baltimore City, which had responsibility for design, selected a permanent anchor repair solution.

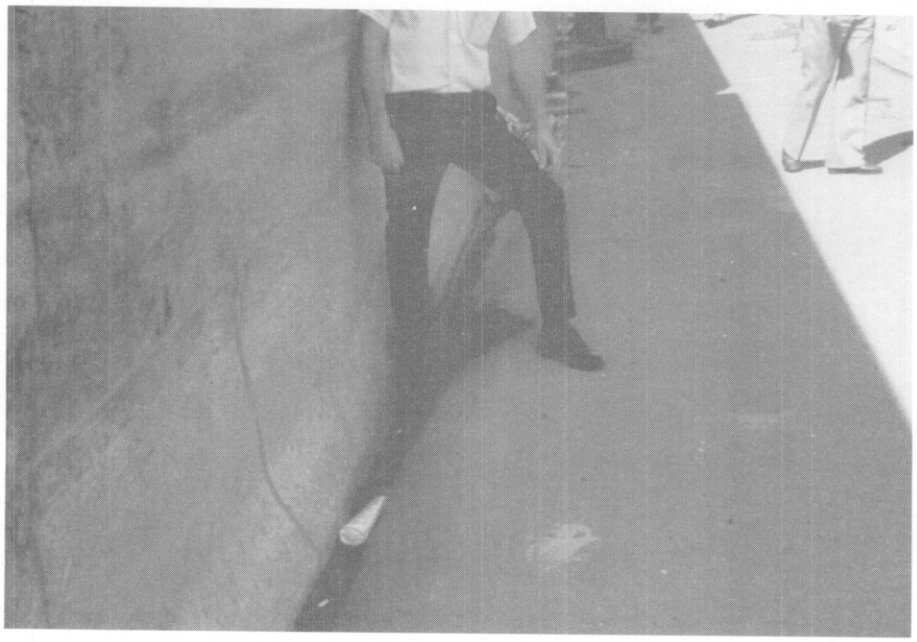
4B.--Wall Base Translation, 1980

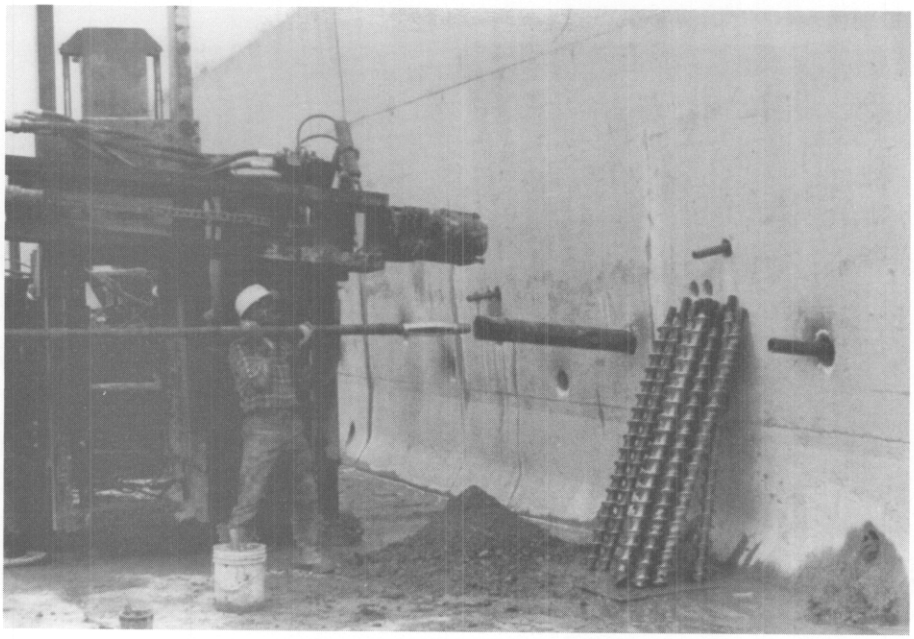
4C.--TMD Anchors Installed, 1981

The TMD anchor has a substantial advantage over the other anchor types installed in cohesive soils in that several stages of grouting and regrouting can be performed in each anchor to develop he required capacity. High pressure grouting in cohesive soils must be done with care as application of excessive pressures will fail the clay surrounding the bond zone, resulting in very low anchor capacities. All 98 anchors on this project achieved the desired test capacity and were accepted (see Figure 4D). After lockoff, all anchor heads were encapsulated with plastic, greased-

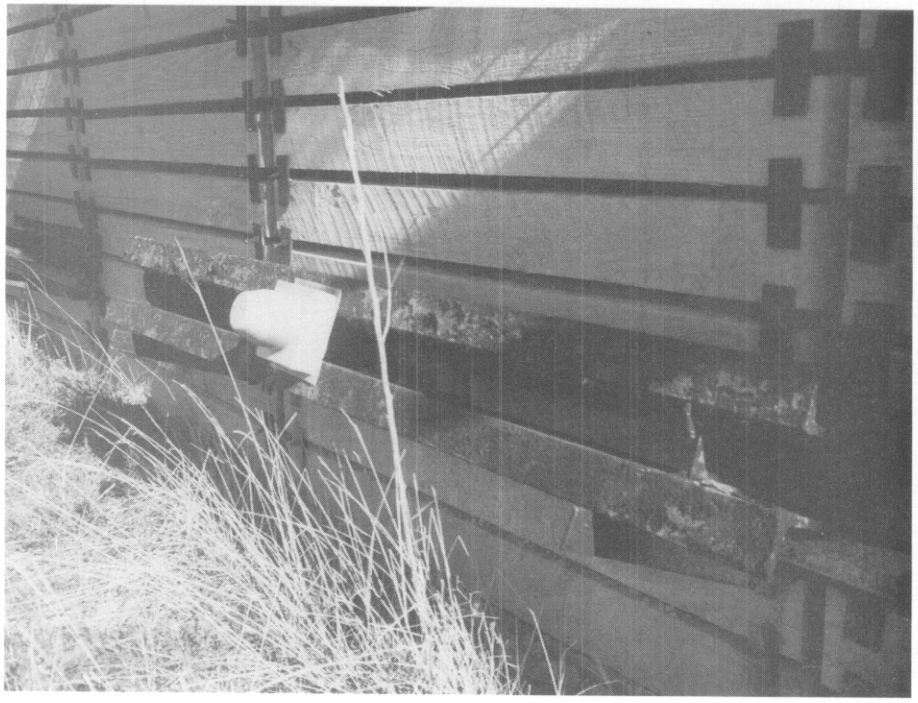
The inspection also disclosed that the "Tapecoat TC Mastic," used as protective coatings on exposed steel surfaces, was blistering and peeling. Corrosion of the waler was observed beneath the peeled coating (see Figure 6E).

Figure 6E
Blistering and Peeling of Protective Coating on Waler

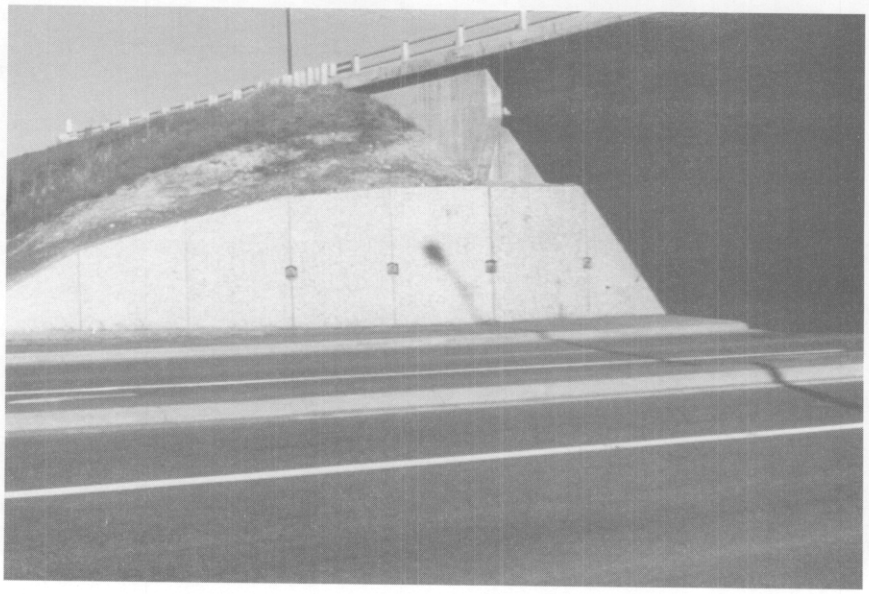
Figure 7.--Alaska Dimond Boulevard Project

Although the final report for this project has not been submitted, observations made for a year after the construction indicate the anchored wall is functioning as designed (see Figure 7). It does appear that the wall moved <u>into</u> the backslope a small amount which caused a decrease in the lockoff load on the tendons. The reasons for this movement and decrease in load may be better known when the final report is received in 1990.

Completed Dimond Boulevard Wall

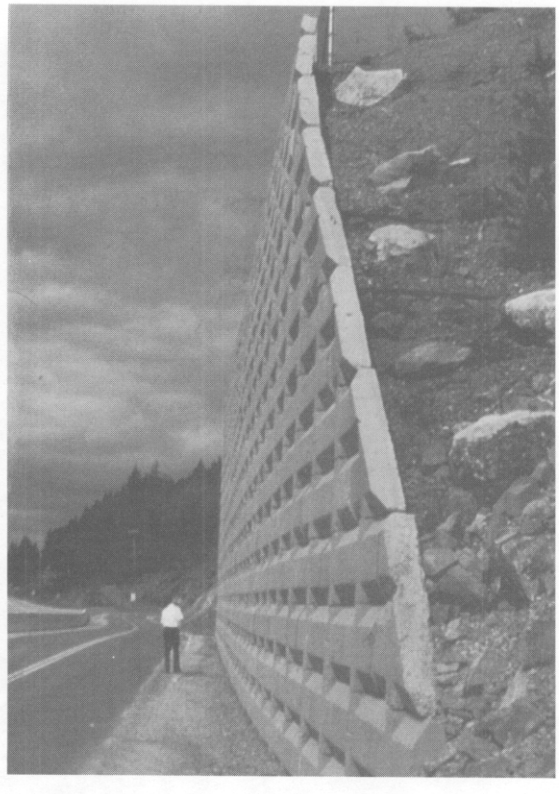
A 34-foot high by 200-foot long retaining wall was built in 1975 to preserve a pioneer cemetery located above the proposed grade just west of Hope, Idaho. The wall was designed with a flexible face of precast reinforced concrete segments (stretchers) interconnected by vertical steel rods. Lateral support of the flexible panels was achieved in the lower 12 feet with rock bolt tiebacks, in the middle 8 feet by gravity wall design, and the upper 14 feet by deadman anchors. Following construction, the stretchers began to crack and spa11 and the face began to tilt. A study of wall conditions in 1978-79 concluded that interaction of the vertical rods and reinforcing steel of the stretchers was causing the reinforcing steel to break out of the stretchers in the lower 12 feet of the wall (see Figures 9A-9B).

Figure 9A.--Hope Wall Condition, 1980

It was recommended that the wall be strengthened in this section and that long-term corrosion of unprotected steel wall elements be considered in the rehabilitation.

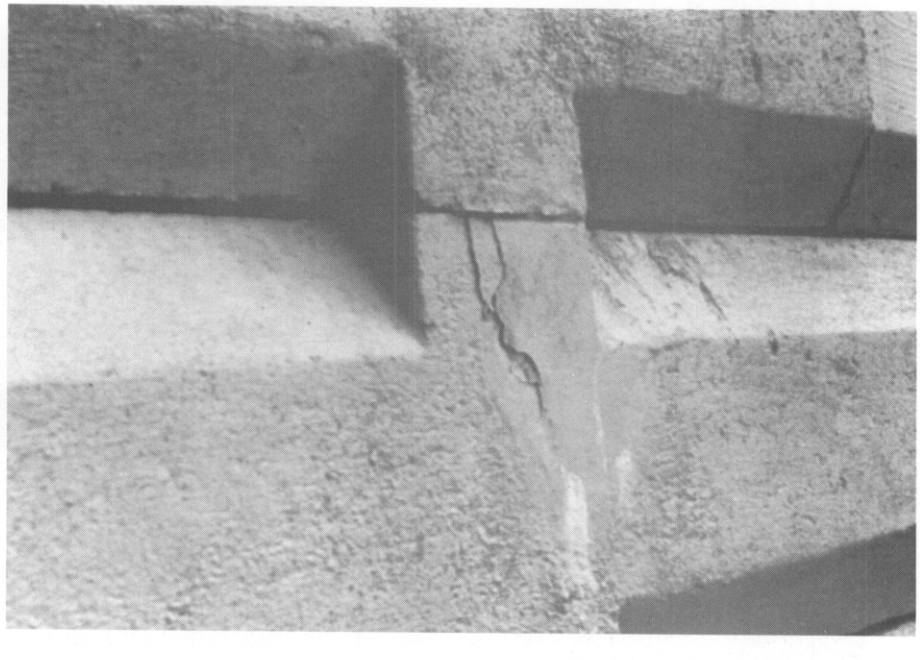
Figure 9B.--Closeup of Crack in Lower 12 Feet of Wall

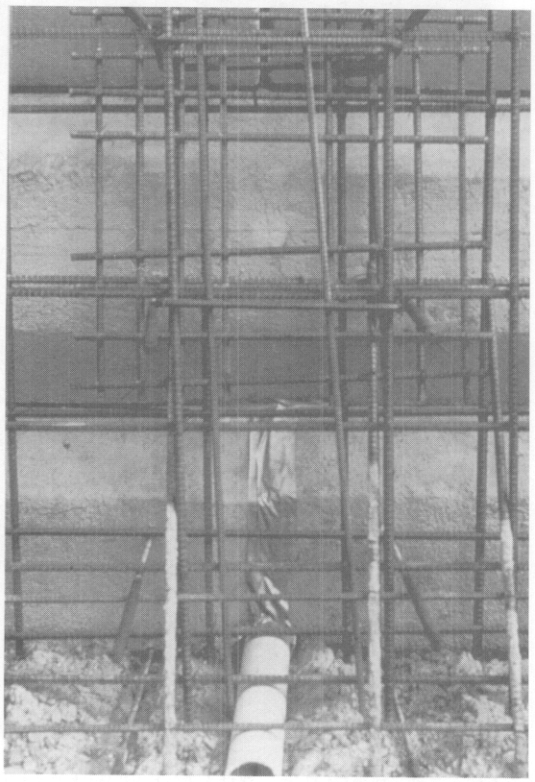
Figure 9C.--New Reinforced Fascia Wall
Poured Prior to Anchor Installation

The permanent anchor design was complicated by the delicate condition of the existing wall face. Normally, the anchors would be drilled through the wall and then stressed against the existing wall face to above design load. However, the thin wall face could not withstand any concentrated load. The available clearance to the adjacent roadway allowed placement of a 16-inch thick reinforced concrete face over the bottom 12 feet of the existing face. Although this thickness was adequate to distribute the anchor design load over the face area, test stressing the anchors to above design load on this new face was not deemed prudent.

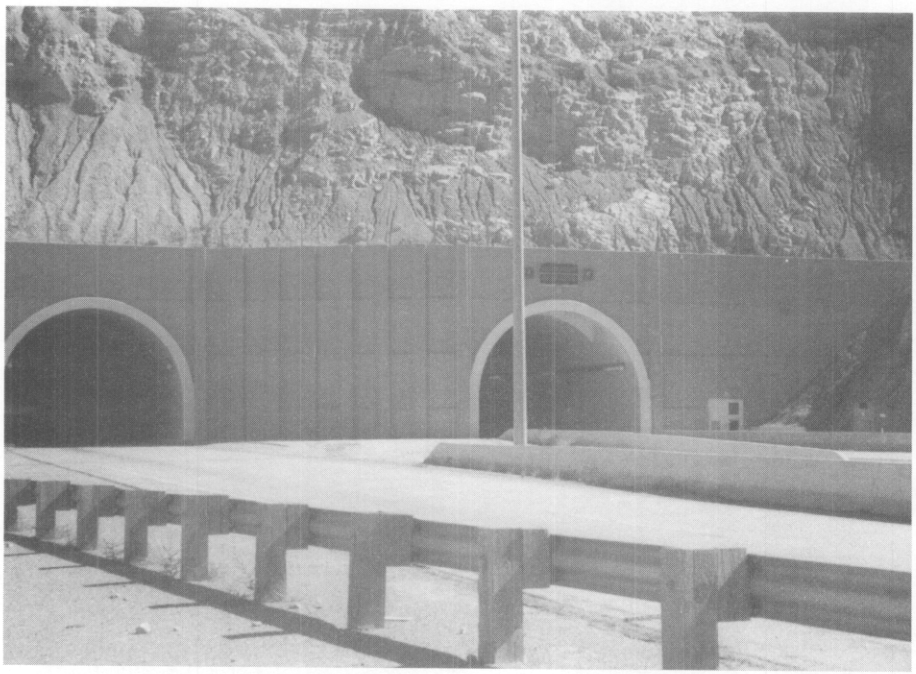
Figure 10A.--Completed West Portal, Carlin Canyon Tunnel
Vertical Beams Contain Anchors

Two problems were overcome in the permanent anchor design. First, the thickness of the existing wall was inadequate to support and distribute the required permanent anchor loads (45 to 70 tons per anchor). This problem was resolved by casting vertical concrete beams at specified center-to-center distances along the panels. The 1 3/8-inch diameter single-corrosion-protected bar anchors were placed through and stressed against the beams, which were adequately reinforced to sustain the stressing load and distribute the force over the panel height. The second problem only occurred at panels where the backfill had been removed. Permanent anchors are normally post-tensioned to the required proof load after installation. However, passive resistance behind the excavated panels was insufficient to allow stressing the anchors to the test loads without damaging the wall. In addition, backfill should not be placed and compacted around anchors that have previously been installed. Backfill compaction operations can damage the corrosion protection of the permanent anchor and can cause bending of the tendon free length under the compactive load. Such a backfill procedure was used in the original portal construction and reportedly caused inward wall deflections due to bending of the rods.
