AC NO: AC 20-76
DATE: 21 Oct 71

MAINTENANCE INSPECTION NOTES FOR BOEING B-707/720 SERIES AIRCRAFT

SUBJECT: MAINTENANCE INSPECTION NOTES FOR BOEING B 707/720 SERIES AIRCRAFT

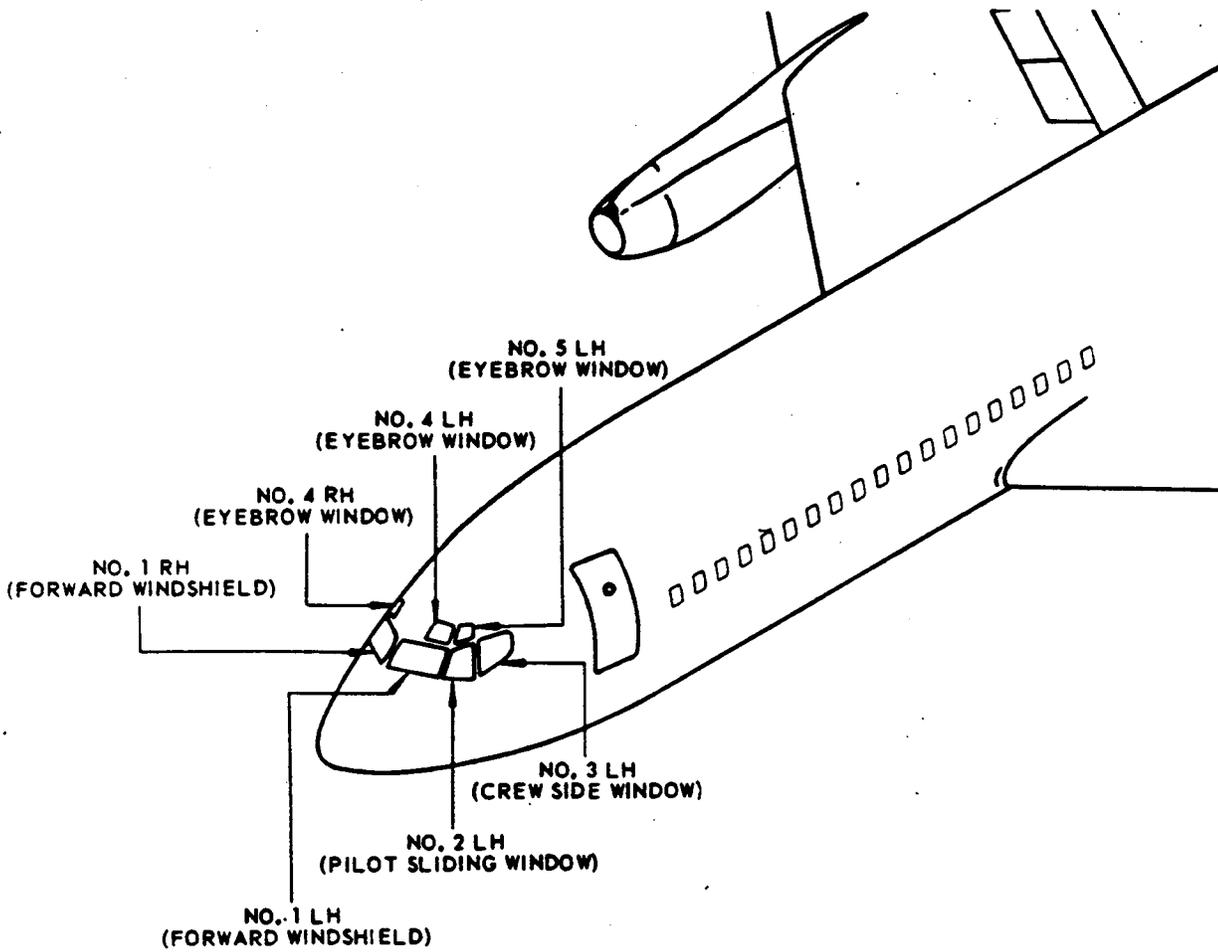
FIGURE 1. CONTROL CABIN WINDOW LOCATIONS

- (1) Inspection. Examine each window for:
- (a) Scratches, cracks, delaminations, discoloration of panes, and chipping.
 - (b) Binding of sliding windows, positive locking and locking mechanism release, seal deterioration, wear of bushings and guides.

- (c) Loose or missing window frame fasteners.
 - (d) Rain repellency of windows.
- (2) Scatched Windows.
- (a) Inner pane scratched. Inner pane scratches may contribute to a window failure under cabin pressure and heat.

- (b) Outer pane scratched. Scratches on the outer pane reduces pane strength under normal cabin pressurization conditions. Any scratch causes stress concentration.

- (3) Cracked panes. Any window with a cracked pane should be replaced.
 - (a) Inner pane cracked. This pane takes pressurization load and the airplane should not be pressurized if this pane is cracked.

- (b) Outer pane cracked. Cracks that extend toward the center of the pane or span the pane usually become progressively worse and the pane should be replaced at the first opportunity.

- (c) Cracking of vinyl usually occurs in the upper aft corner of the No. 1 windshields. It is a fail-safe, bird-proof core. The window should be replaced at the first opportunity.

- (4) Delamination. A delamination is the separation of either pane of glass from the vinyl core. When minor delamination occurs between the inner or outer pane and the vinyl core, the airplane could be flown pressurized. An electrically heated window need not be replaced due to delaminations unless the visibility is restricted or lack of window heating, or the pane is scorched.

- (5) Chipping. Chips on the laminated surface of the glass are layers or flakes of glass broken from a surface by excessive stresses. Presence of glass chips on laminated surface should be reason enough for window replacement if airplane is to be pressurized.

- (6) Arcing. Arcing will produce hot spots with possible eventual result of a cracked pane.
- b. Passenger Cabin Windows. These windows are located between the fuselage frames in the areas where passenger seating is provided. Passenger cabin windows consist of outer, center, and inner panes. The outer and inner panes are each capable of taking the full cabin pressurization load. The inner pane is nonstructural. All three panes are acrylic. The emergency exit hatch passenger window installations are very similar to those for the outer and center panes of the other passenger windows. (See Figure 2).

- (b) Scratches are easily detected by visual examination and are critical if they exceed certain limits. Manufacturer's maintenance manuals provide recommended limits on scratch, depth and length and should be consulted. (Figures 1 & 2)

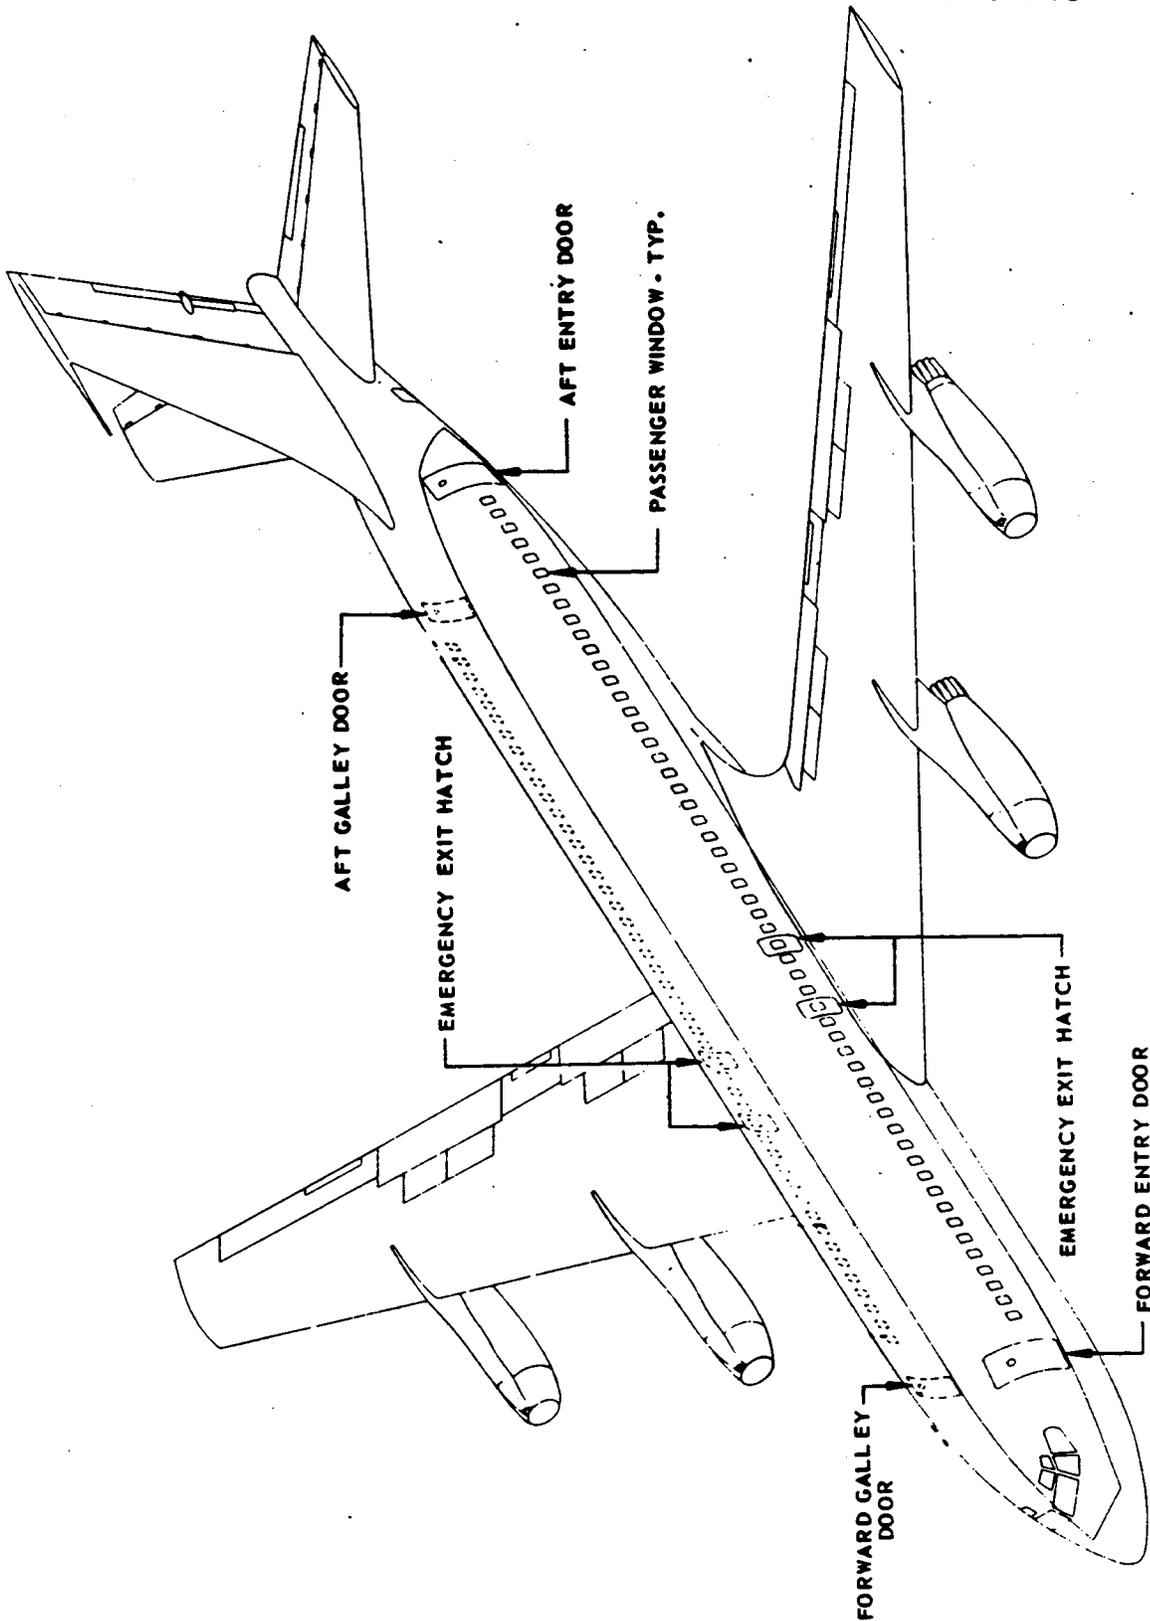
FIGURE 2. PASSENGER CABIN WINDOW LOCATIONS

- (1) Inspection/checks of passenger cabin windows. Examine the window for:
 - (a) Scratches, cracks, and crazing of acrylic panes.
 - (b) Deterioration of seals.

- (c) Marks, Scratches, and dents.
 - (d) Loose or missing fasteners at window retaining brackets.
